**BC 240494 – Lot 44, 5 Nirmal Way, Rolleston**

**Photos for failed Post wrap Cavity Inspection**

**POST WRAP / CAVITY** - 09 Jul 2024 @ 17:38 by Matt Lloyd

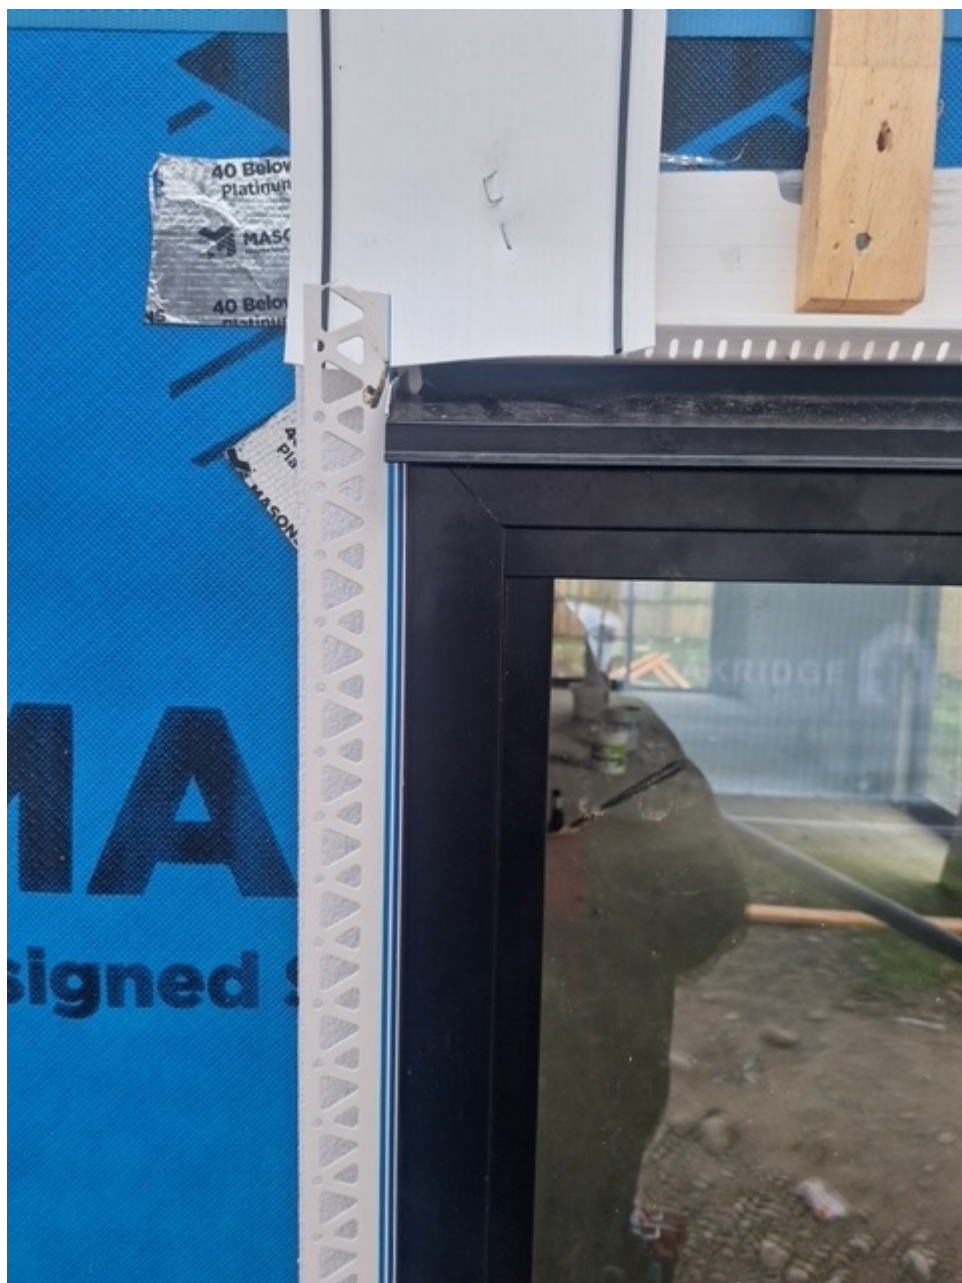
Head flashing above window on gable end in weatherboard cladding has been cut 100mm short at either end. To be replaced. Clear, verifiable evidence to be provided showing new head flashing in place, taped to wrap with stop ends sealed. Ensure compatible flashing tape for Masons UNIwrap is used.
