# Land Information Memorandum

5/80 Mackworth Street

LIM number: H10246001

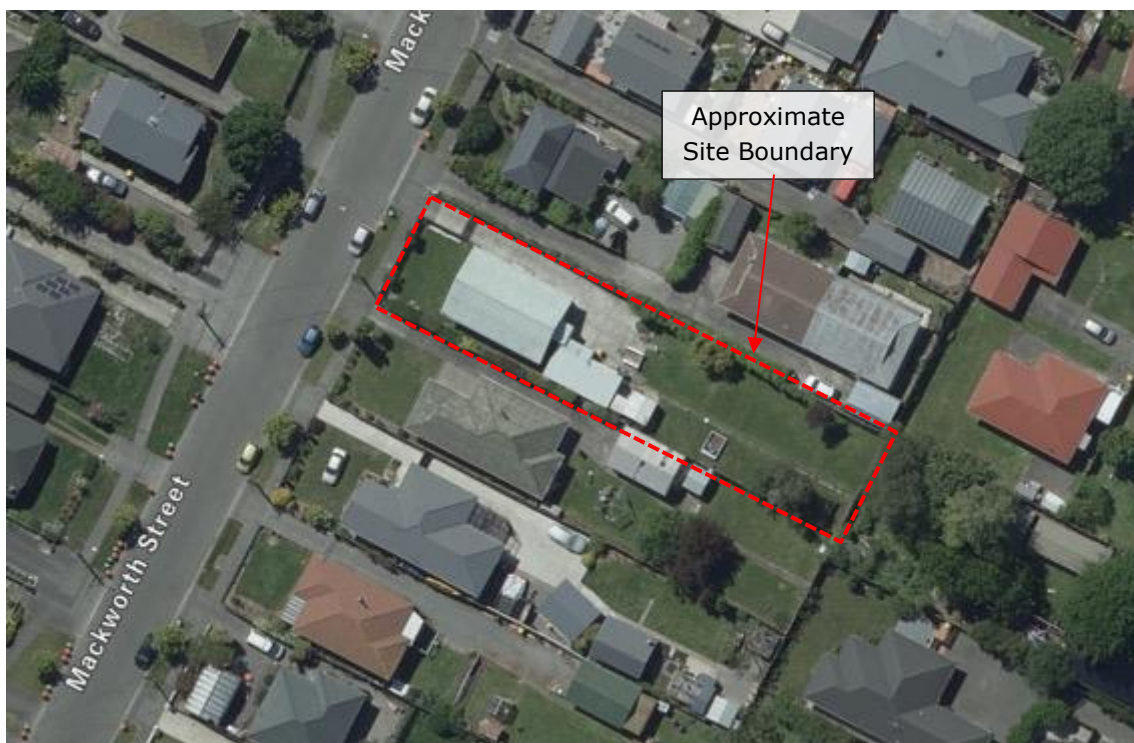
The site is rectangular in shape, extending southeast from Mackworth Street and covers a total area of approximately 809m<sup>2</sup>. The Google Earth coordinates of the approximate centre of the site are: 43°32'24.04"S, 172°40'24.18"E.

**Figure 1: Site Aerial Photo (Courtesy of Canterbury Maps)**

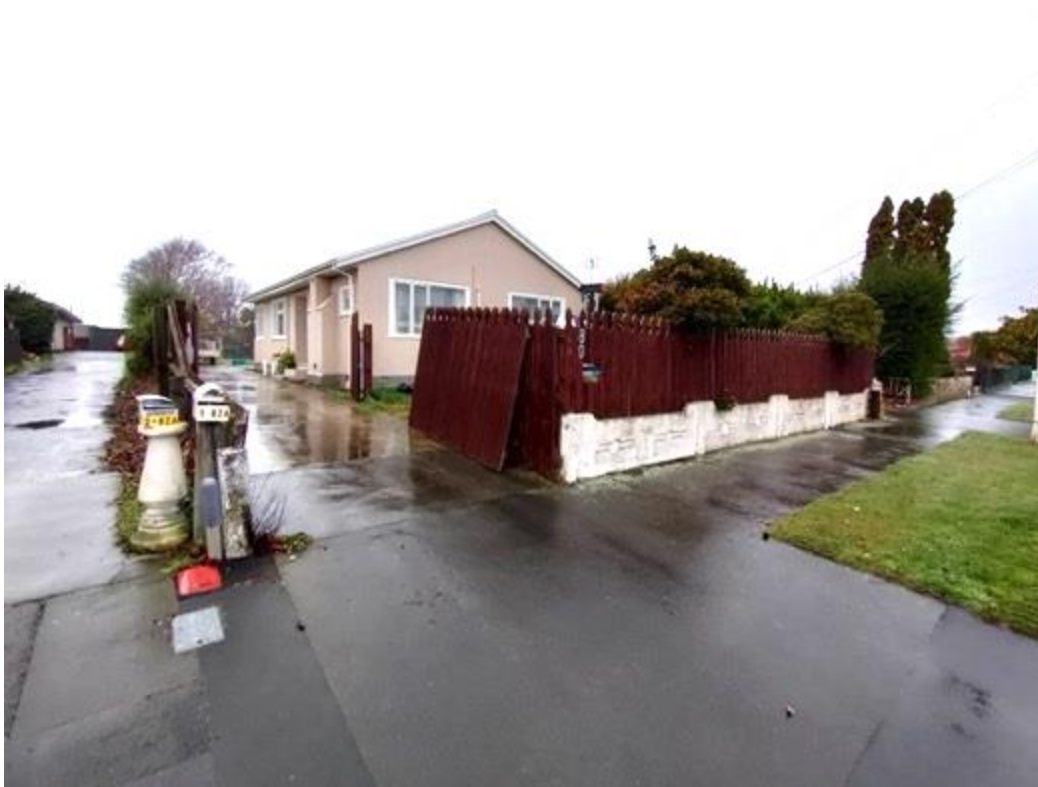
**Figure 2: View of the entrance to the site (Looking Southeast)**

No ground damage was evident at the time of EDC's site visit (19/07/2021). Figures 2, 3, 4 and 5 show the site, taken during the EDC site walkover:

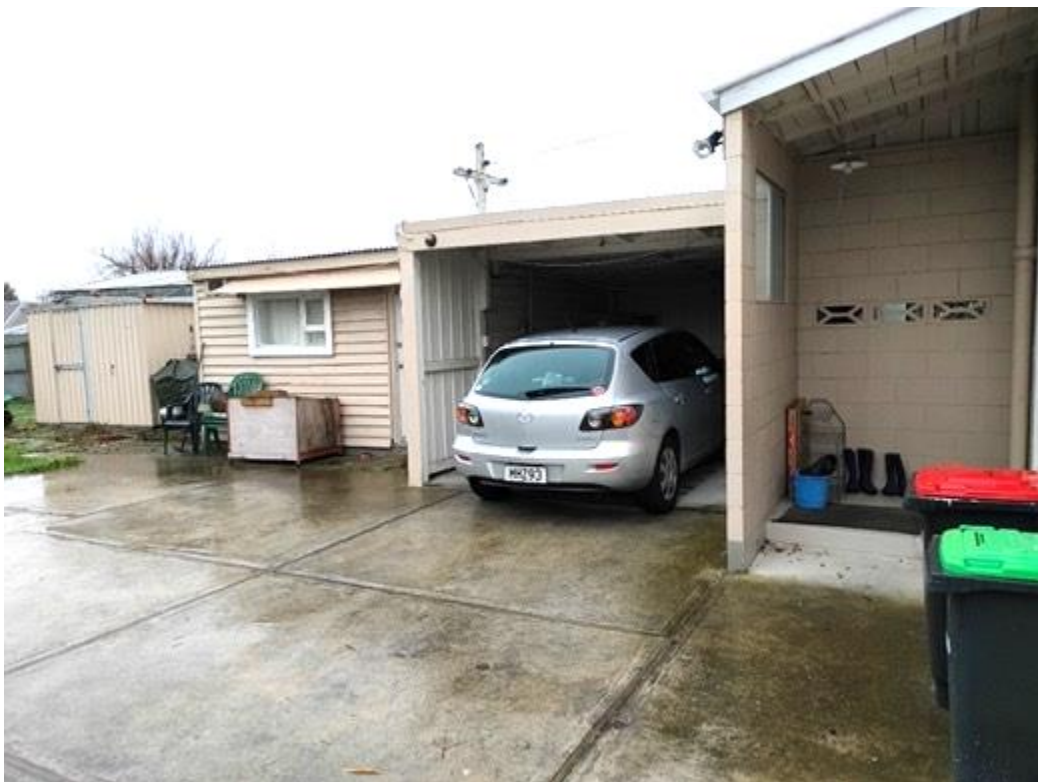
**Figure 3: View of the carport and attached shed (Looking Southeast)**

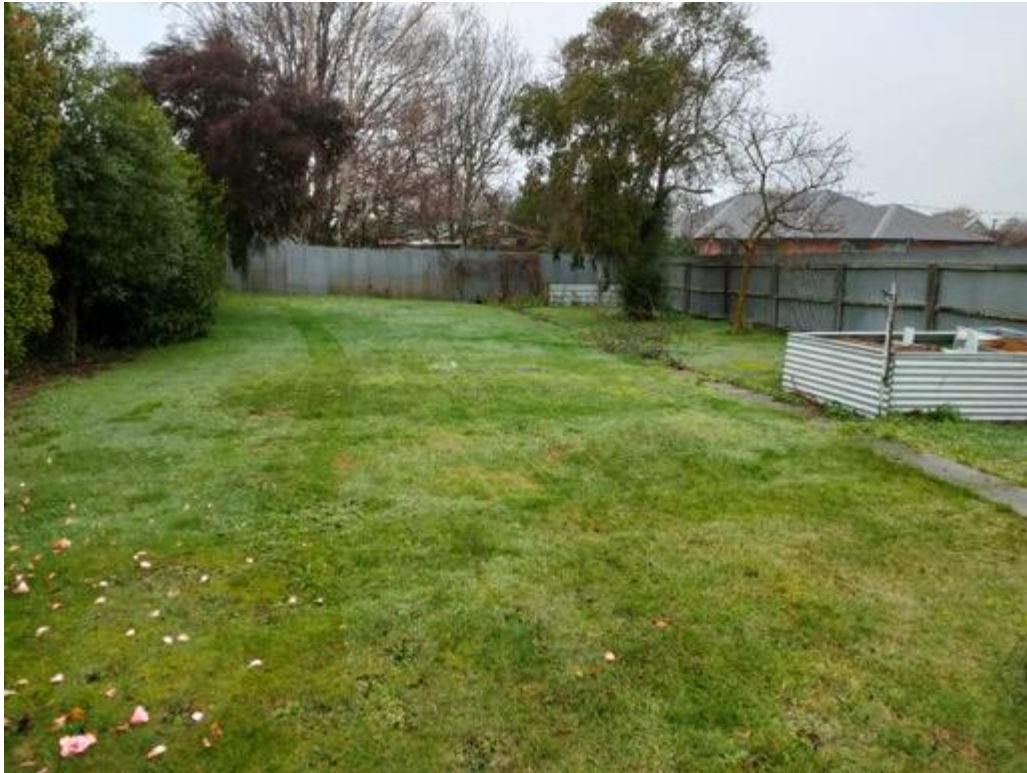
**Figure 4: View of the rear garden (Looking Southeast)**

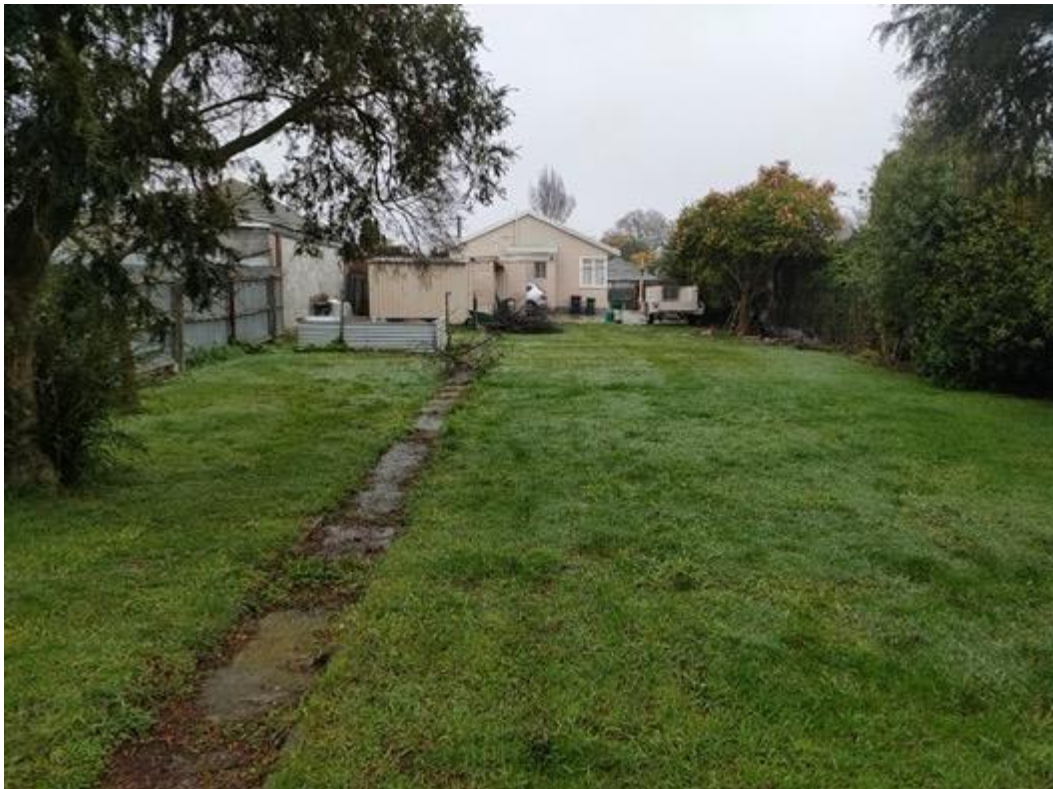
**Figure 5: View of the rear garden (Looking Northwest)**

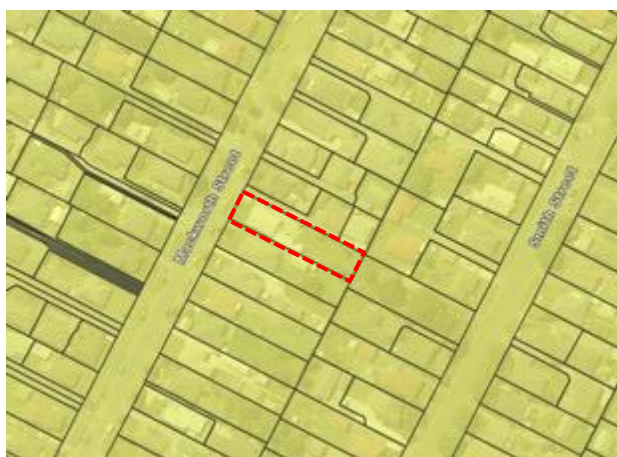
The Canterbury Maps website indicates the site is located in an area labelled 'Green Zone - Technical Category 2' (TC2). According to the MBIE, TC2 classification indicates minor to moderate land damage from liquefaction might occur.

**Figure 6: Site Aerial Photo with Current Technical Category Classification Area**
