## **\*\* APPENDIX**

| Project name | New Gourlay Home |
| Address | 16 Oaklands Place, Ngongotaha Rotorua |

O'Brien Geotech Ltd has been engaged by Mark Lam to undertake a geotechnical assessment for a proposed new house at 16 Oakland Place, Ngongotaha. This report outlines the investigations undertaken, the analysis carried out and provides recommendations on the foundation aspects of the proposed development.

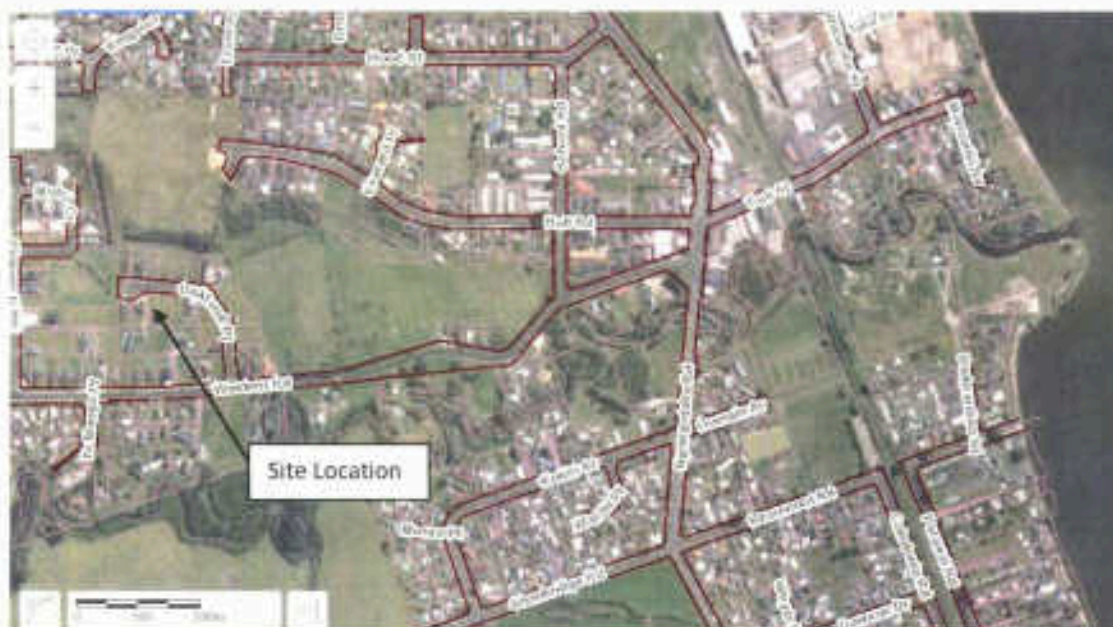
Figure A: Site Location

The site is located in Stage 2 of the Oakland Subdivision in Ngongotaha, approximately 1.5km from the lake. The site location is shown on Figure A below. It is legally described as Lot 70 DP 389915 and has an area of 1143m<sup>2</sup>.

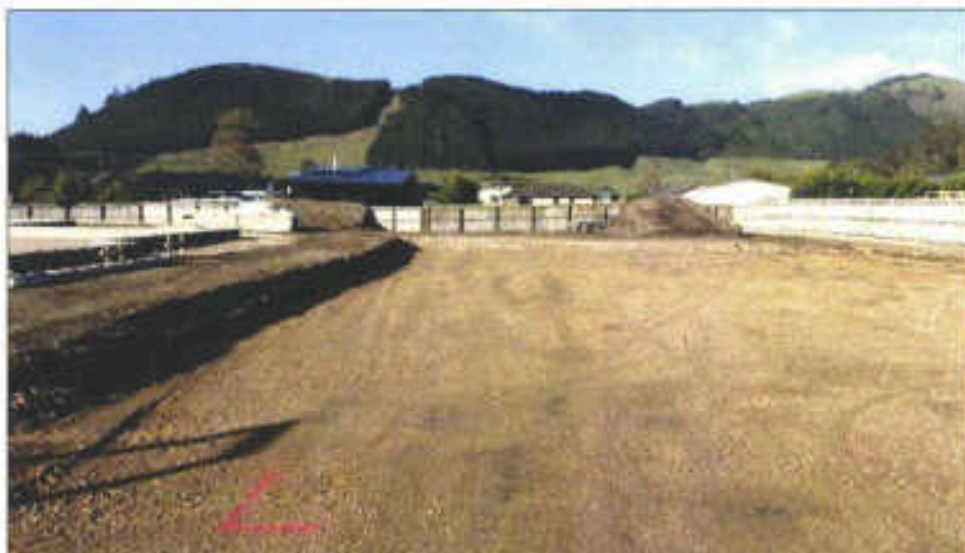
Subgrade inspected and probed. Considered to be acceptable, work can proceed.

*Photograph Showing Cleared Site*

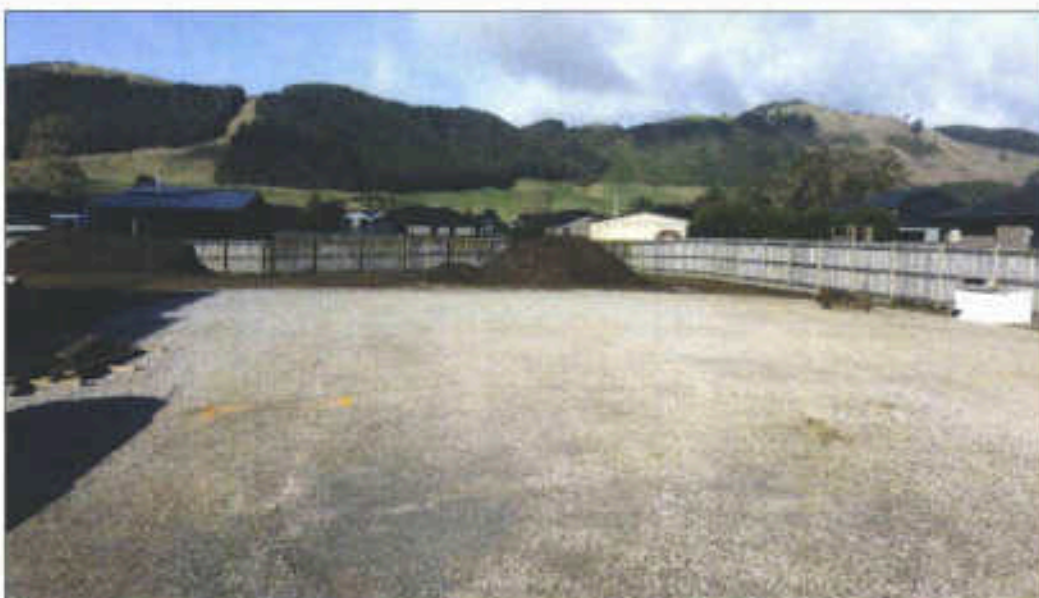
Fill fines tested using Scala Penetrometer. Approximately 400mm of fill present. Test locations and test results attached. Compaction acceptable. Work can proceed.

*Photograph Showing Filled Site*

Subsequent to the investigation unsuitable soils were excavated and replaced with approximately 400mm of compacted pumice. The compaction of the pumice was tested and was found to be acceptable (refer to Site Inspection Report in Appendix B). It is understood that the level of the top of the pumice fill is approximately 300mm below the original Finished Floor Level (RL286.25m). A current platform level of RL285.95m has therefore been assumed in this assessment.
