# **GEOTECHNICAL COMPLETION REPORT**

**237 & 239 Marsden Point Road,  
Ruakaka  
(Lot 2 DP 152421)**

**Report reference:** 17560

**Date:** 9 September 2022

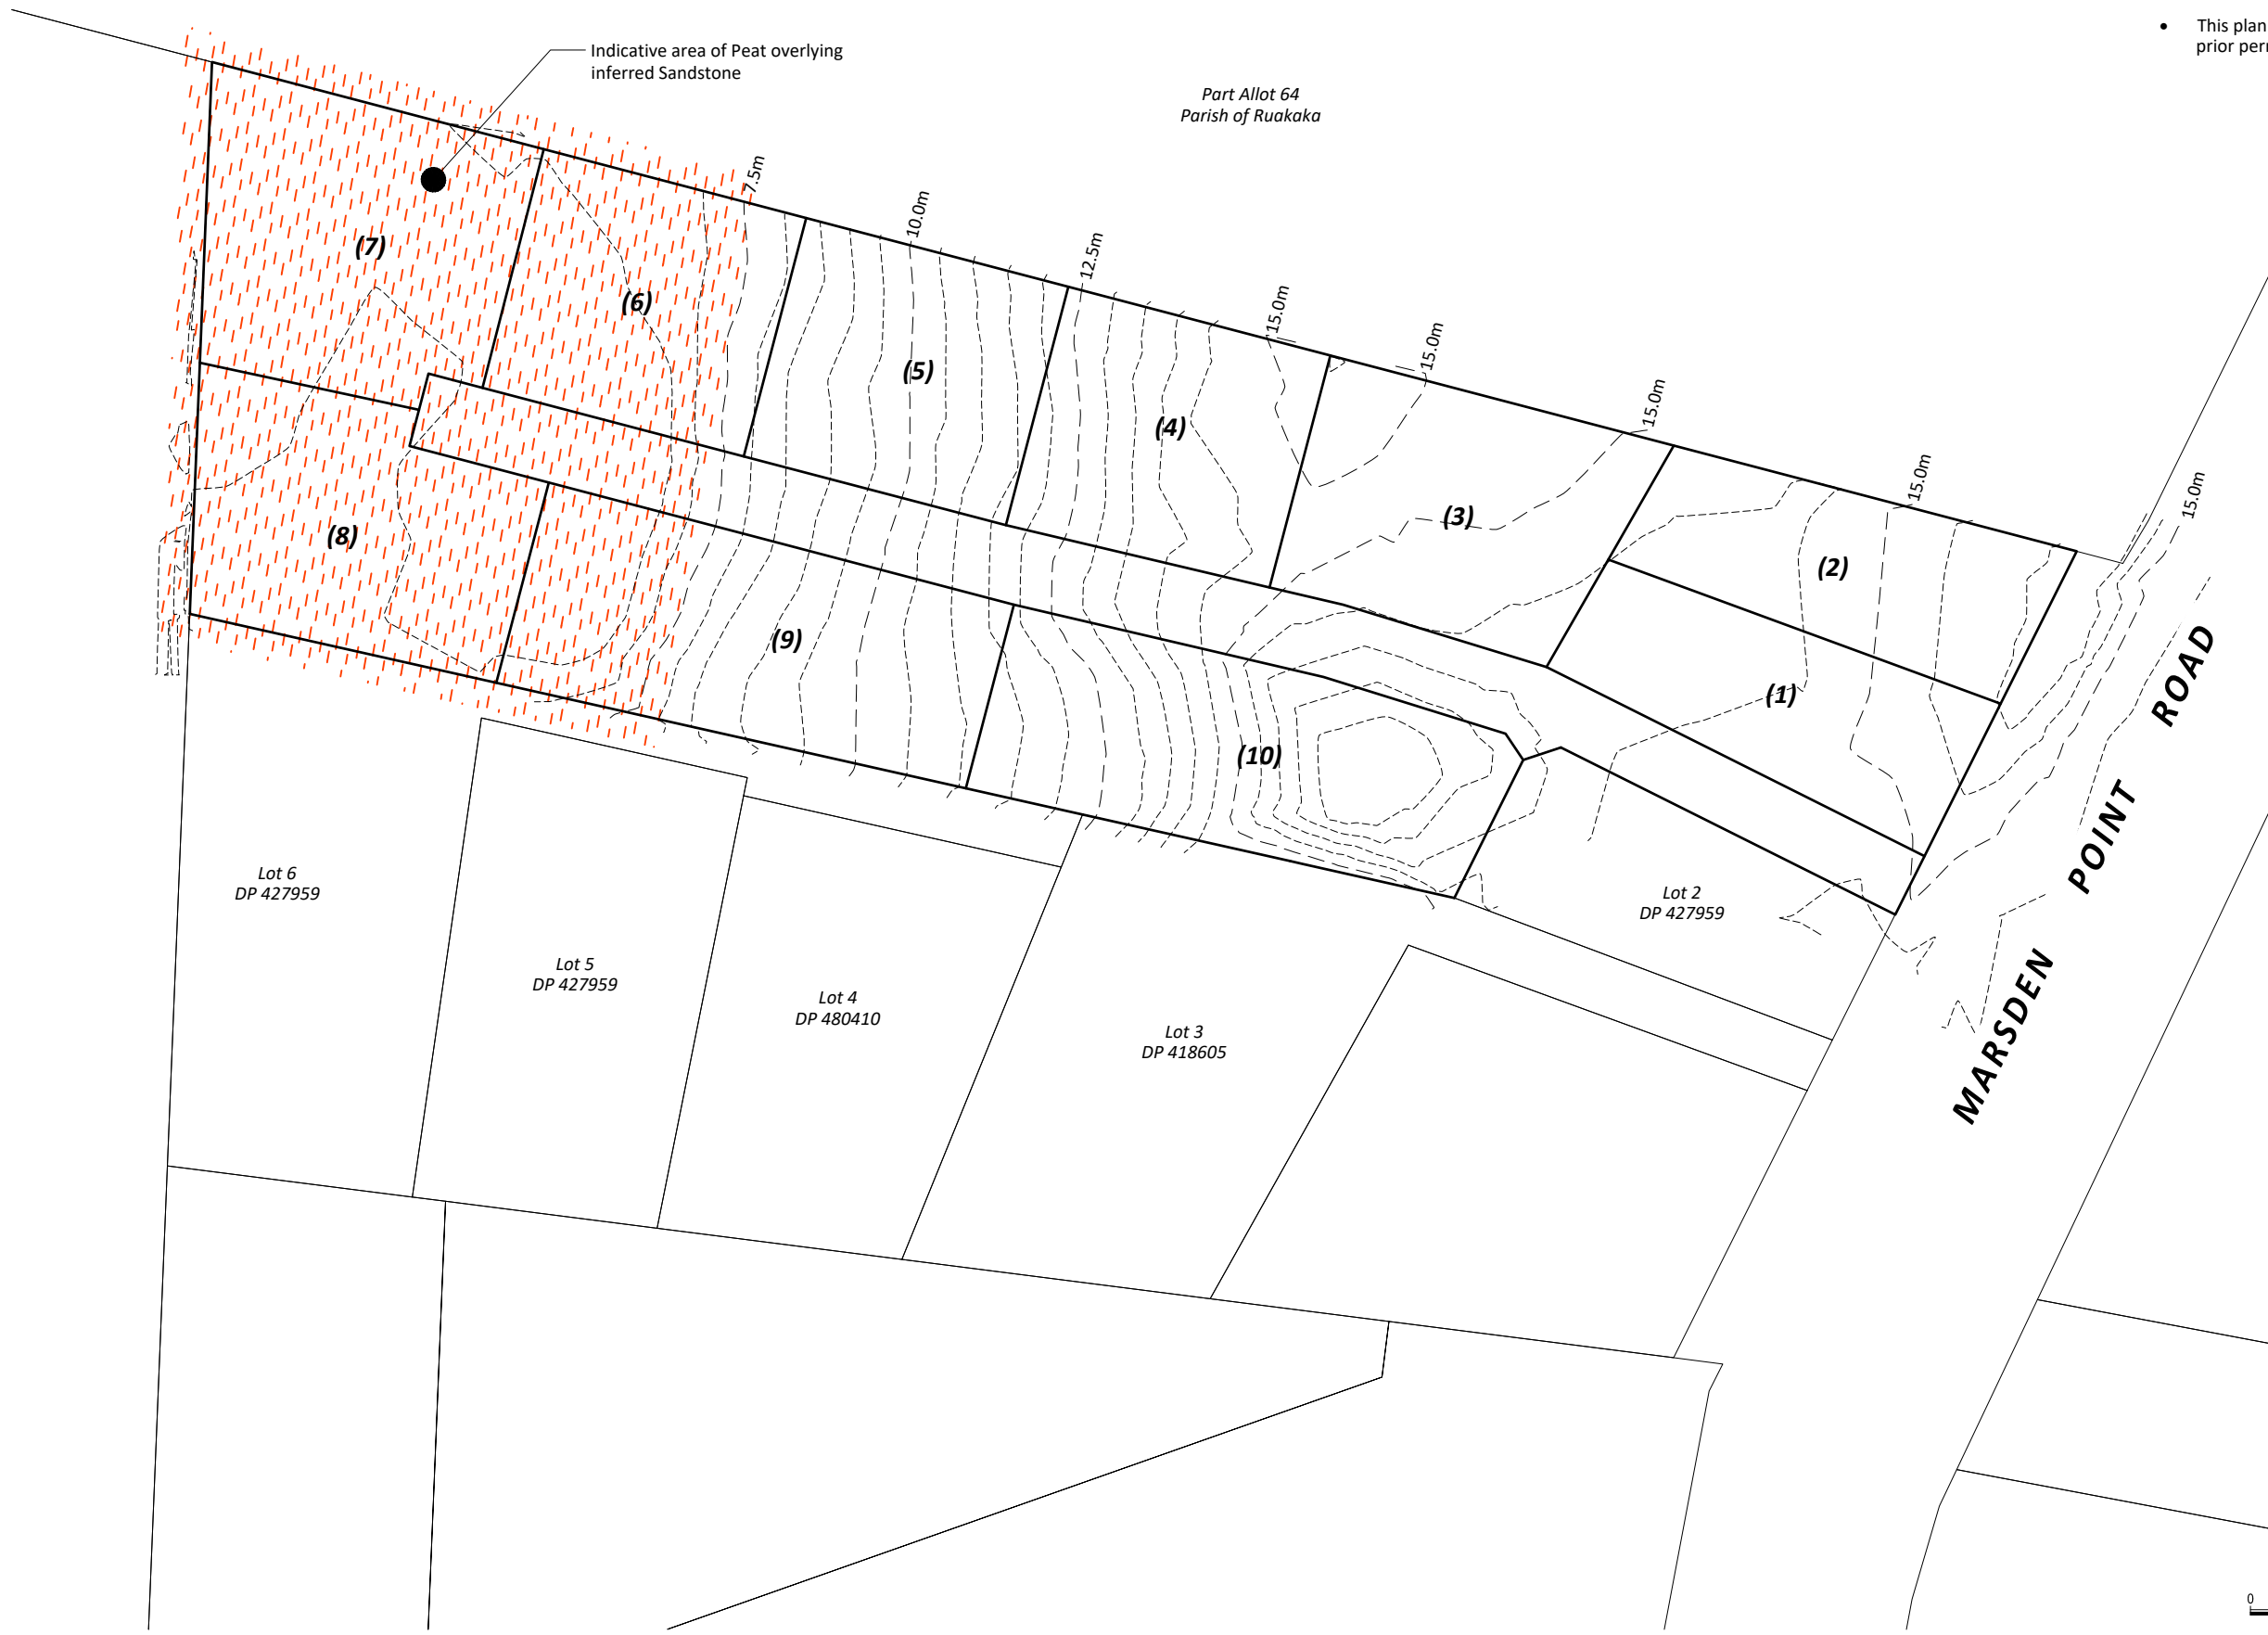
Earthworks undertaken at 237 & 239 Marsden Point Road consisted of stripping of topsoil and undercutting of peat, approximately 1.0m deep, filling of site won material, and spreading of topsoil. An as-built cut and fill drawing has been prepared by RS Eng, shown on Sheet 1 of Appendix A.

Contours are shown at 0.5m crs.  
Contours are derived from Topographical Survey data from Reyburn and Bryant (2021) and are shown at OTP64 Vertical Datum.

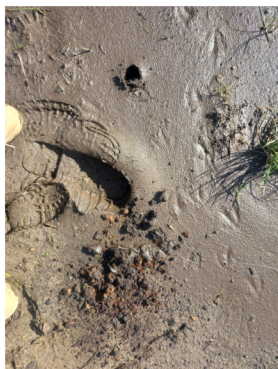
**HOLE NO.:**  
**HA03**

Refusal due to being unable to penetrate sandstone

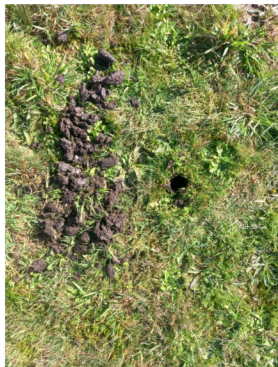
**HOLE NO.:**  
**HA05**

Groundwater Not Encountered

Refusal due to being unable to penetrate sandstone

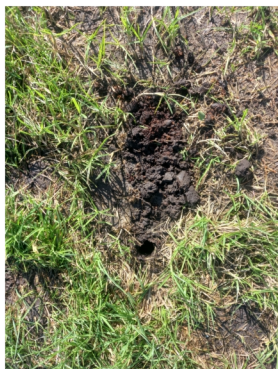
**HOLE NO.:**  
**HA07**

Refusal due to being unable to penetrate sandstone

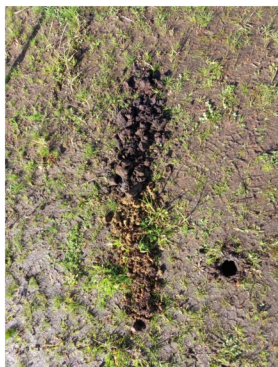
**HOLE NO.:**  
**HA10**

Refusal due to being unable to penetrate sandstone

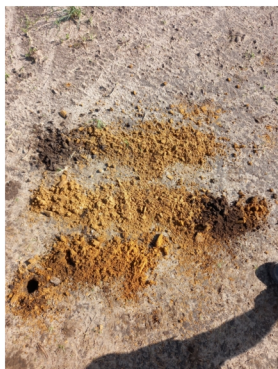
**HOLE NO.:**  
**HA11**

Groundwater Not Encountered

Refusal due to being unable to penetrate sandstone

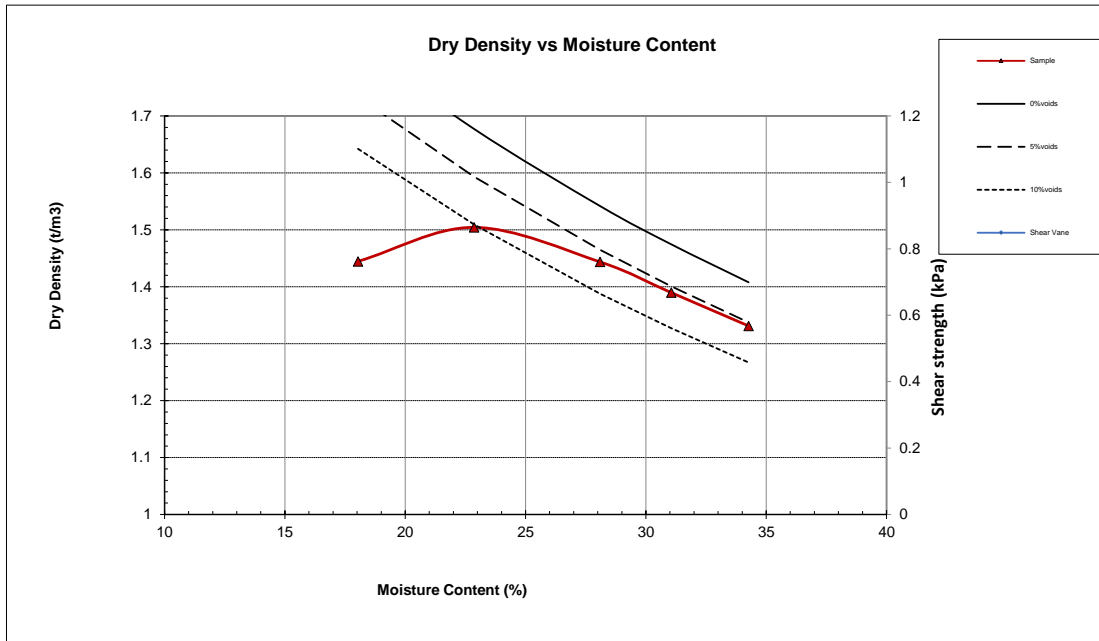
Test Results			
Water Content (%)	Dry Density (t/m <sup>3</sup> )	Shear Vane (kPa)	
		Peak	Residual
18.0	1.445	N/A	
22.9	1.504		
28.1	1.444		
31.1	1.390		
34.3	1.331

Solid Density (t/m<sup>3</sup>) = 2.72 Assumed  
 Optimum Water Content (%) = 23  
 Max Dry Density (t/m<sup>3</sup>) = 1.50  
 Natural Water Content (%) = 23

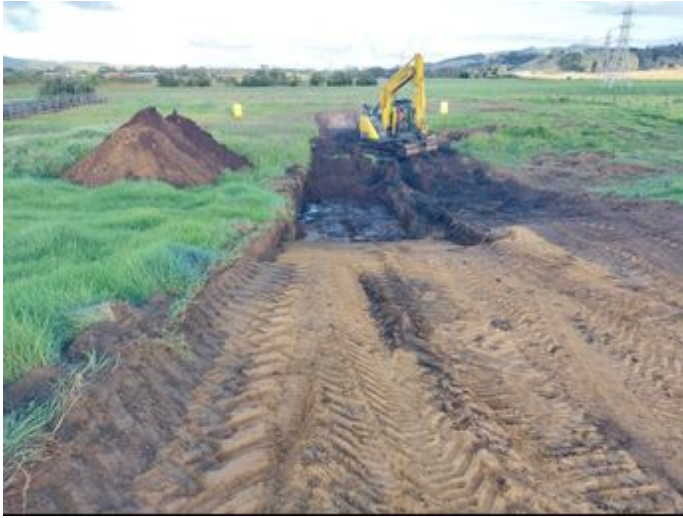
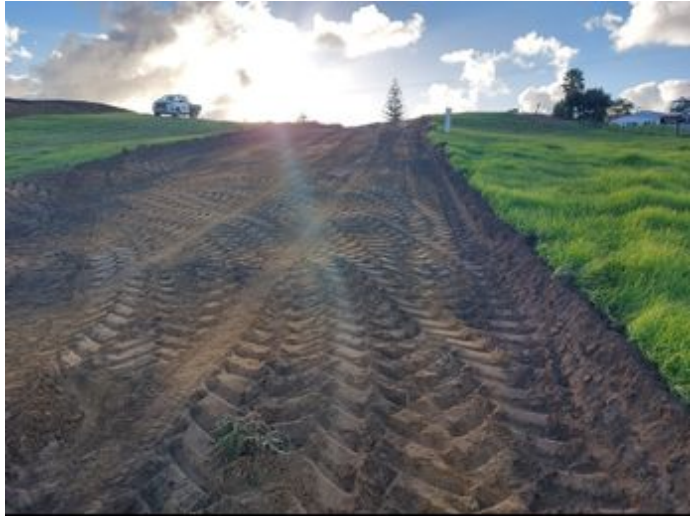
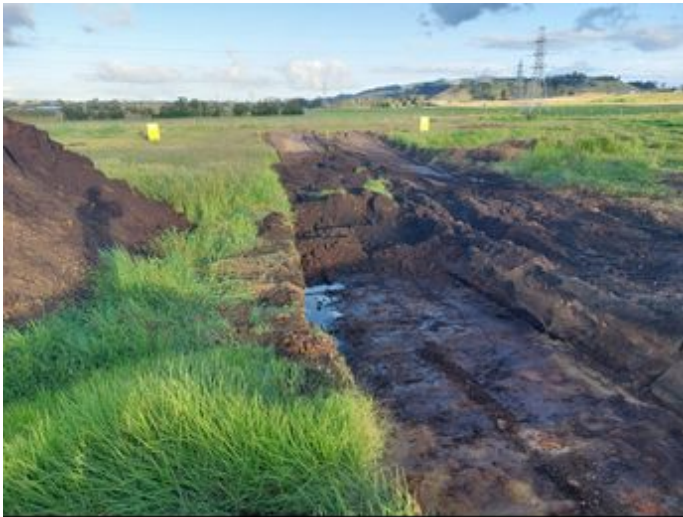
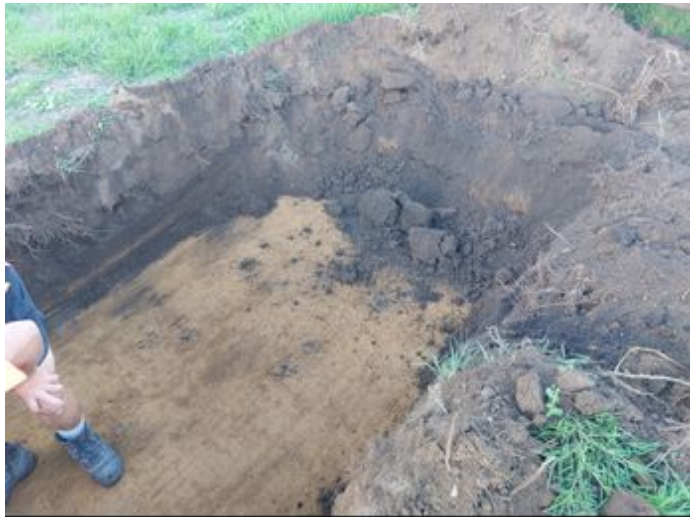
**Inspection No.** 1

Shallow testpit in North east corner of site revealed about 300mm of loose uncontrolled fill over grass and original topsoil before reaching original sand at approx. 0.6m. Material to be removed to expose original ground before placement and compaction of fills.

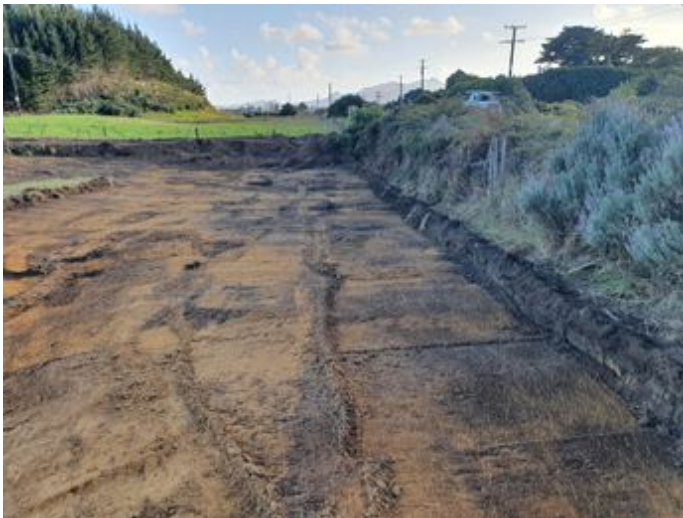
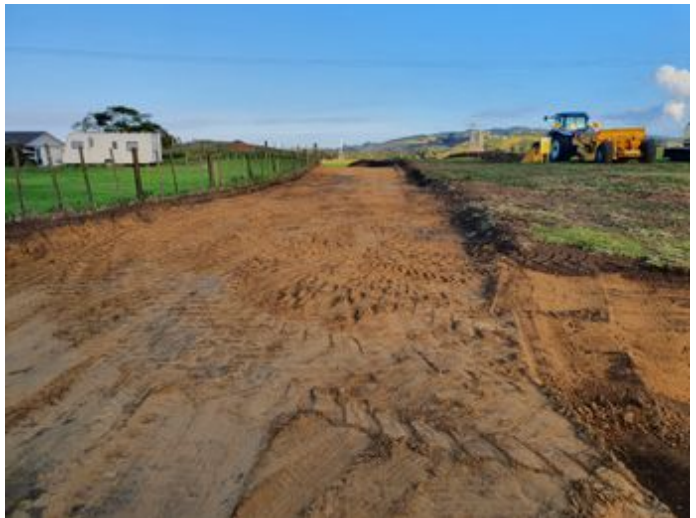
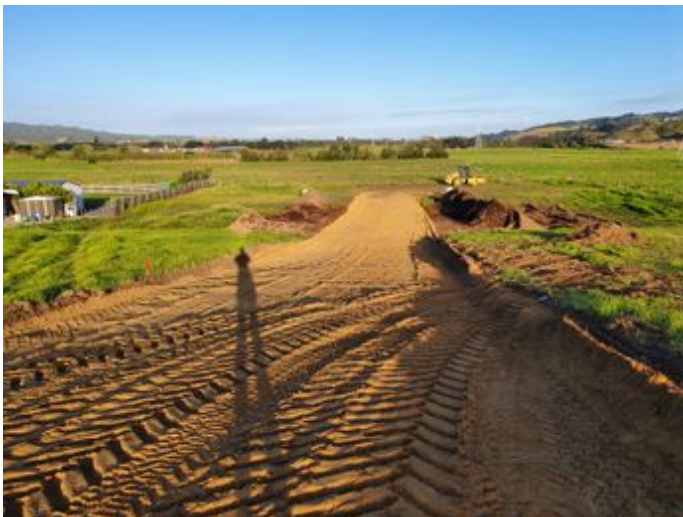
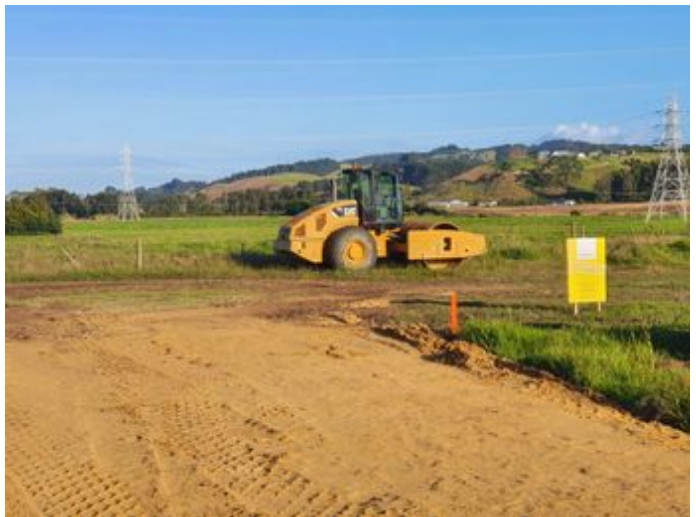
**Inspection No.** 2

4 X Scalas in R.O.W backfill (where peat removed) recorded generally <15mm/blow indicating adequate compaction is being achieved. Surface is slightly looser, typical of sand. Edges of backfill also slightly looser, concentrate compactive effort along edges as much as possible going forward.
