## Tenancy Healthy Homes Warrant of Fitness

| <b>Property Address:</b> | 113 King Edward Street |
| <b>Date Of Inspection:</b> | 29/05/2026 |
| <b>Job Number:</b> | 46110 (2) |

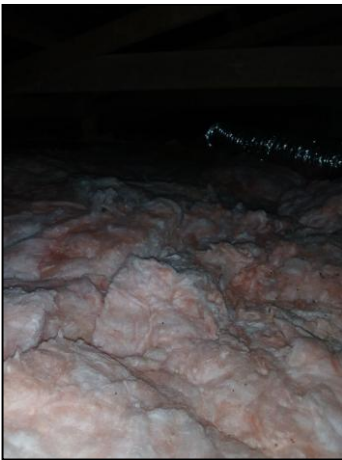
### CEILING INSULATION

**Ceiling Product:** Segments

**Minimum Thickness:** Over 120mm

**R-Rating:** Zone 3 R3.3

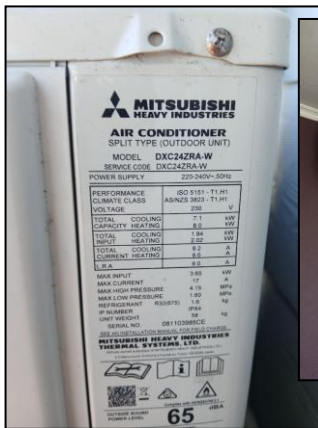
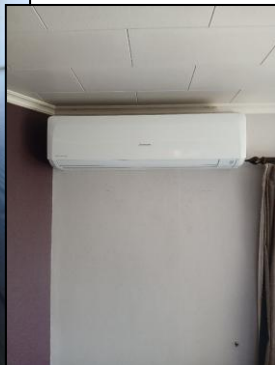
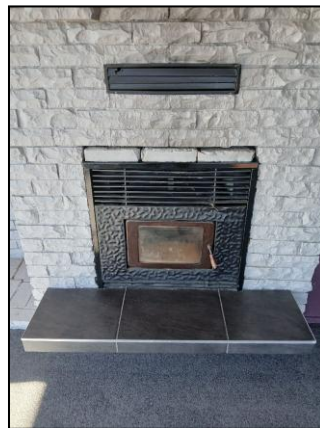
**Heating Type :** Heat Pump and Kent Woodburner

**Current Capacity:** 8.0 kW and 14kW

**Required Capacity (kW):** 6.7 kW

**Additional Comments:** Downstairs Lounge has 8.1kW heat pump

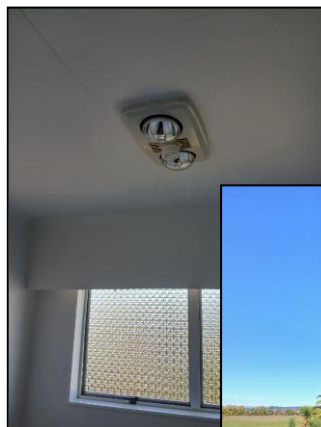
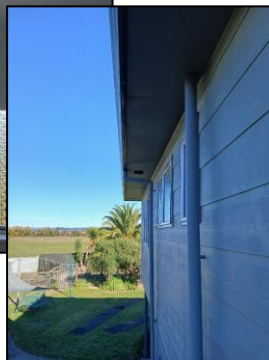
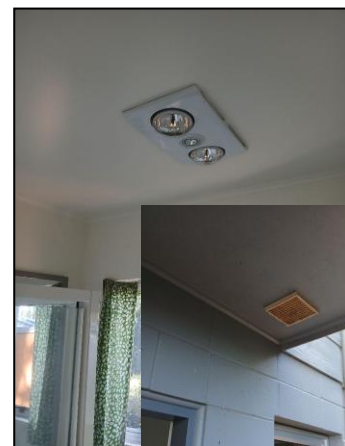
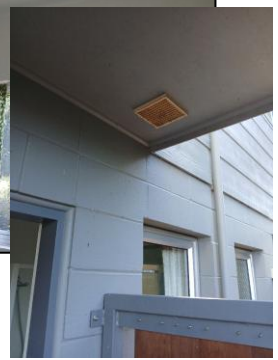
**Kitchen Fan:** Venting sufficiently (Ducting of 150mm or 50 Litres p/s)

**Bathroom Fan:** Venting sufficiently (Ducting of 120mm or 25 Litres p/s)

**D/Stairs Bathroom:** Venting sufficiently (Ducting of 120mm or 25 Litres p/s)

**Additional Comments:** Opening windows Bedroom 1 = 2; Bedroom 2 = 3; Bedroom 3= 3; Bedroom 4= 2; Living = 4; Dining = 3; Kitchen = 3; Downstairs lounge = 4

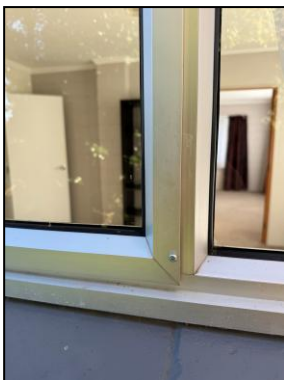
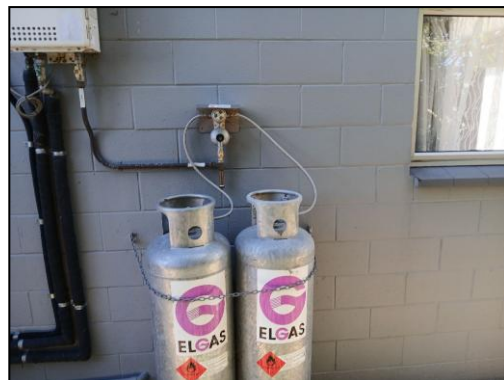
Bottle Location Compliant, solid base, no ventilation openings 1 meter either side, chains installed.

Pigtail Condition: Satisfactory

Labeling on pipework: Present

Gas Installation for: Hot Water

**Additional Comments:** Note windows are screwed shut
