| | <b>Pool Audit Checklist:</b><br><b>Pool – FOSPA Schedule</b> | Ref: PA 02 |
| | | Doc No: RDC-731209 |

15 Carter Drive, Pomare, Rotorua

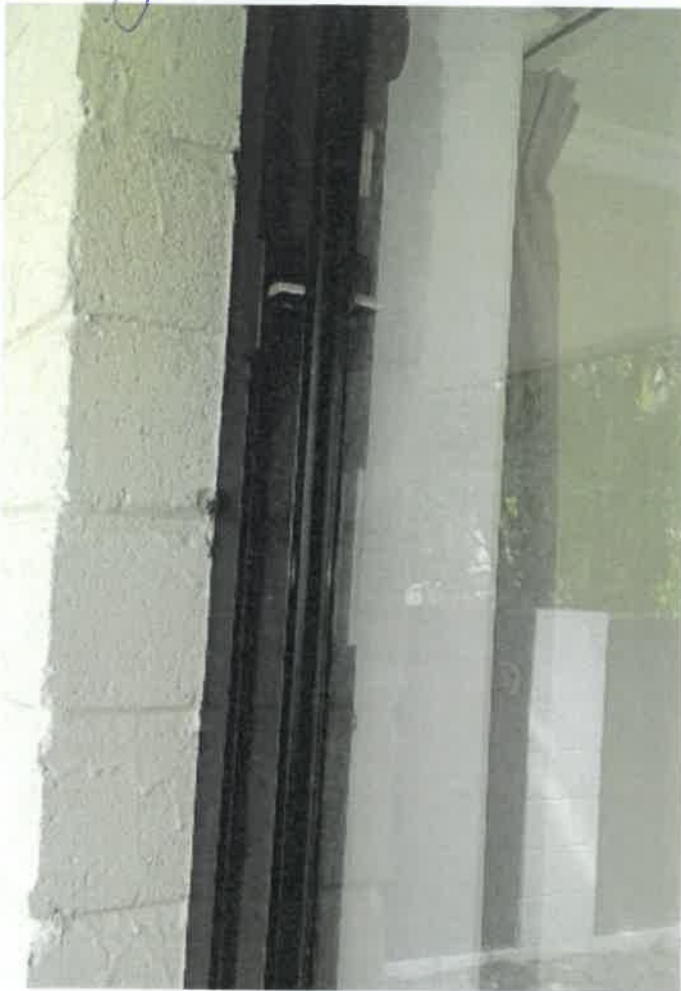
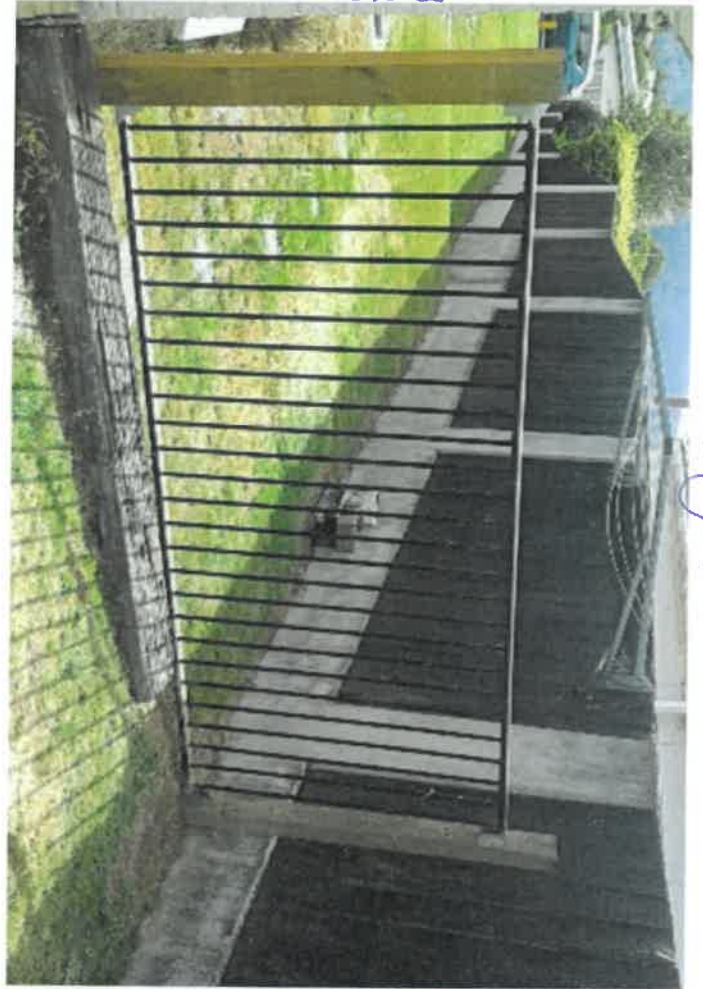
alarm fitted

Permanent fence.

① Gate - on North boundary closest to East boundary is @  
 2440mm wide span - should be 1000mm or less.

- Option: Permanently fix shut this gate.

Permanently fixed complies 03/04/19 ✓

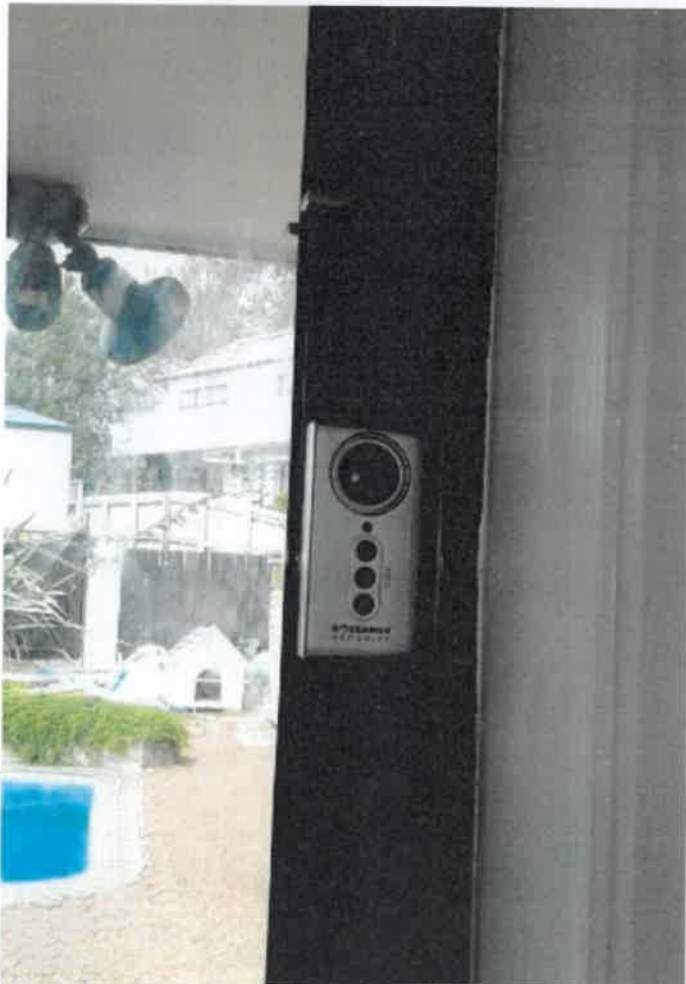
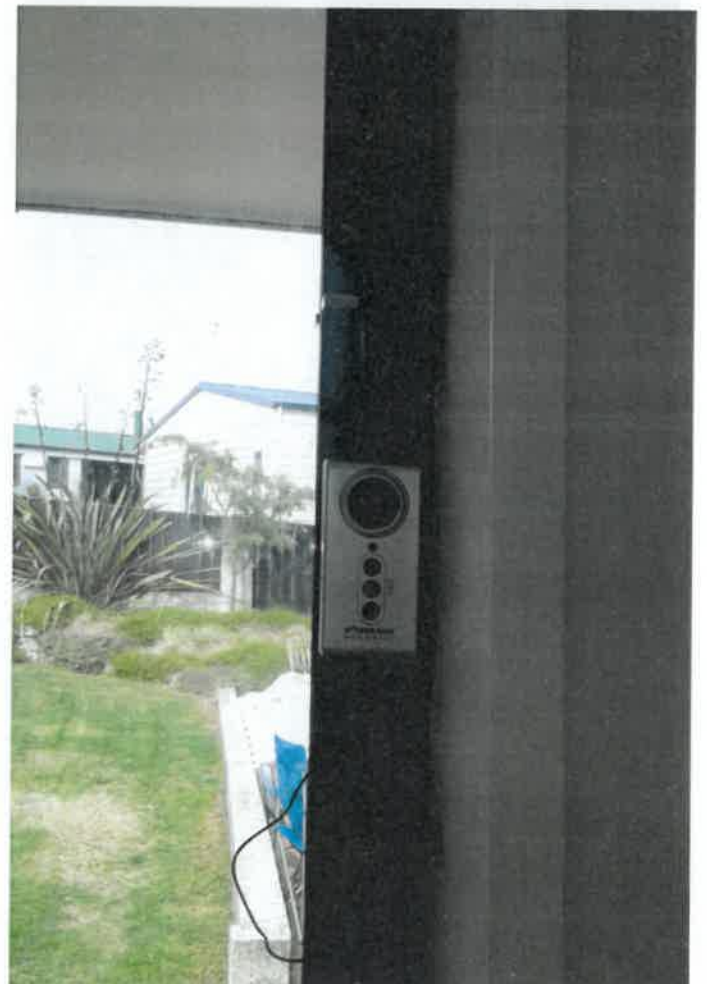
alarm fitted

⑤ 2x Ranch sliding doors load out to immediate pool area - to  
 comply with F9 AS1 & NZ Building Code

Alarm on latch fitted complies 03/04/19 ✓

- Fit an audible alarm on both sliding doors @ 1500mm  
 from the ground or above AND fit a self latching  
 latch fitted @ 1500mm or higher from the ground  
 level.

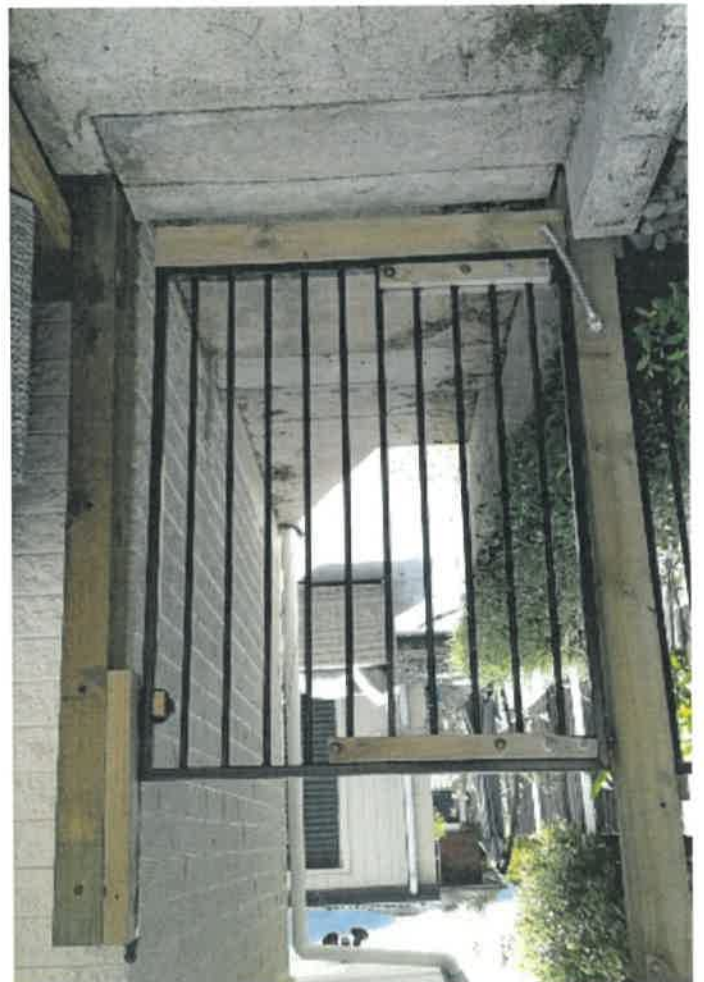
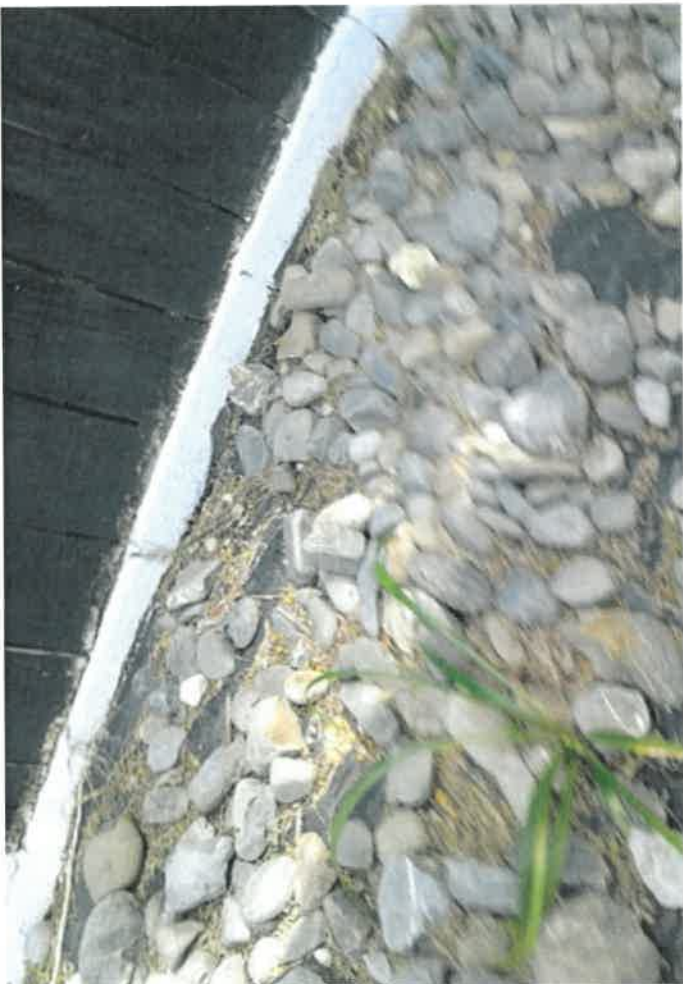
Now spray - low @ 1870 mm.

④ Single gate North side gate closest to West boundary - does not self  
 close and activate latching device from a distance of  
 1500mm

- Option - Tighten spring to make gate self close

Option - Fit another spring to make gate self close ✓

complies 03/04/19
