New Stormwater Design for Graeme Brown,  
116 Richard Street, Opotiki.

**GEOTECHNICAL REPORT – BUILDING FOUNDATION SOILS**

116 Richard Street  
OPOTIKI

## BUILDING CONDITION REPORT FOR RELOCATION

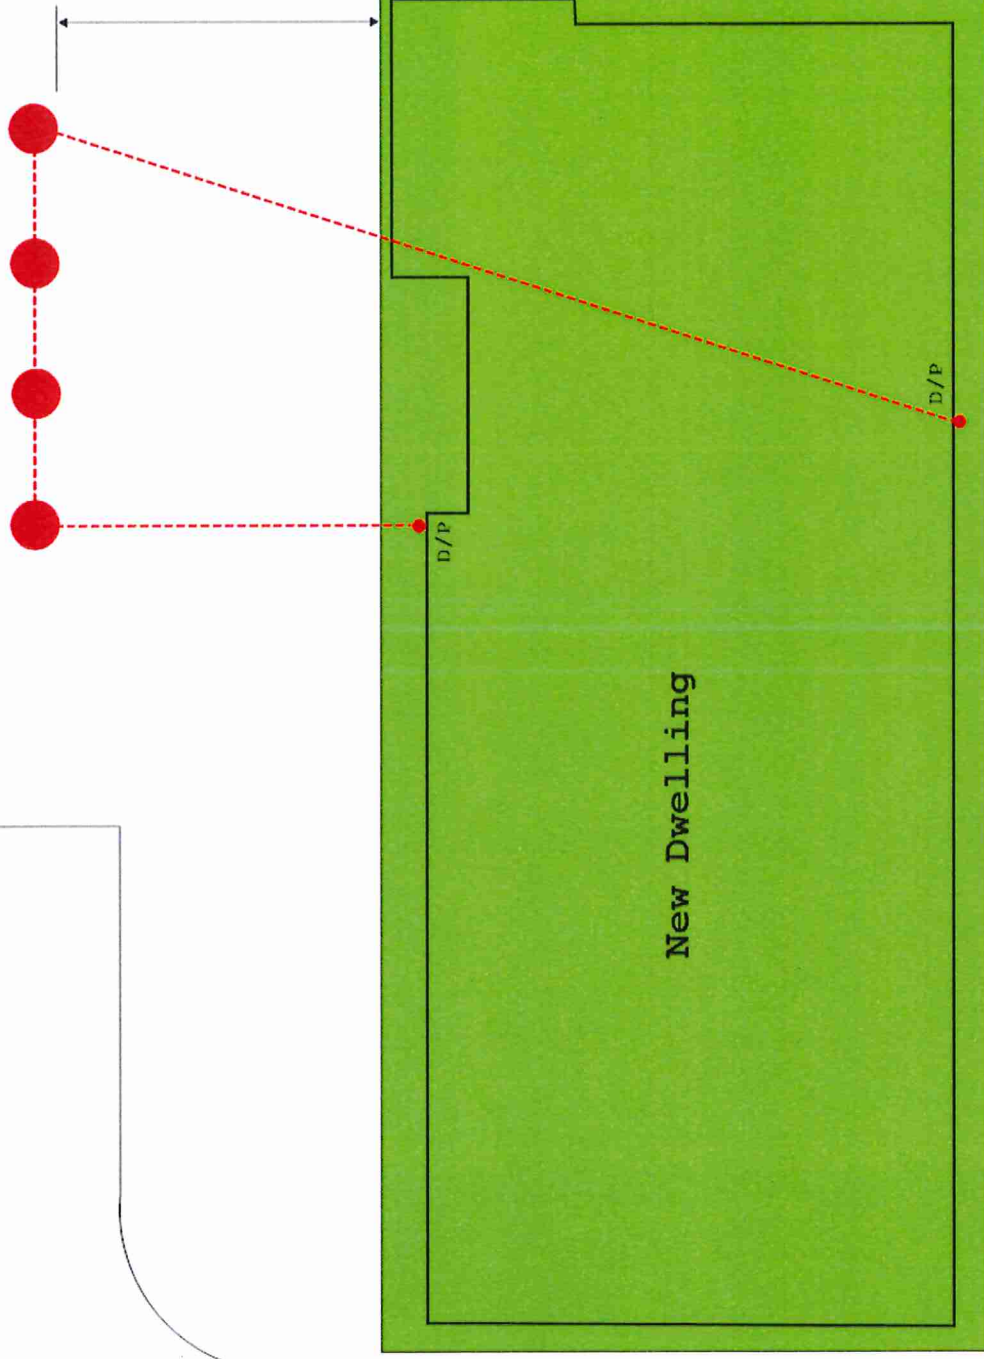
116 Richard Street Stormwater System

4 - 900mm x 900mm  
Soakholes laid in  
series as per plan

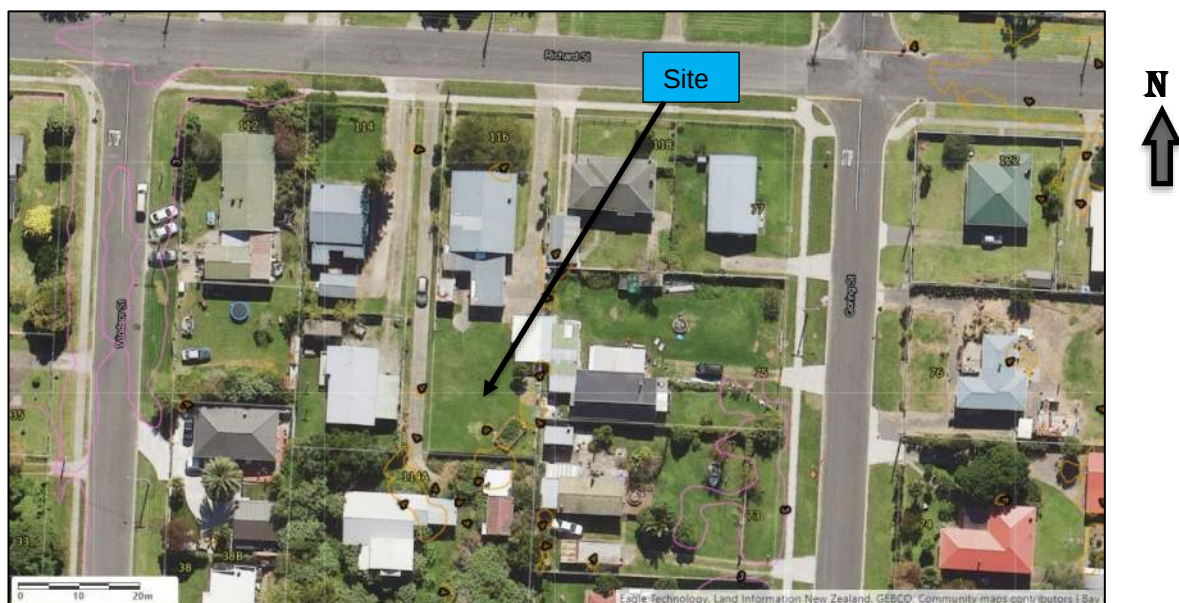
Figure 3: Site Topography (courtesy BOPRC GIS)

According to ODC GIS information the surrounding land is predominantly flat at approximately 4m RL (Moturiki Datum 1953) and there are piped services available to the site.

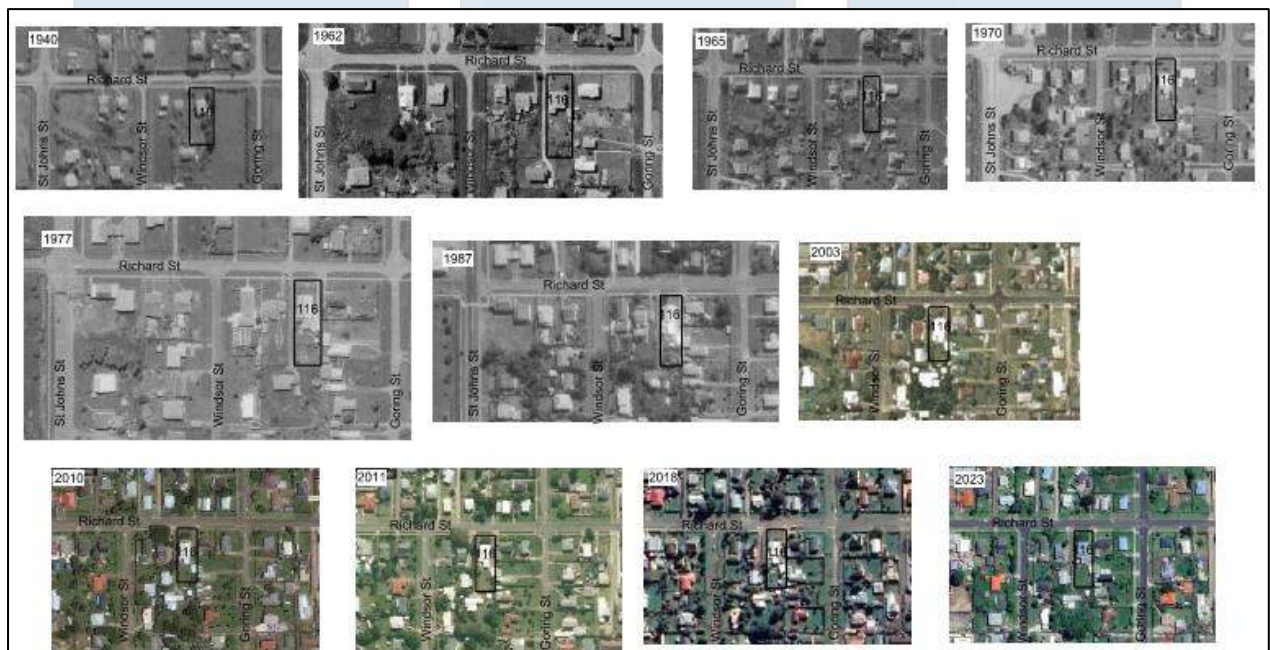
Figure 5: Aerial views by date (courtesy Retrolens)

The earliest image was from 1940 which showed the front house. The 1962 image shows the site surrounded by houses. There is no evidence of bulk earthworks ever being performed or ground instability at the investigation site.

Also, no signs of large trees or vegetation. May have been a small garage or shed in the general area that has been removed.

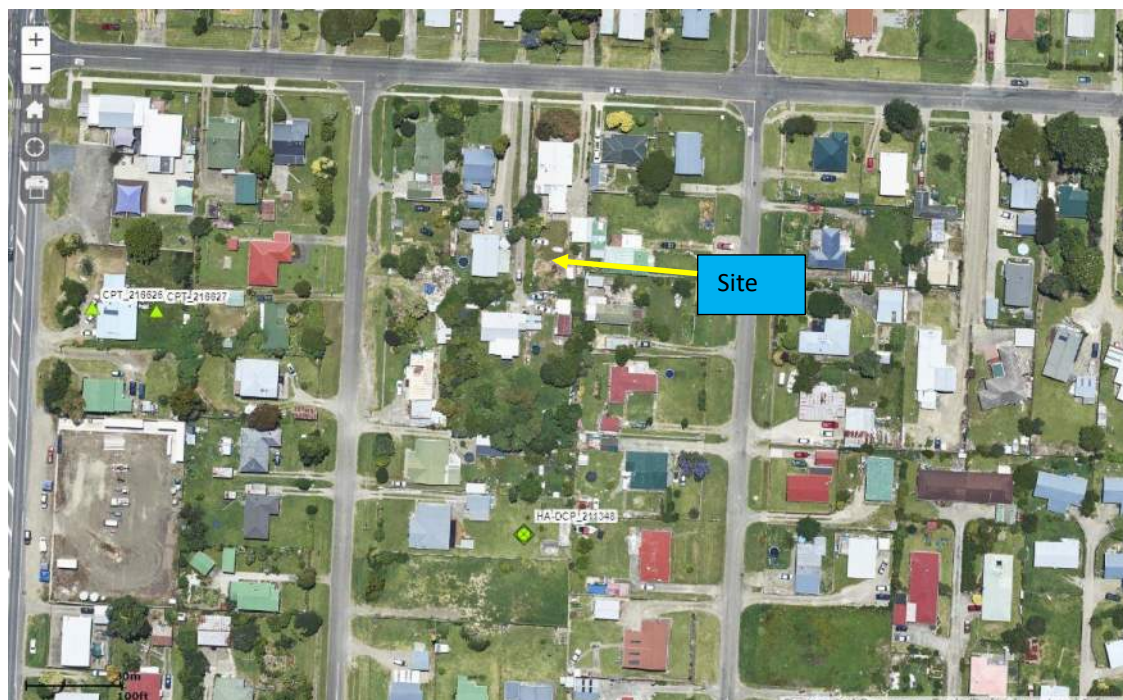
Figure 8: Registered investigations 50m from site (courtesy NZG database)

The NZG database shows previously registered geotechnical investigations in the area. The green triangles show the CPT test sites that are in the same geology unit, per 6.2.4, and within 50m of the site.

The CPT data will be used to complete a CPT based liquefaction assessment. See this in a later section. The water table was viewed at 1.5m depth (dated 23/3/2023). The probe was pushed to 12m depth.

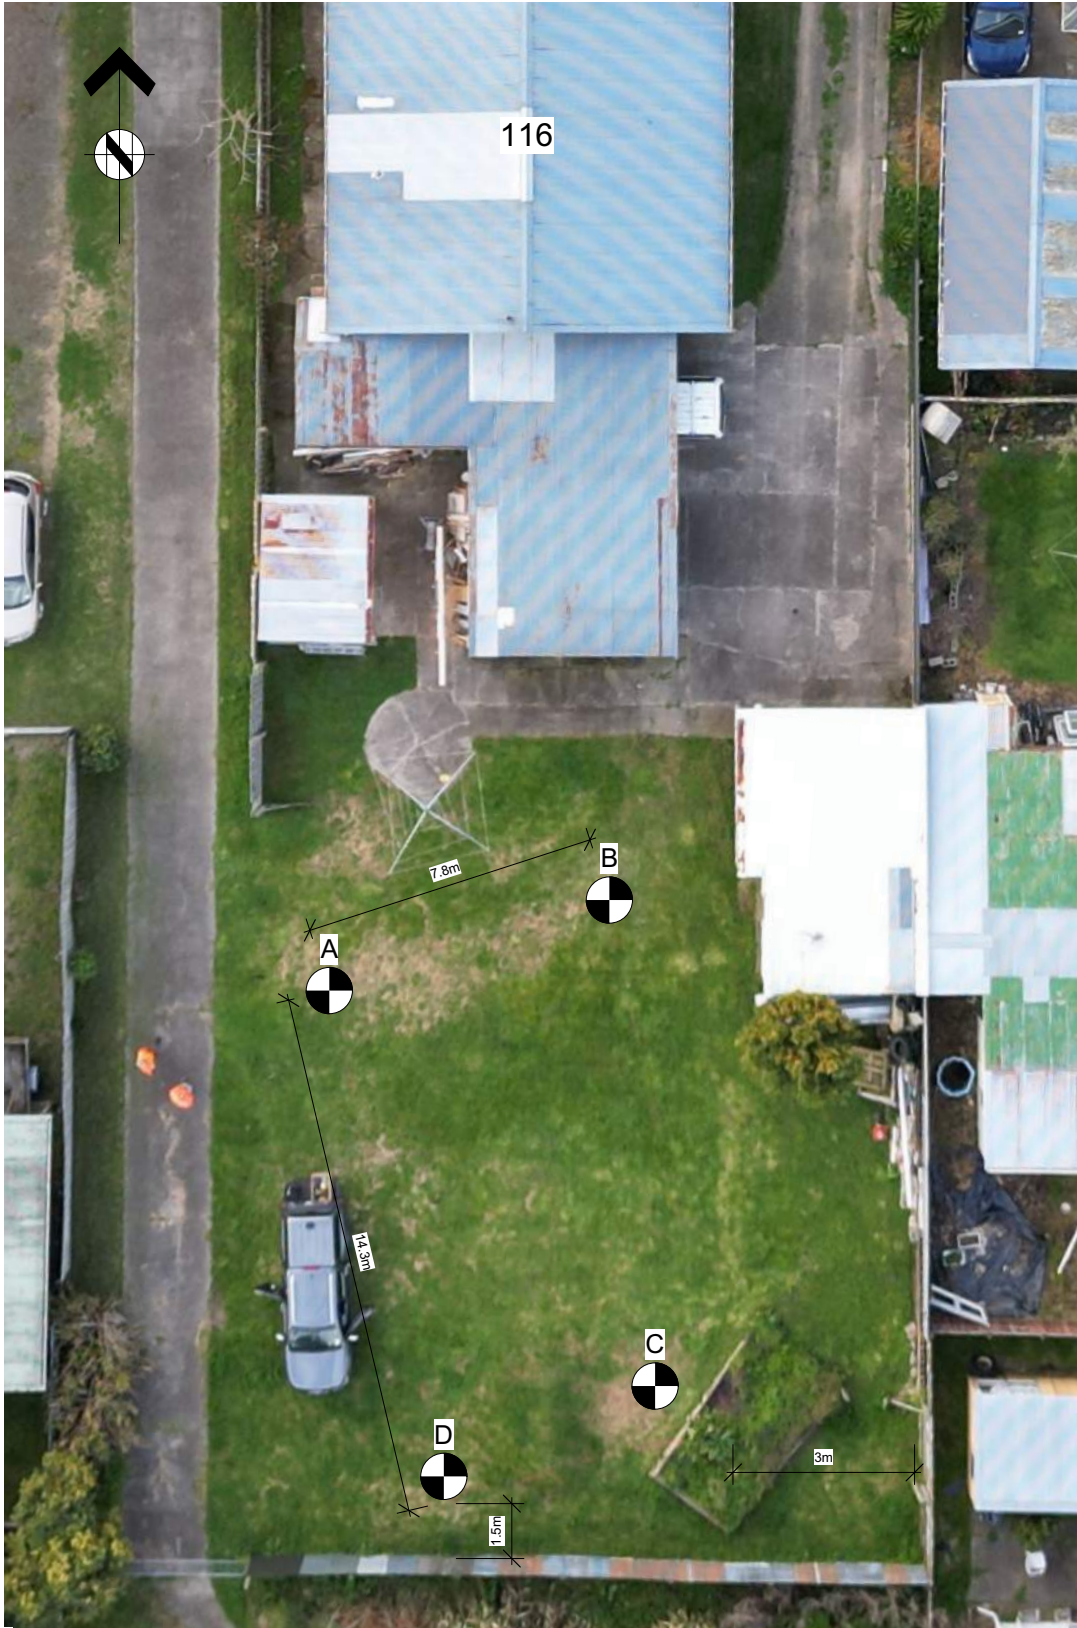
1 SITE TESTING  
SCALE 1:200 @ A3

MCEL Hand Testing: DCP, Hand Auger and Shear Vane.

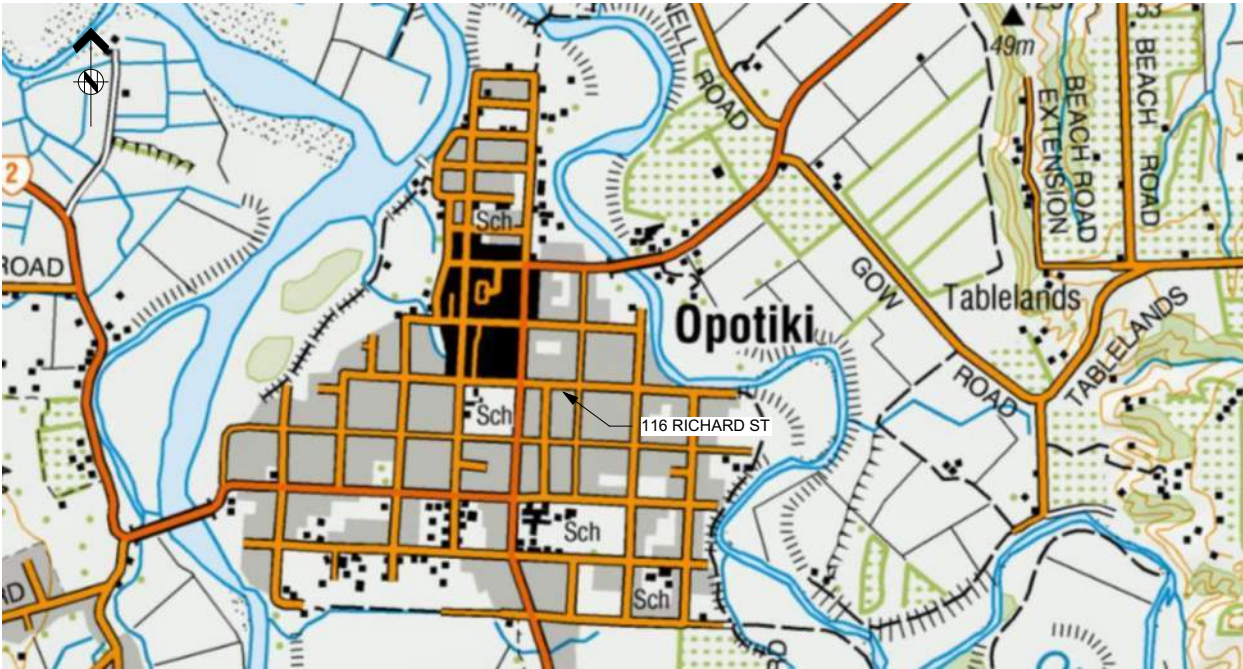
2 SITE LOCATION  
NOT TO SCALE

KEY

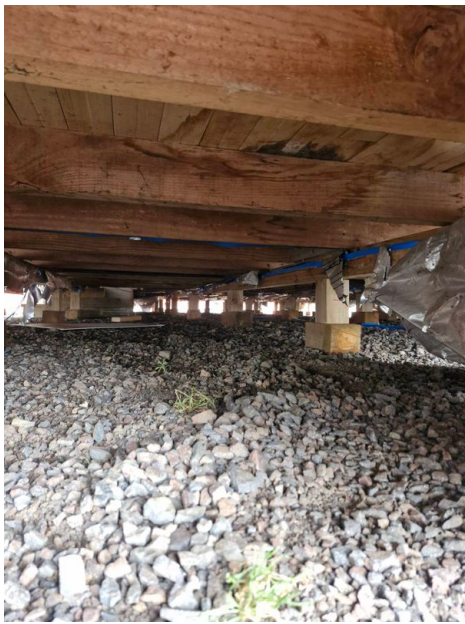
**Sub floor services: Plumbing**

PVC waste, Copper Water

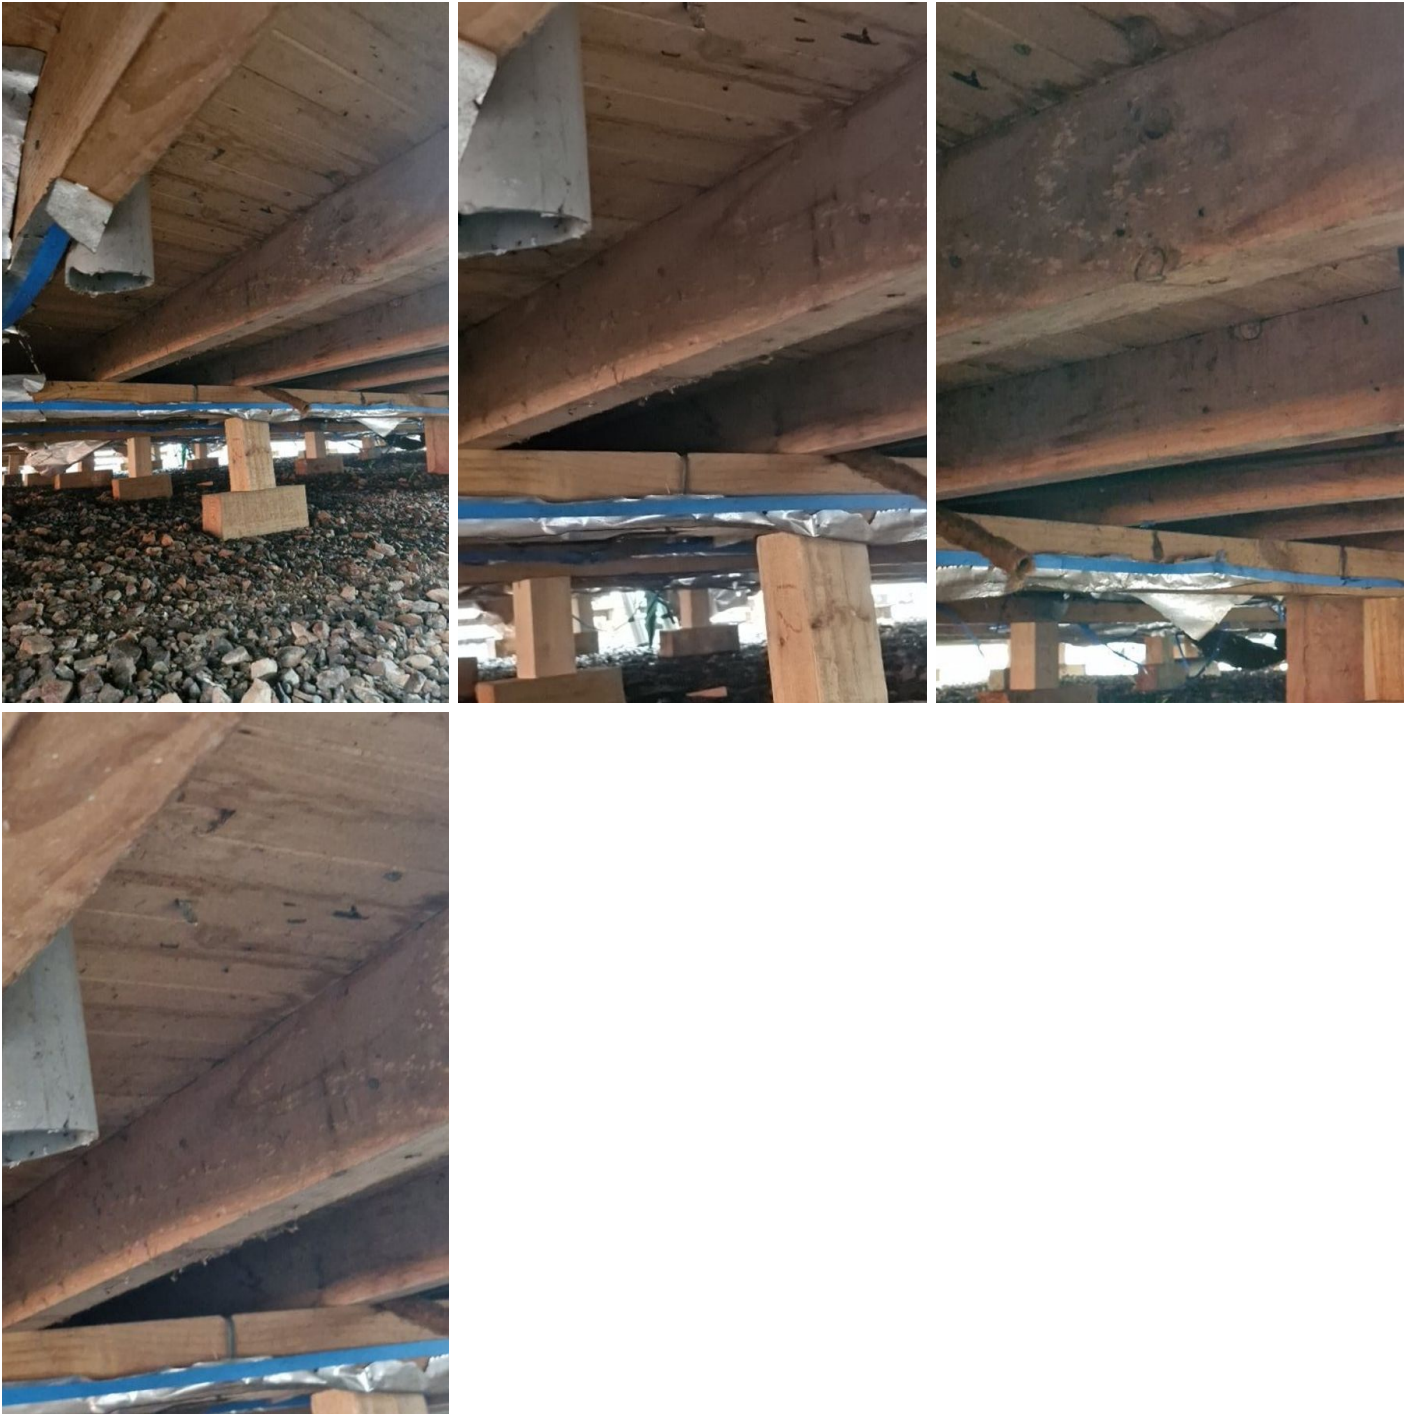
**Floor Structure: Framing & Floor Material**

Ex 150x50 joists in good condition, Ex100x70 bearer, T&G Flooring

**Sub floor services: Plumbing and electrical to be reconnected upon relocation**

All disconnected sub floor plumbing and electrical to be reconnected and made good upon relocation by qualified contractors to a professional standard.

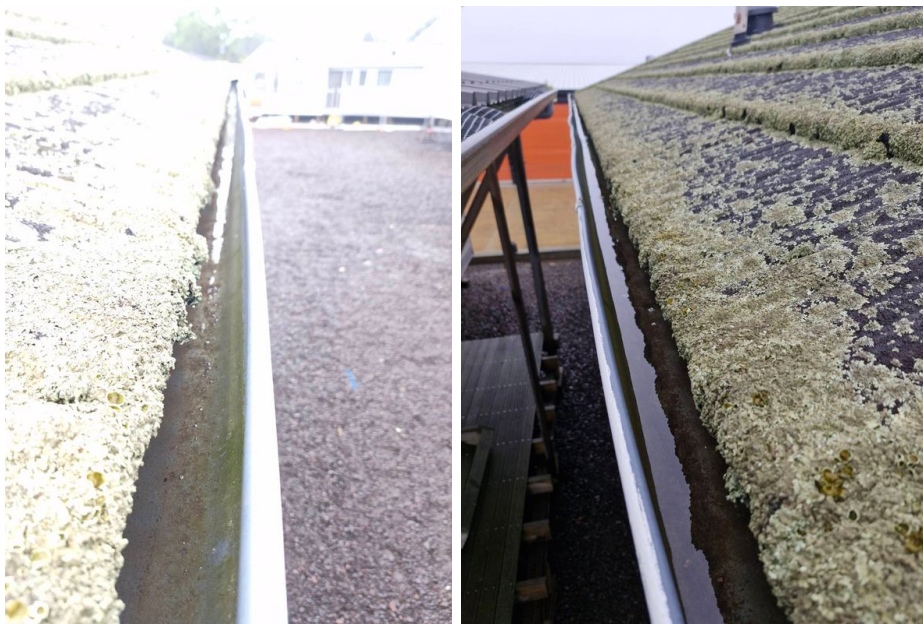
**Coverings: Material**

Metal, Tile

The roofing system is a modern-style texture coated pressed metal tile in relatively good condition with significant lichen growth visible that treatment may be required for.

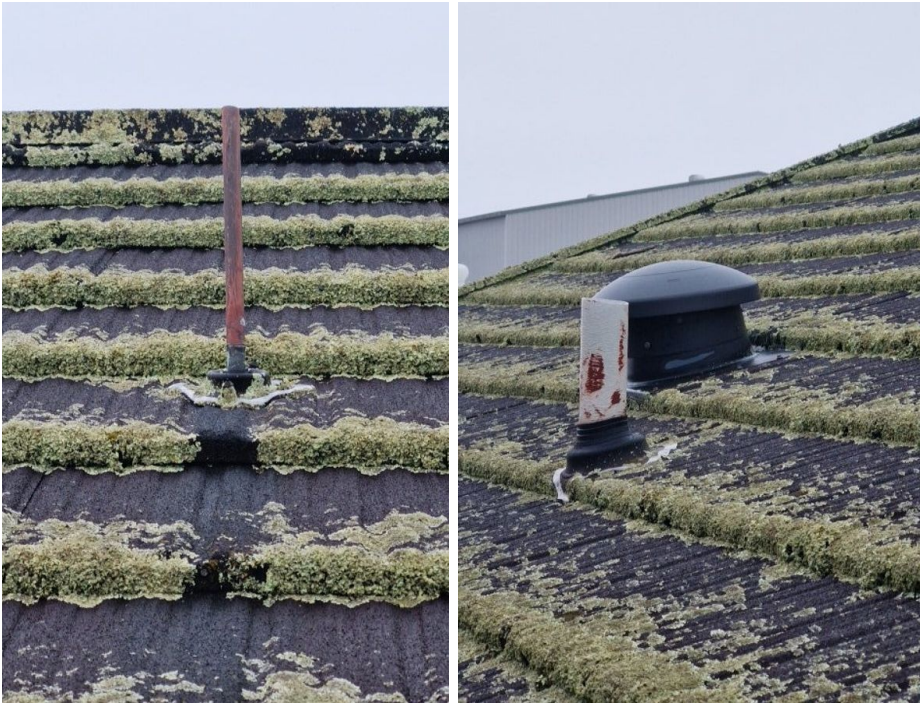
**Skylights, Chimneys & Other Roof Penetrations: Small Penetrations (under 85mm)**

Terminal vent pipe under 85 mm, How water pressure relief pipe

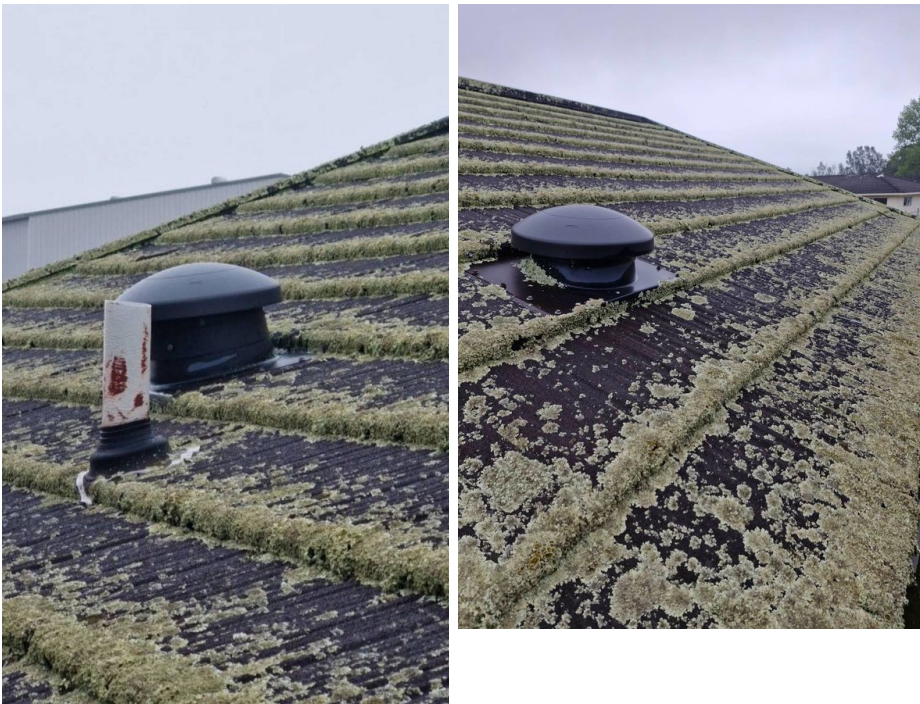
### **Skylights, Chimneys & Other Roof Penetrations: Large Penetrations (Over 85mm)**

Multiple large penetrations, Large extraction vent

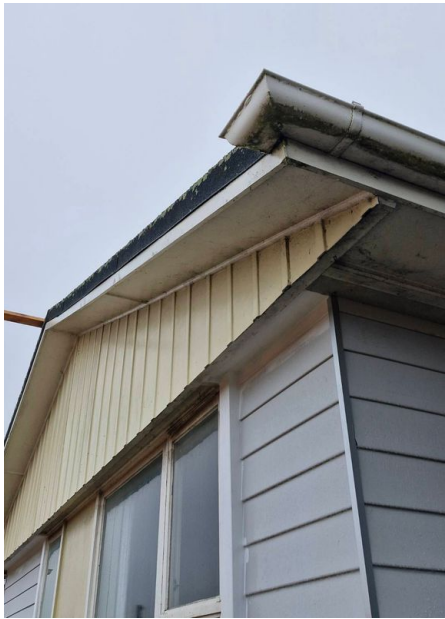
**Eaves, Soffits & Fascia: Fascia Material**  
Painted, Timber, In serviceable condition

**Eaves, Soffits & Fascia: Eaves Width/s**  
600mm

**Exterior Plumbing : Sewer Connection**  
New connection upon relocation

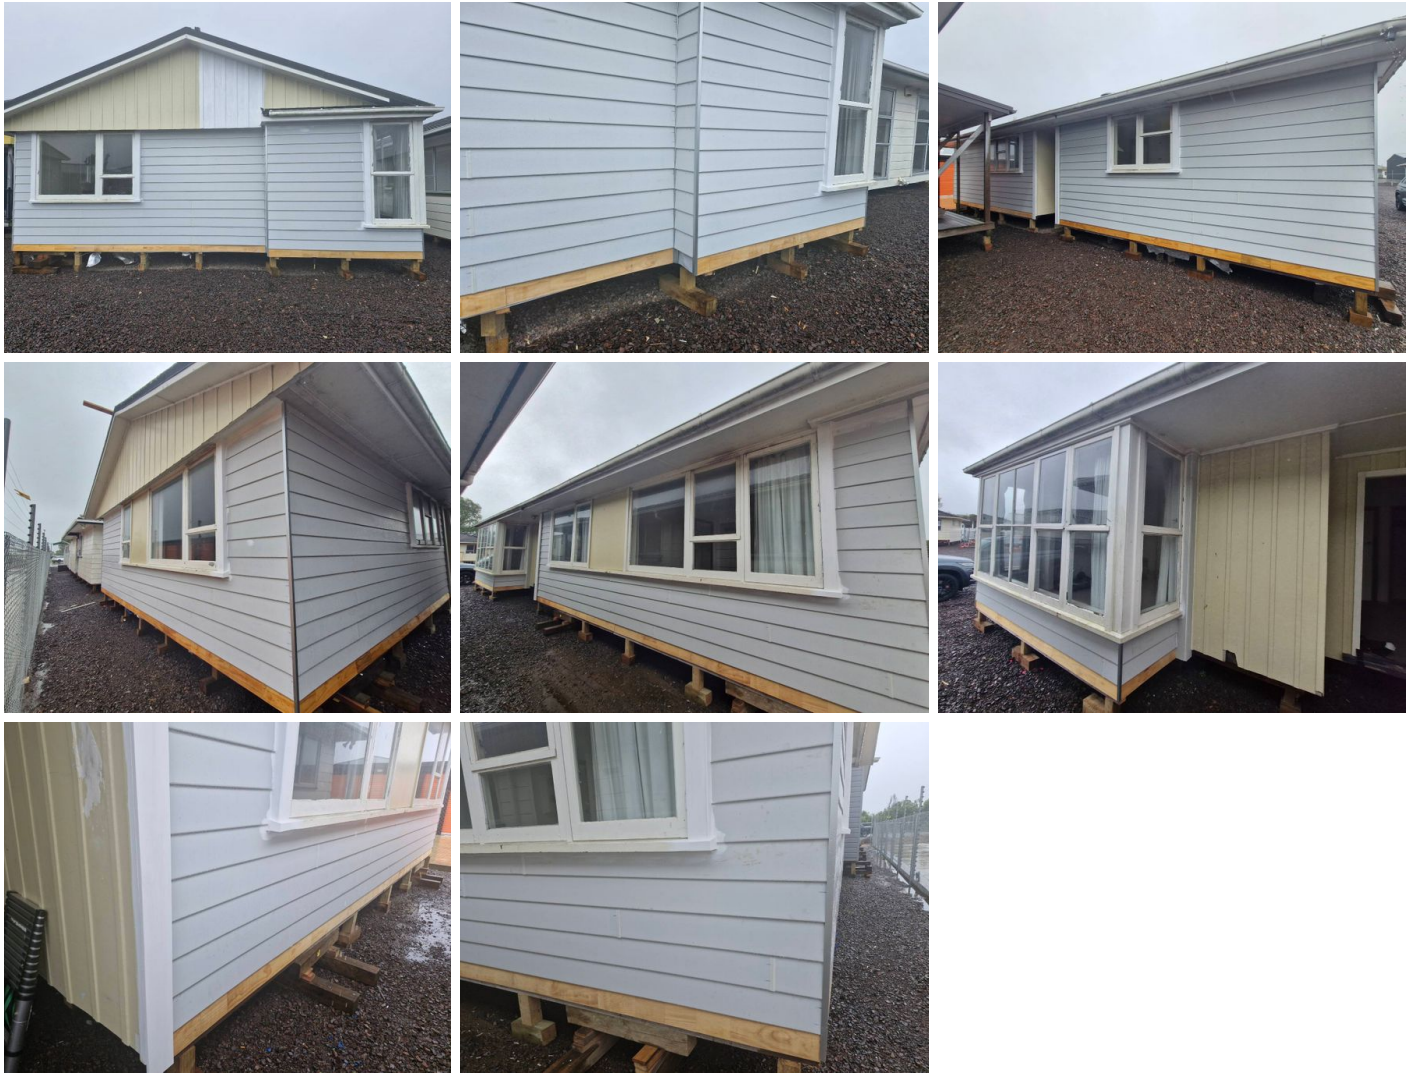
Secondary cladding system in use on the gable ends and around the entrance way is a direct fixed vertical profile overlapping joint fibre cement sheet with a painted finish in servicable condition, with some transportation damage visible that may require repair upon relocation.

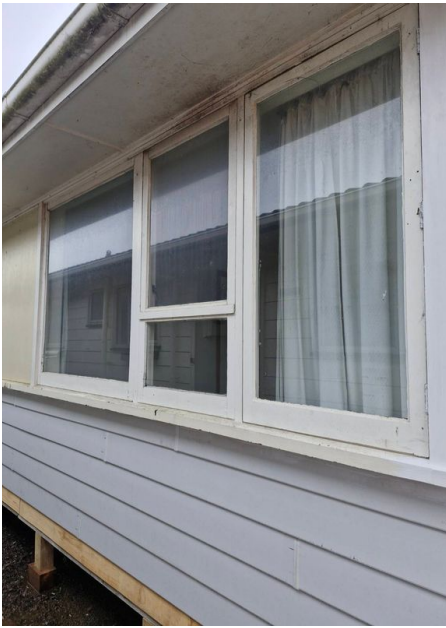
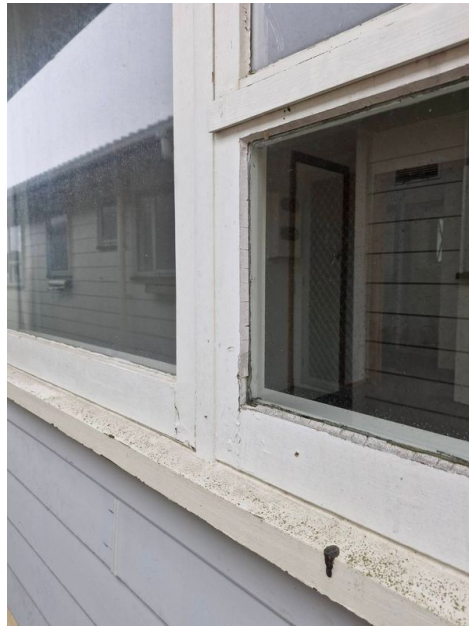
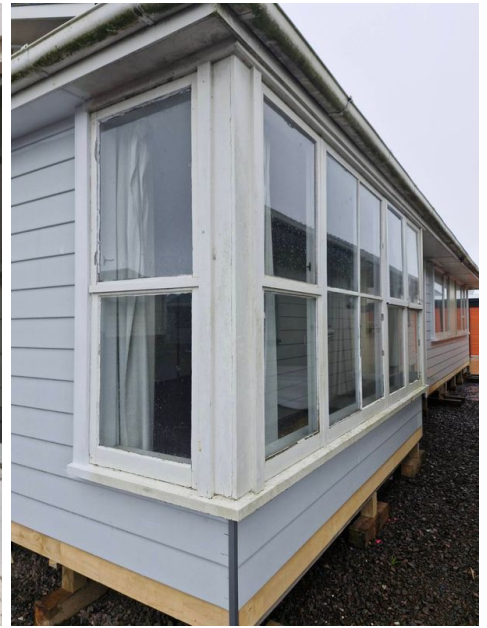
### Exterior Doors & Windows : Window Frames

Older style aged but serviceable timber joinery

Paint is flaking and generally poor condition on timber joinery.

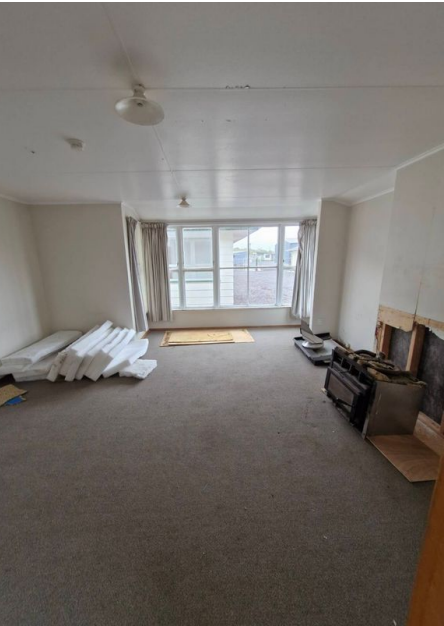
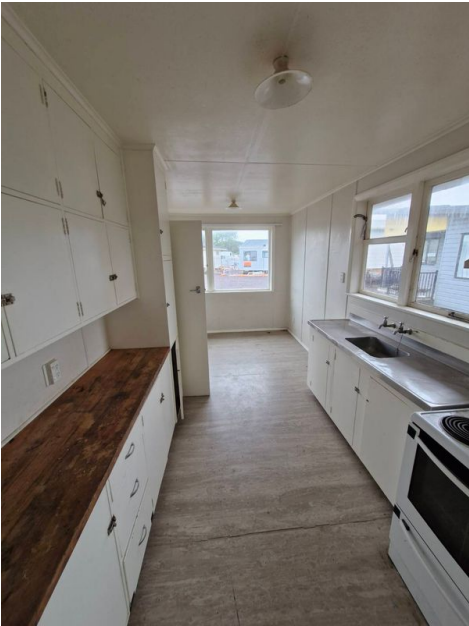
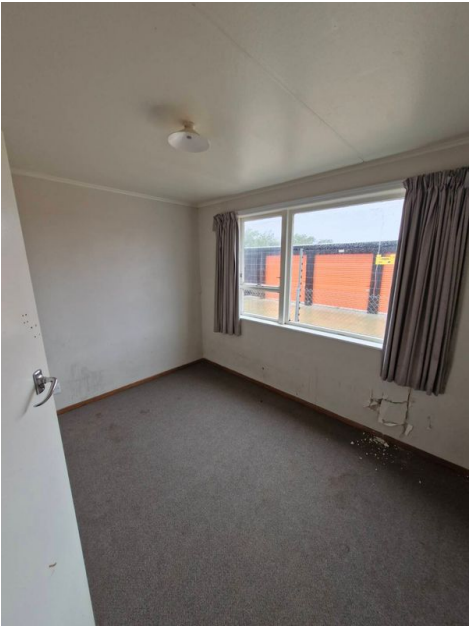
| <b>Walls: Wall Material</b><br>Brick, Plasterboard, Walls in serviceable condition, Some flaking and damaged paint visible |

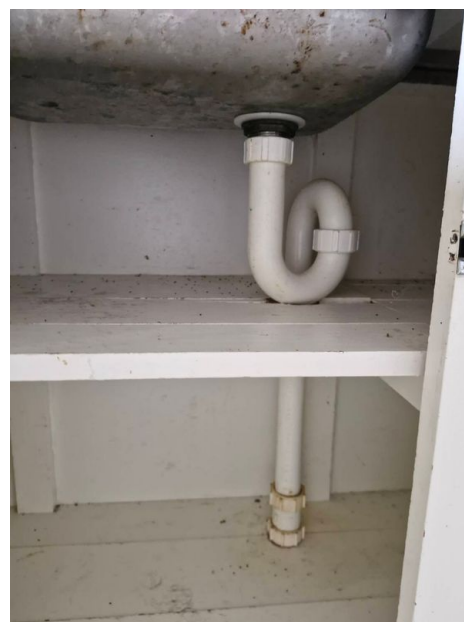
#### Sink & Services : Under Bench Plumbing

PVC Waste Pipes

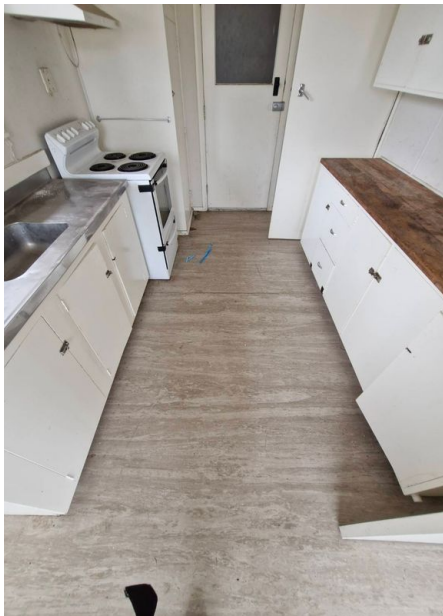
#### Floors: Floor Coverings

Vinyl, Poor condition
