**P25145.V1**

## **SITE SUITABILITY ASSESSMENT**

THIS REPORT IS FOR RESOURCE CONSENT PURPOSES ONLY  
102D Maungakawa Road, Cambridge

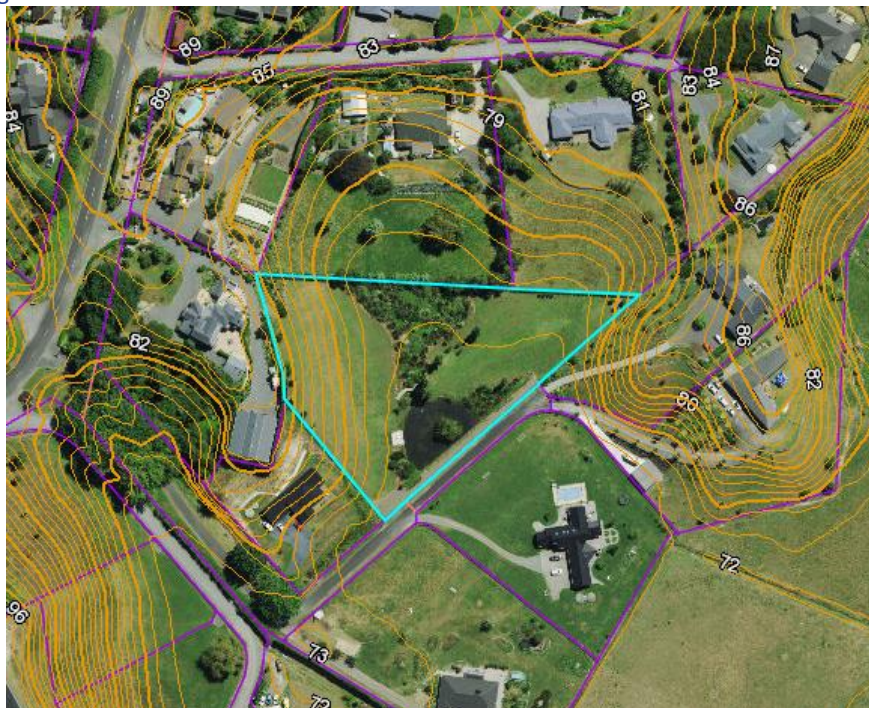
*Figure 1: Indicative location of the investigated area at the subject site.*

The area of investigation covered the eastern section of the property. Within this area, the ground is generally near level to gently sloping towards the south-west into an existing shallow pond with a wetland situated within the middle of the overall lot (i.e., to the west of the area under investigation). Based on contour data from the Waikato Regional Council GIS, the ground level within the area of interest ranged from approximately 71m RL to 73m RL. (all RL's are relative to the Moturiki Datum).

The proposed site is currently an open area covered with mown grass, as shown on the latest aerial photograph below, refer Figure 1.

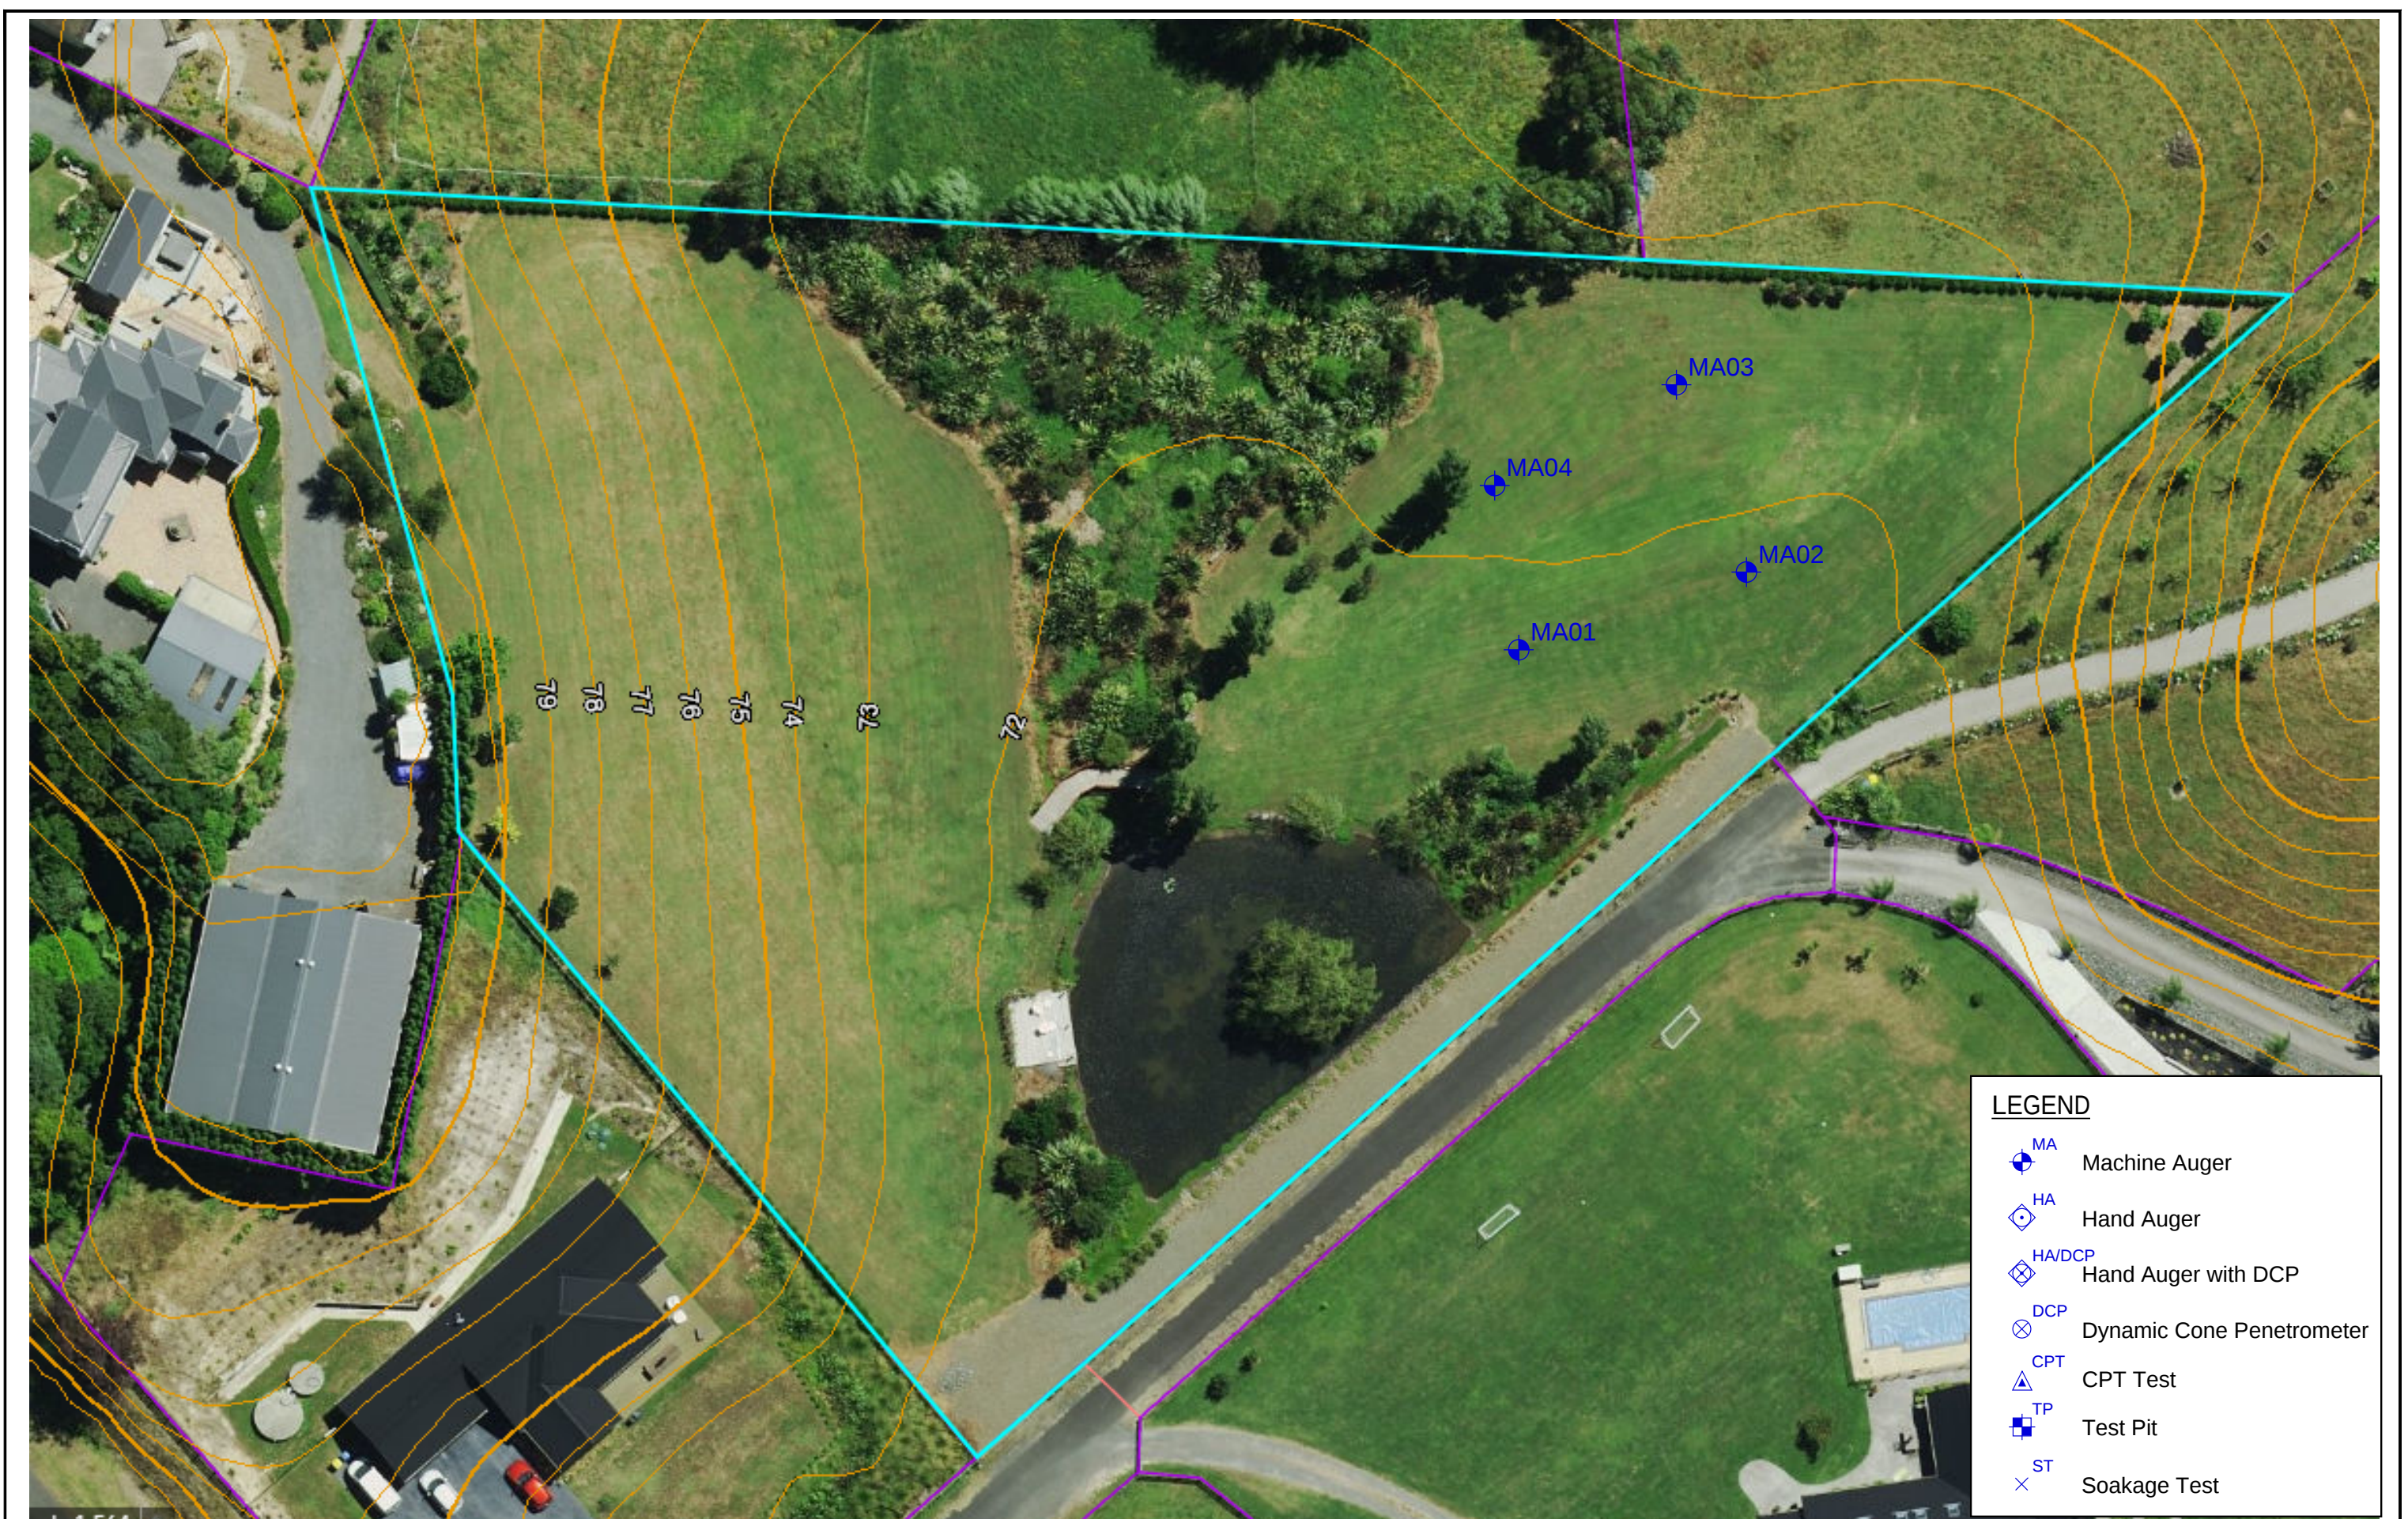
## TEST LOCATION PLAN

Locations of the boreholes are shown on the ‘Test Location Plan’ attached within Appendix A. All logging of the HA core has been undertaken in accordance with the ‘NZ Geotechnical Society Guidelines for the description of soils and rocks’<sup>3</sup> presented in Appendix B ‘Soil Logs’.
