**Paul Schultz**  
**26 Balmoral Terrace, Tauranga**  
**Proposed Subdivision**  
**Geotechnical Assessment Report**

**September 2021**

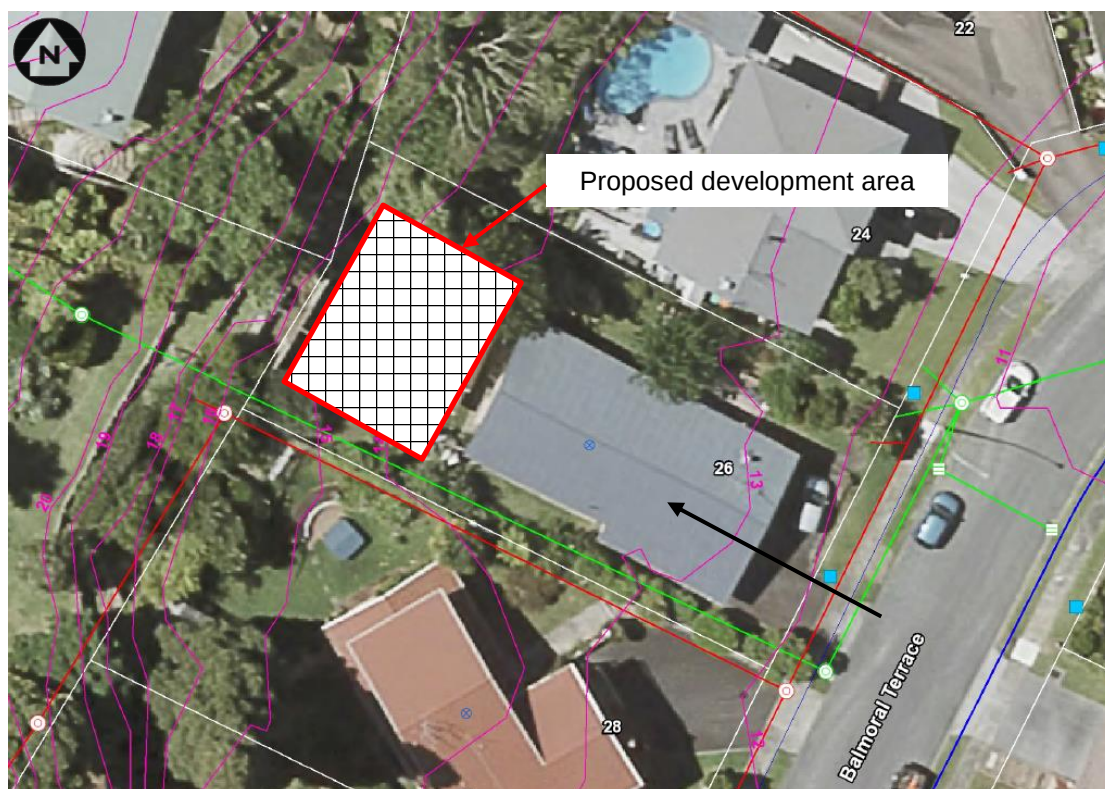
Figure 1 – Site Location

The site location, existing services pipes, and proposed house site are shown in Figure 1 below, including 1.0m contour lines.

The development comprises of subdividing the property into two lots. The proposed location of the second house site in the north-western part of the site is shown in Figure 1 below. A new driveway for the proposed new house will be constructed along the north-eastern boundary of the site.

There is an existing dwelling within the south-eastern part of the site. The topography of the site is mostly flat, with a 25-degree uphill slope present at the back of the section towards the neighboring property to the north-west. The height of the slope ranges from 5 to 6m. A stormwater line runs along the south-western boundary of the property.

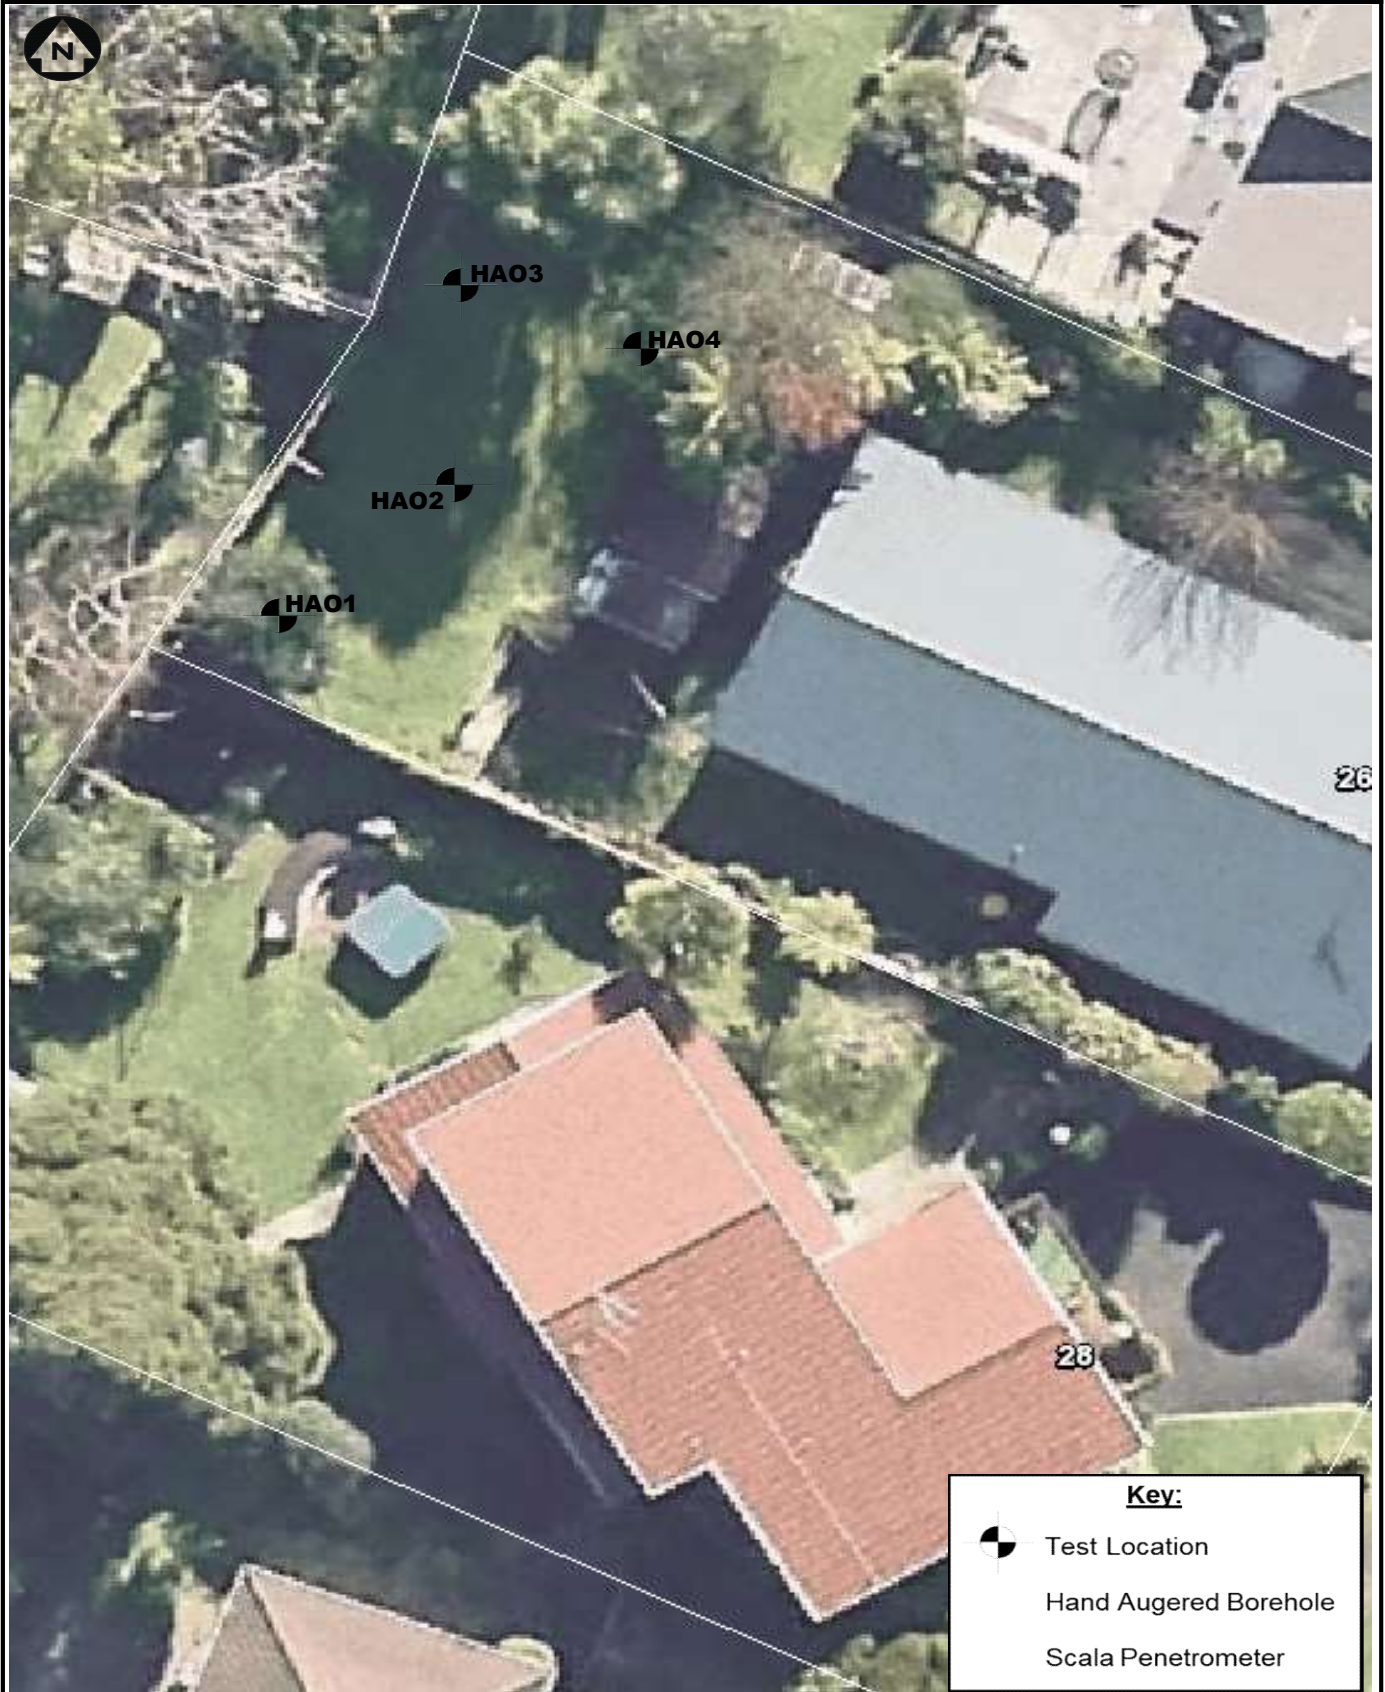
### Test Location Sketch

Test locations are shown on the test location plan, included in Appendix B. Test results are also included in Appendix B.
