# 14102501

**LOCATION**  
 13 Pratt Street  
 9510 Waikouaiti  
 Otago Region  
 NZ

4306:2005 inspection baseline 1.2

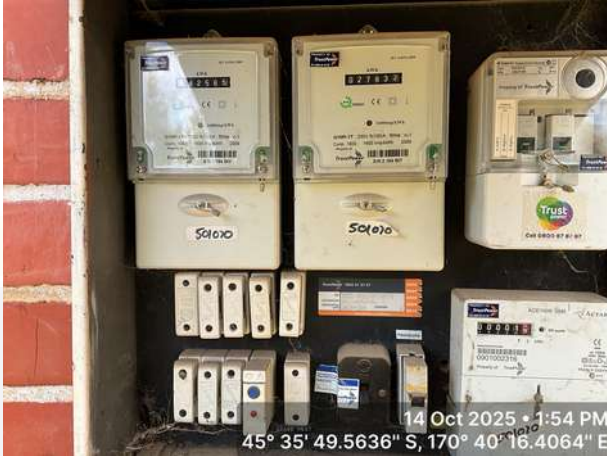
### 8 BREAKER BOX

Electrical note:

Ideally, all homes would apply a gold standard approach to electrical design and fitout. In practice, this looks like TPS (Tough Plastic Sheath) wiring in good condition, with all junctions terminated and protected, all cables appropriately specified, tidily pinned, and mechanically protected in all accessible or habitable portions of the property. Mainboard would ideally be Plastic, Formica or in some cases Alloy, with an RCD for every supply group, and modern MCBs. We cannot test buried cable depth and compliance, or assess visual condition of cabling in walls, or under insulation - as such, there is always a case to be made, that electrical inspection is desirable regardless of observed condition. This is less necessary the newer a property is, as standards have evolved. An important point however, is that electricity contributes to an under appreciated risk for homeowners. Risks include underground or overhead wiring - a close approach permit and/or isolation are required to work within 5 metres of powerlines - this includes even simple tasks, like trimming trees or bushes, painting bargeboards, or cleaning spouting. Err on the cautious side when working near with electricity.

Wiring - some modern TPS can be seen, howsoever there are areas where condition is poor - recommend an electrical inspection be undertaken.

Suggest electrical inspection, Old or risky wiring visible

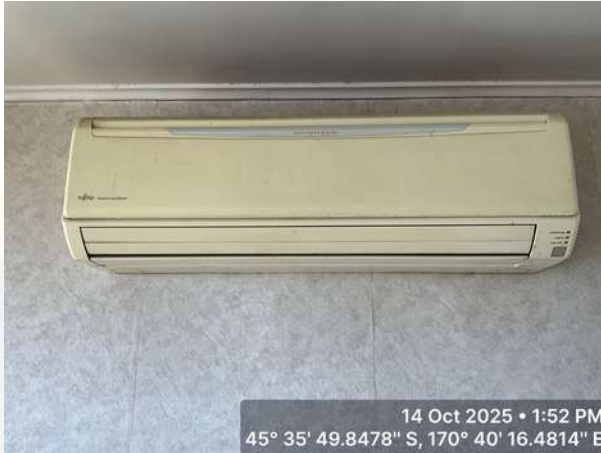
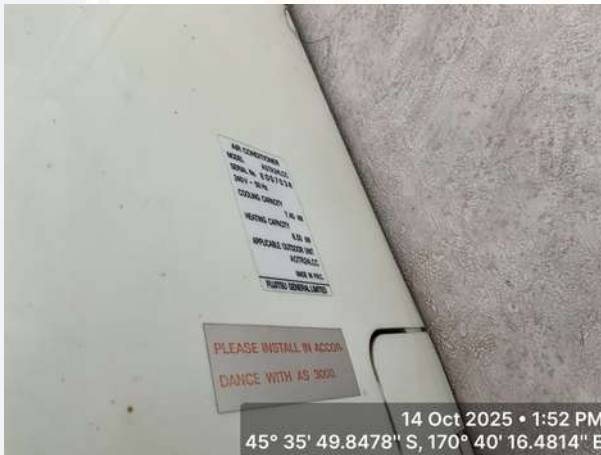
10 AIR CONDITIONER

Model number (heat output and COP can be looked up from this)

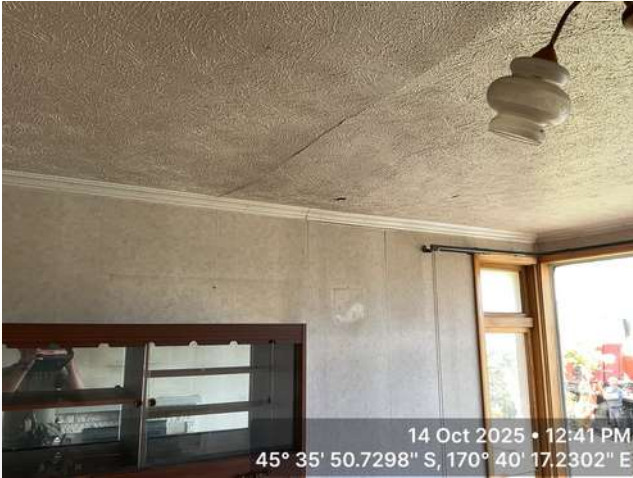
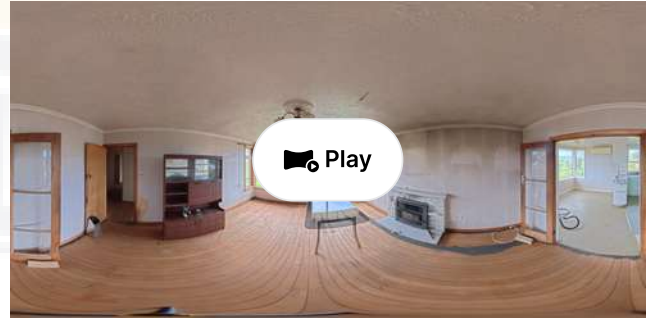
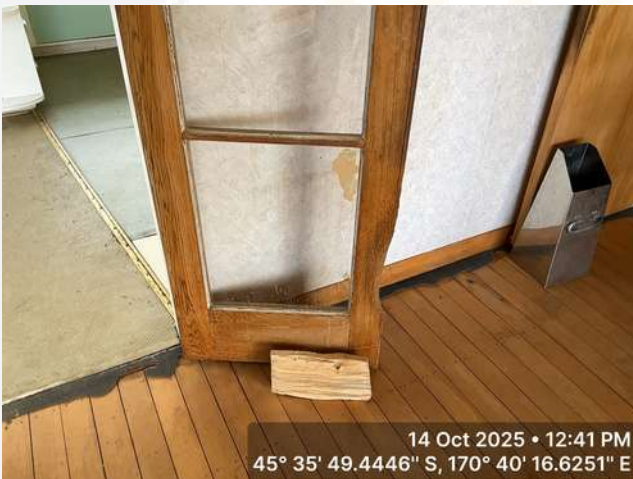
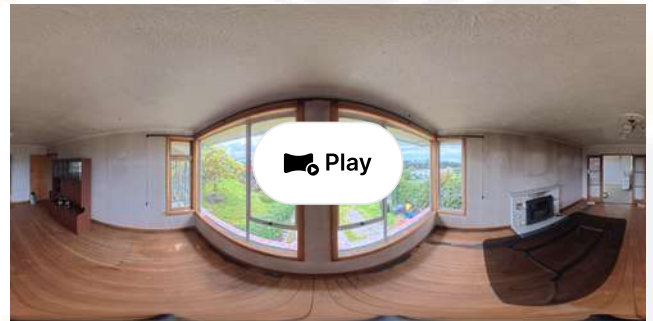
## ▼ Living Room/Ground Floor

**Weathertightness and moisture ingress** Ceiling in the lounge has been replaced was falling down regibbed and painted  
 Active leak, Occasional leak, Minor visible damage, possibly more when opened, wall, ceiling, plumbing,  
 Significant works anticipated, Benefit to completing vapour proof barrier

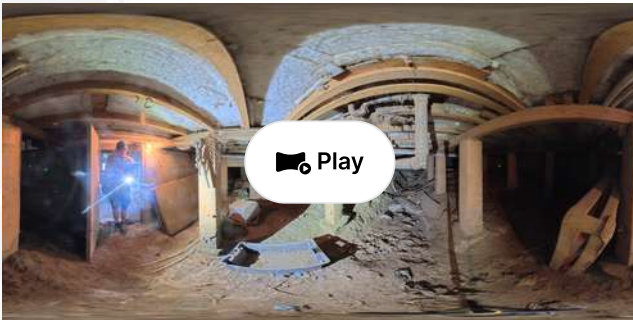
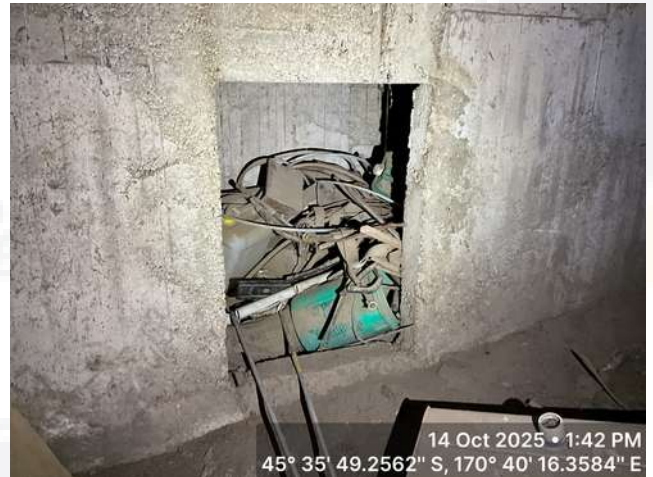
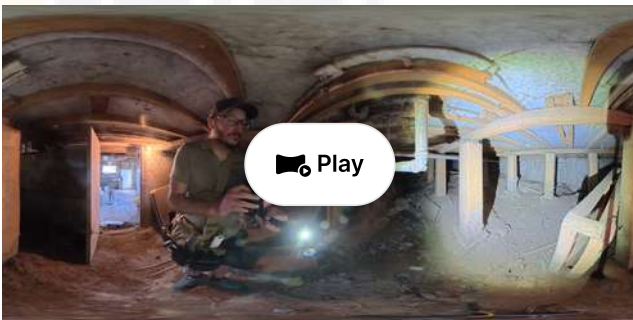
## ▼ Unfinished Basement/Semi-Basement

Plumbing - wastes have had poor work undertaken, sealed with insulation tape, falls incorrect. It is evident there have been a number of grey water leaks into subfloor area over a significant time.
