| Property Address: 37 Symonds Road | Inspection Number: 1 | Phone: 0274 595 865 (07)3084584<br>Email: hoaani.merritt@outlook.co.nz |
| <b>ITEMS TO BE CHECKED</b> <span style="background-color: green; color: white; padding: 2px;">TAKE PHOTOS</span> | | |

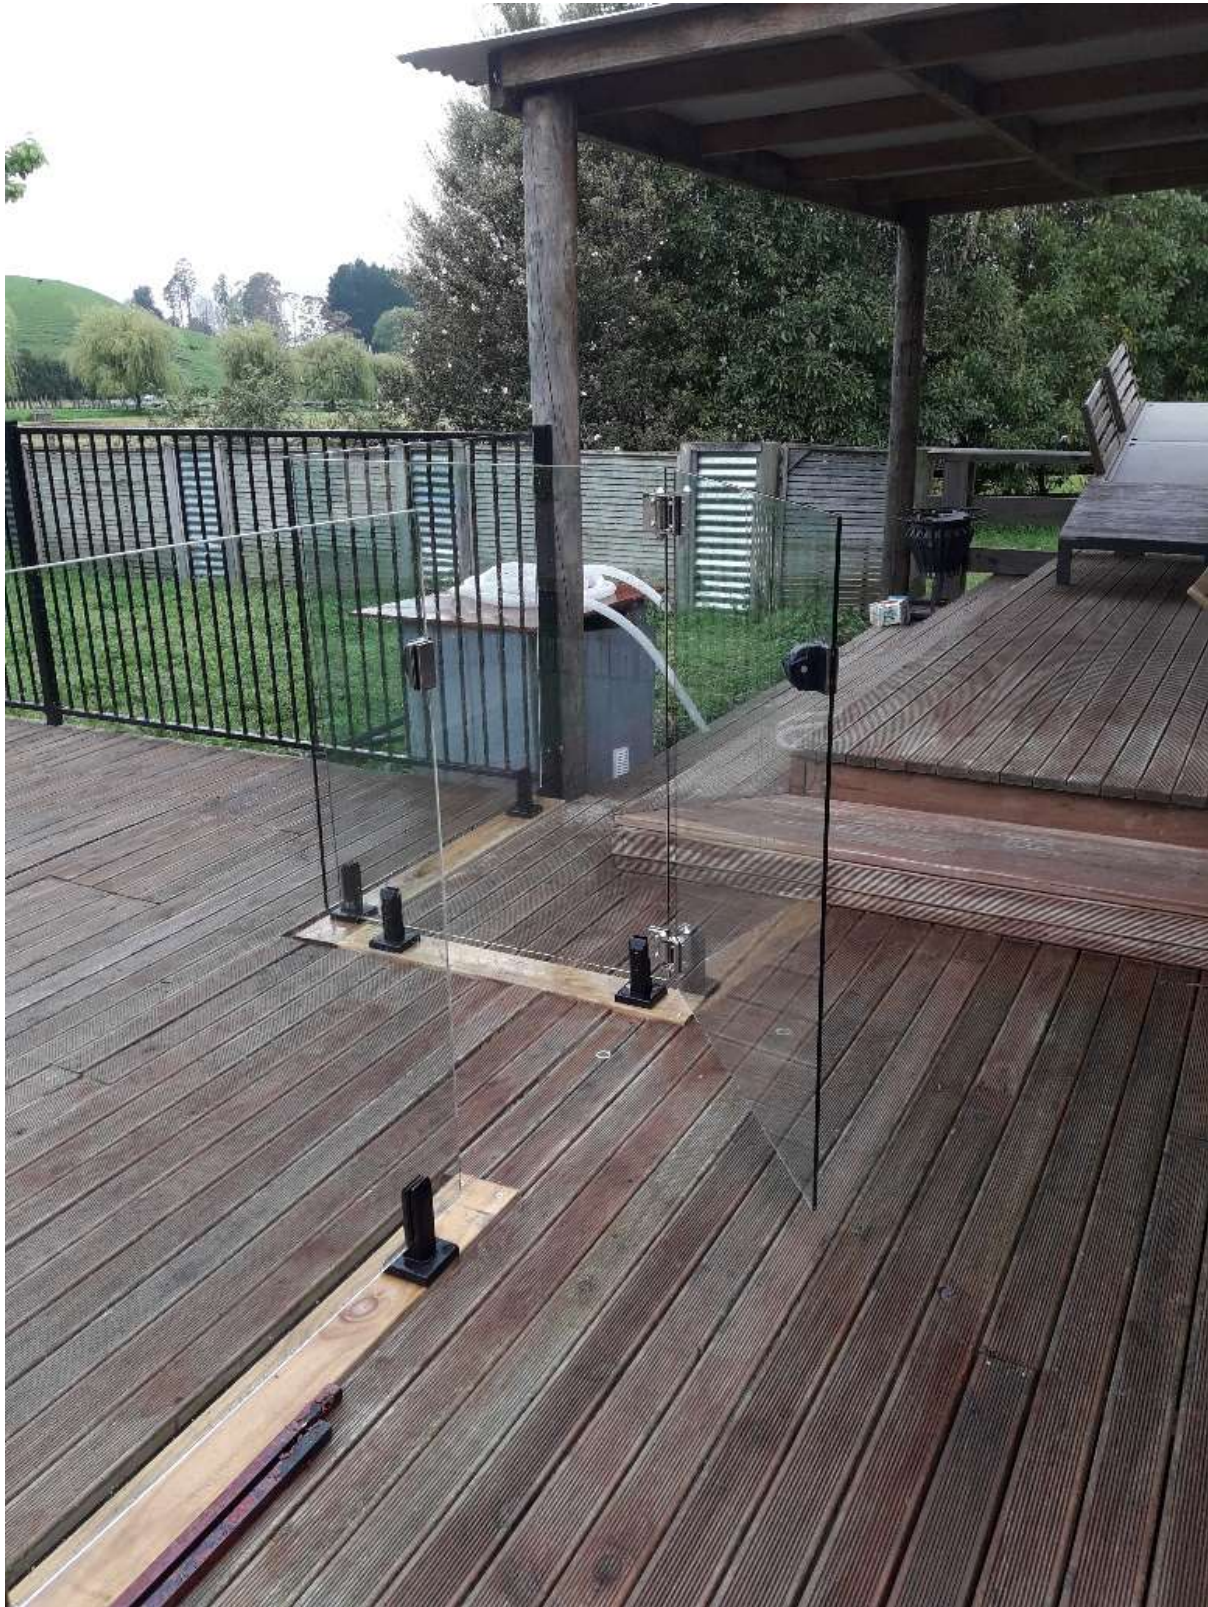
Paige explains by phone that the work has been unable to be done due to Covid. The glass pool access gate to the East is still not self-closing/self-latching. The other glass gate is decommissioned to be an access gate at this inspection.

*Figure 1 - 7 Oct 21 - glass access gate not self-closing.*

- 1) Fit the self-closing latches to both glass access doors of the pool perimeter fencing as soon as they are obtained. The doors to self-close, self-latch from any position (150mm min) and be unable to be shaken.  
**In the interim**, install a suitable temporary “locking system” to the glass gates.
- 2) Install BFPD

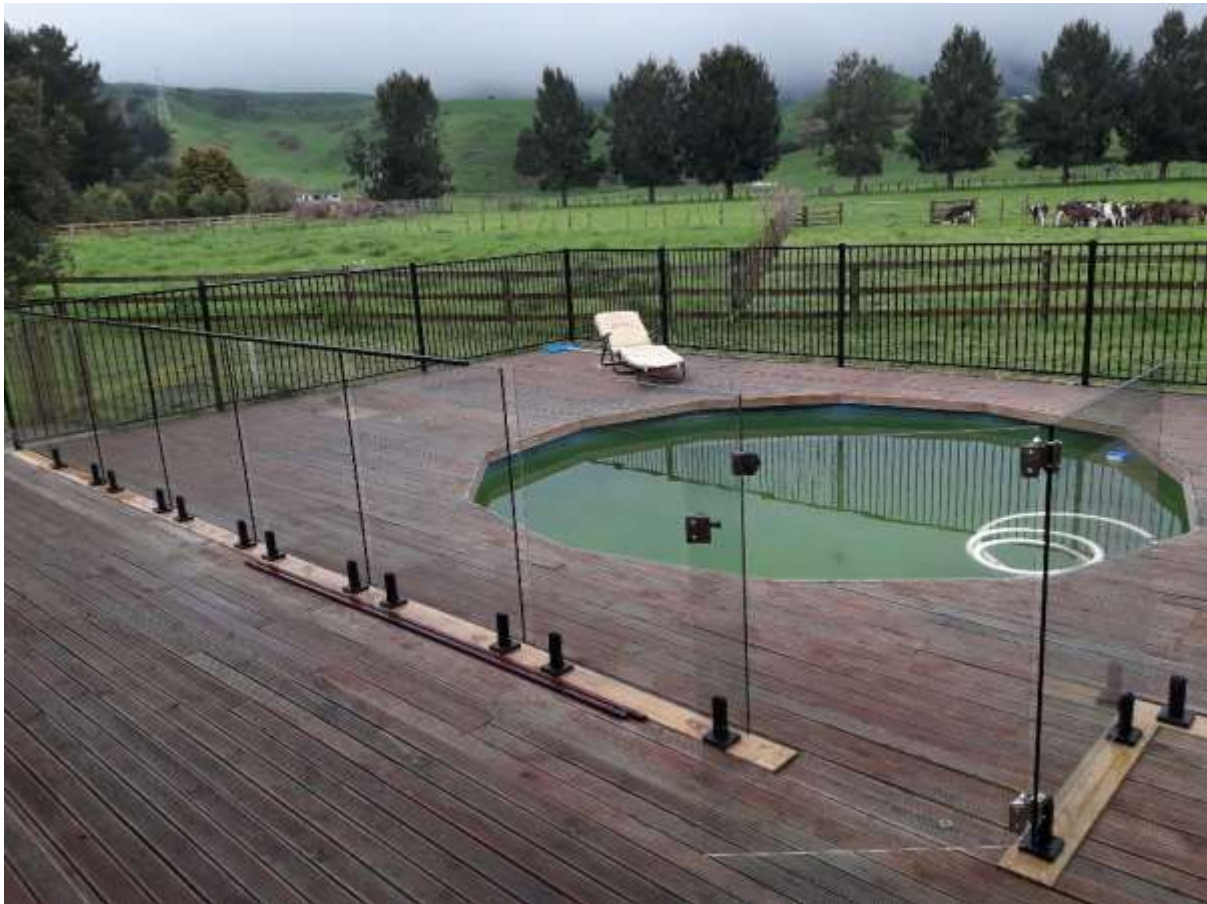
| Self-closing & latching if open @ 150 mm | F | F |
| | | Latching system not installed yet. Unavailable. As per last. No further progress, refer to notes below. |

*Figure 2 - Access gate not self-closing.*

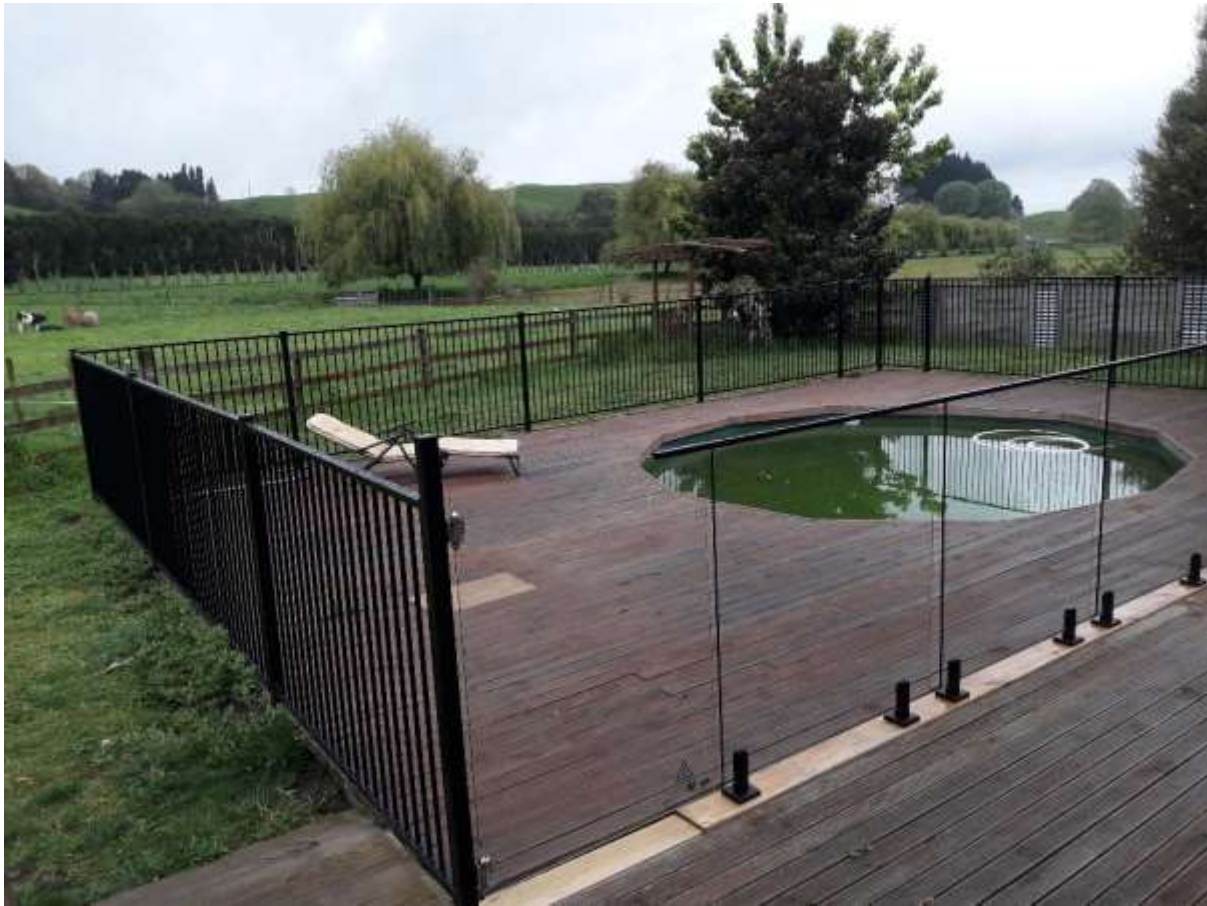
*Figure 3 - Other access gate - decommissioned to be of use. Requires latching device.*
