| Property Address: 37 Symond Road ( <b>Off Braemar Rd Onepū end</b> ) | Inspection Number: 1 | Phone: 0274 595 865 (07)3084584<br>Email: <a href="mailto:hoaani.merritt@outlook.co.nz">hoaani.merritt@outlook.co.nz</a> |

| <b>Work complies with the F9 Acceptable Solutions document</b> | | <b>REPEAT: Work complies with the F9 Acceptable Solutions document</b> | |

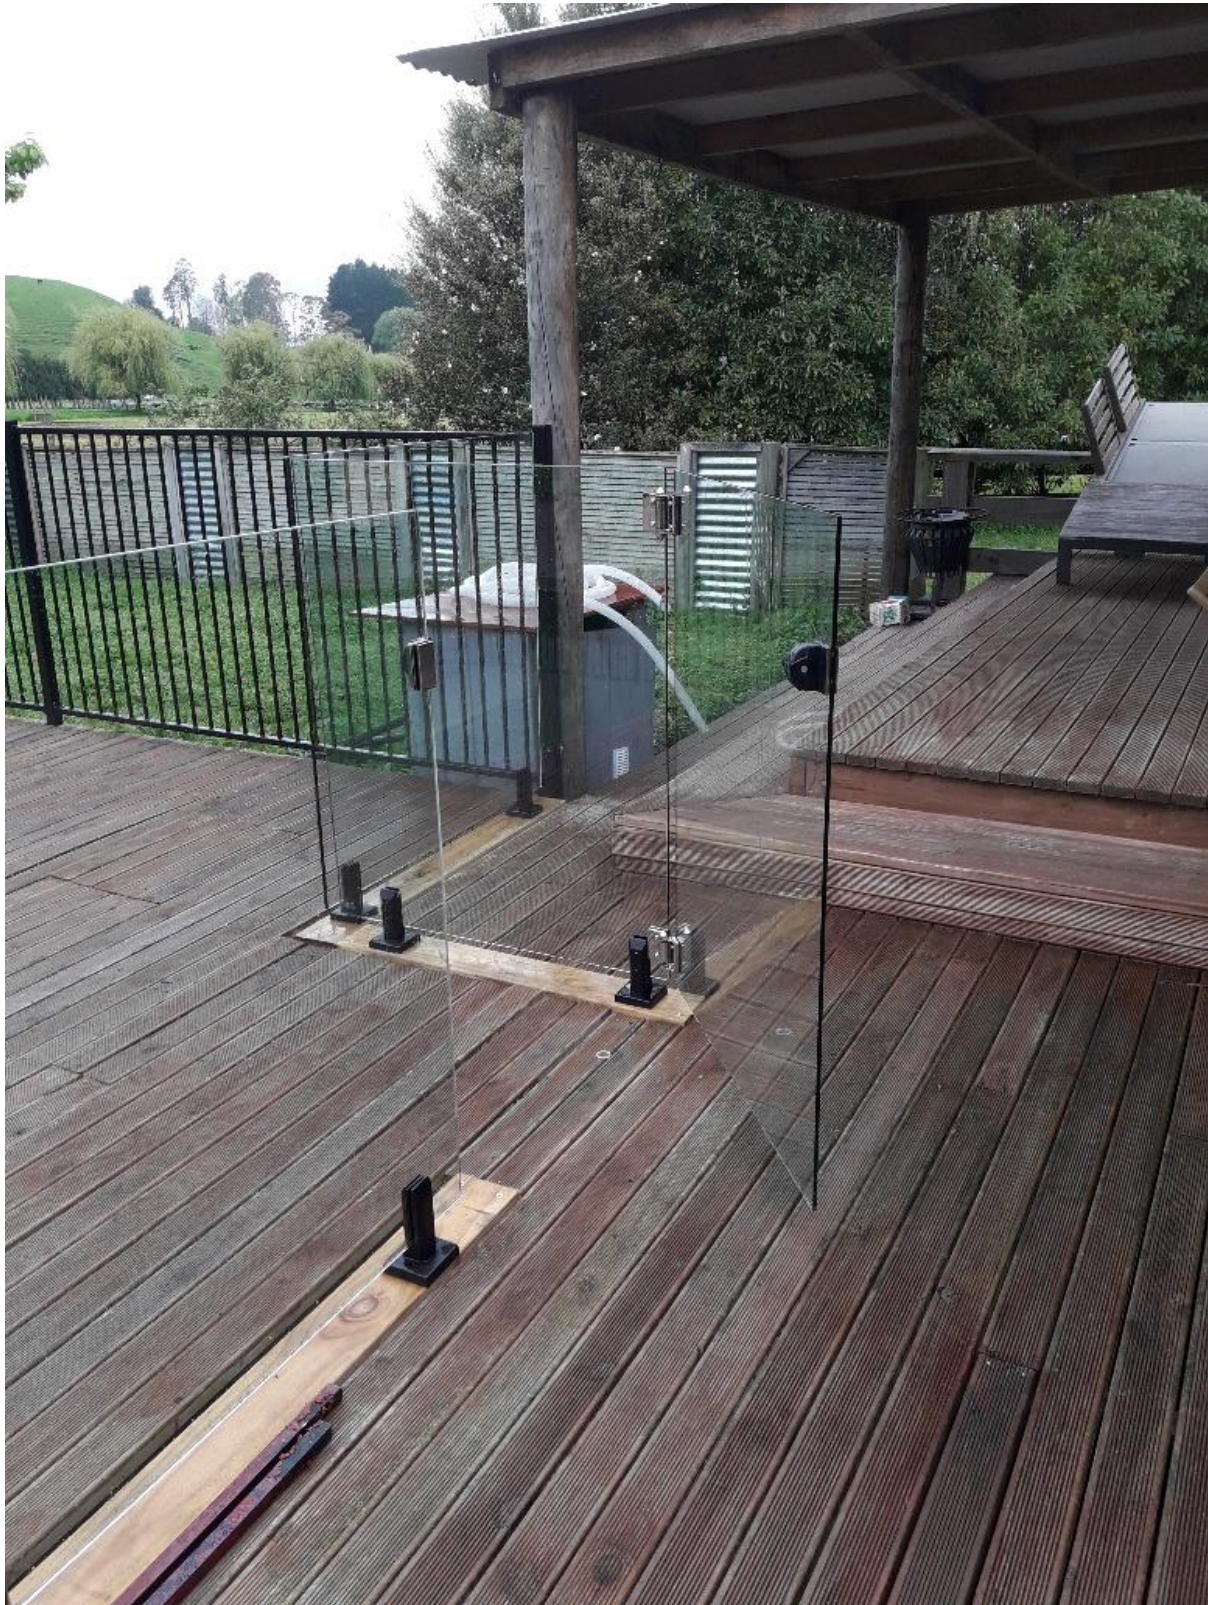
On arrival 2 x internal latching systems are in place on both North & south elevation glass gates which is the issue. The south gate now complies (self-closing/latching from 150mm min), the north one does NOT.

*Figure 1 - 7 Oct 21 - glass access gate not self-closing. **13 Jan 2022 inspection.** Still not self closing/latching. Owner advised to remediate so it does or alternatively lock it when not under direct adult supervision.*

| | | | gates installed. South aspect gate self-closing & latching, the North aspect gate is not as its installation is compromised. Advised to remediate it to self -close/self - latch from 150mm min or ensure to Council that it is to be permanently locked and unable to be open/used unless the pool is under direct adult supervision. |

**Action item 1:** A remediation solution was discussed to lift the gate so it does self-close or alternatively, the gate is to be locked shut on every occasion except when **under direct adult supervision**.
