| Property Address: 37 Symond Road ( <b>Off Braemar Rd Onepū end</b> ) | Inspection Number: 1 | Phone: 0274 595 865 (07)3084584<br>Email: <a href="mailto:hoaani.merritt@outlook.co.nz">hoaani.merritt@outlook.co.nz</a> |

| <b>Work complies with the F9 Acceptable Solutions document</b> | | <b>REPEAT: Work complies with the F9 Acceptable Solutions document</b> | |

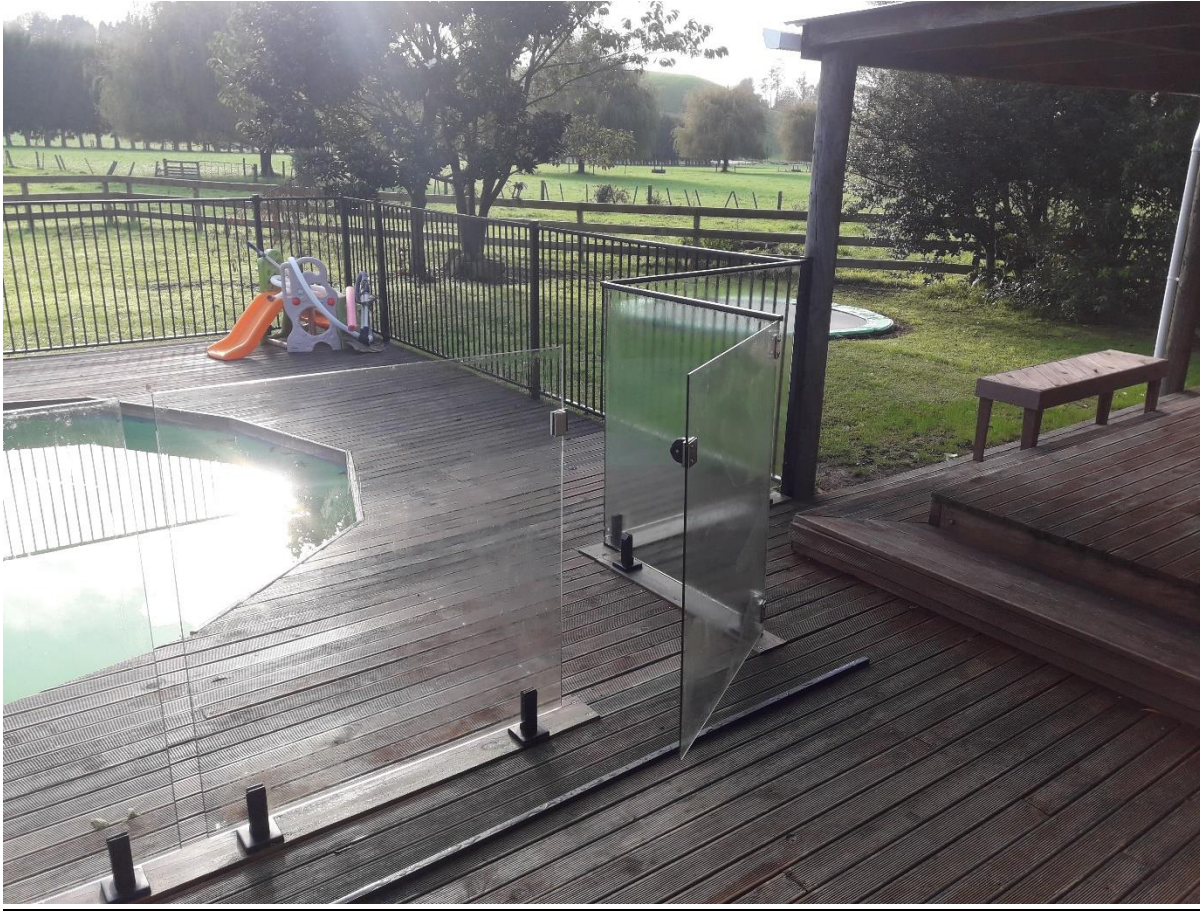
**NOTED:** Pool fencing “capping” - (photos refer) are installed to the glass access gates and that appear to be a method installed to prevent the gates being opened by children.

On use they are easily lifted and then fall to the ground permitting entry to the North access gate which appears to have not been remediated to self-close/latch (see photo below).

The system **noted** in place at today’s inspection is NOT sufficient to comply with the legislative pool safety requirements.

*Figure 1 - North pool access gate AND ("capping" on the deck) that ran across the top of the glass gate and fence panel barrier as a type of locking system.*

**Action item 1:** Re mediate the gate to the North of the pool barrier system to comply with requirements to function the same as the access gate at the other end.

**The gate MUST self-close and self-latch from 150mm min OR be deactivated entirely as an access point by being locked.**

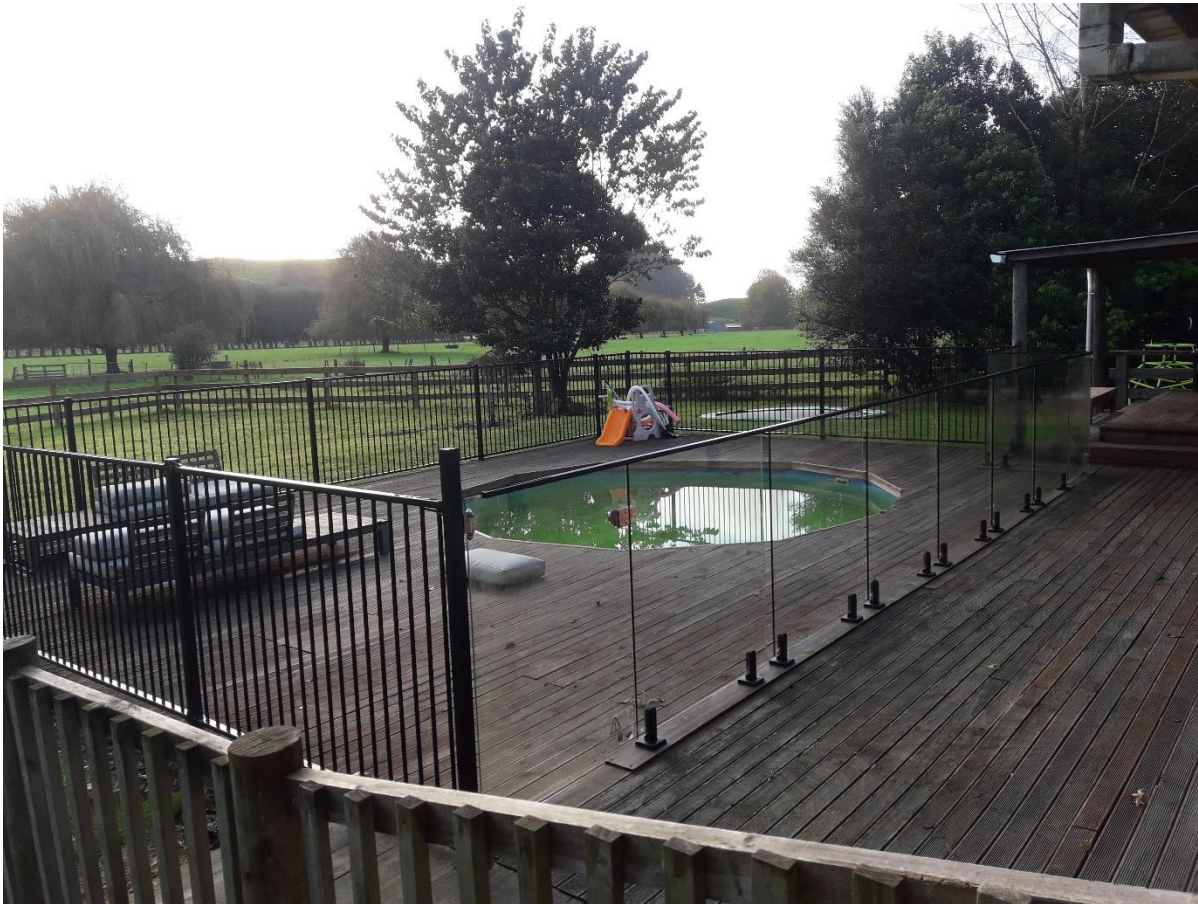
The other access gate functions as required to be compliant.

*Figure 2 - South access gate that functions perfectly AND the "capping" system on top of the gate & glass barrier.*

*This gate functions as required.*

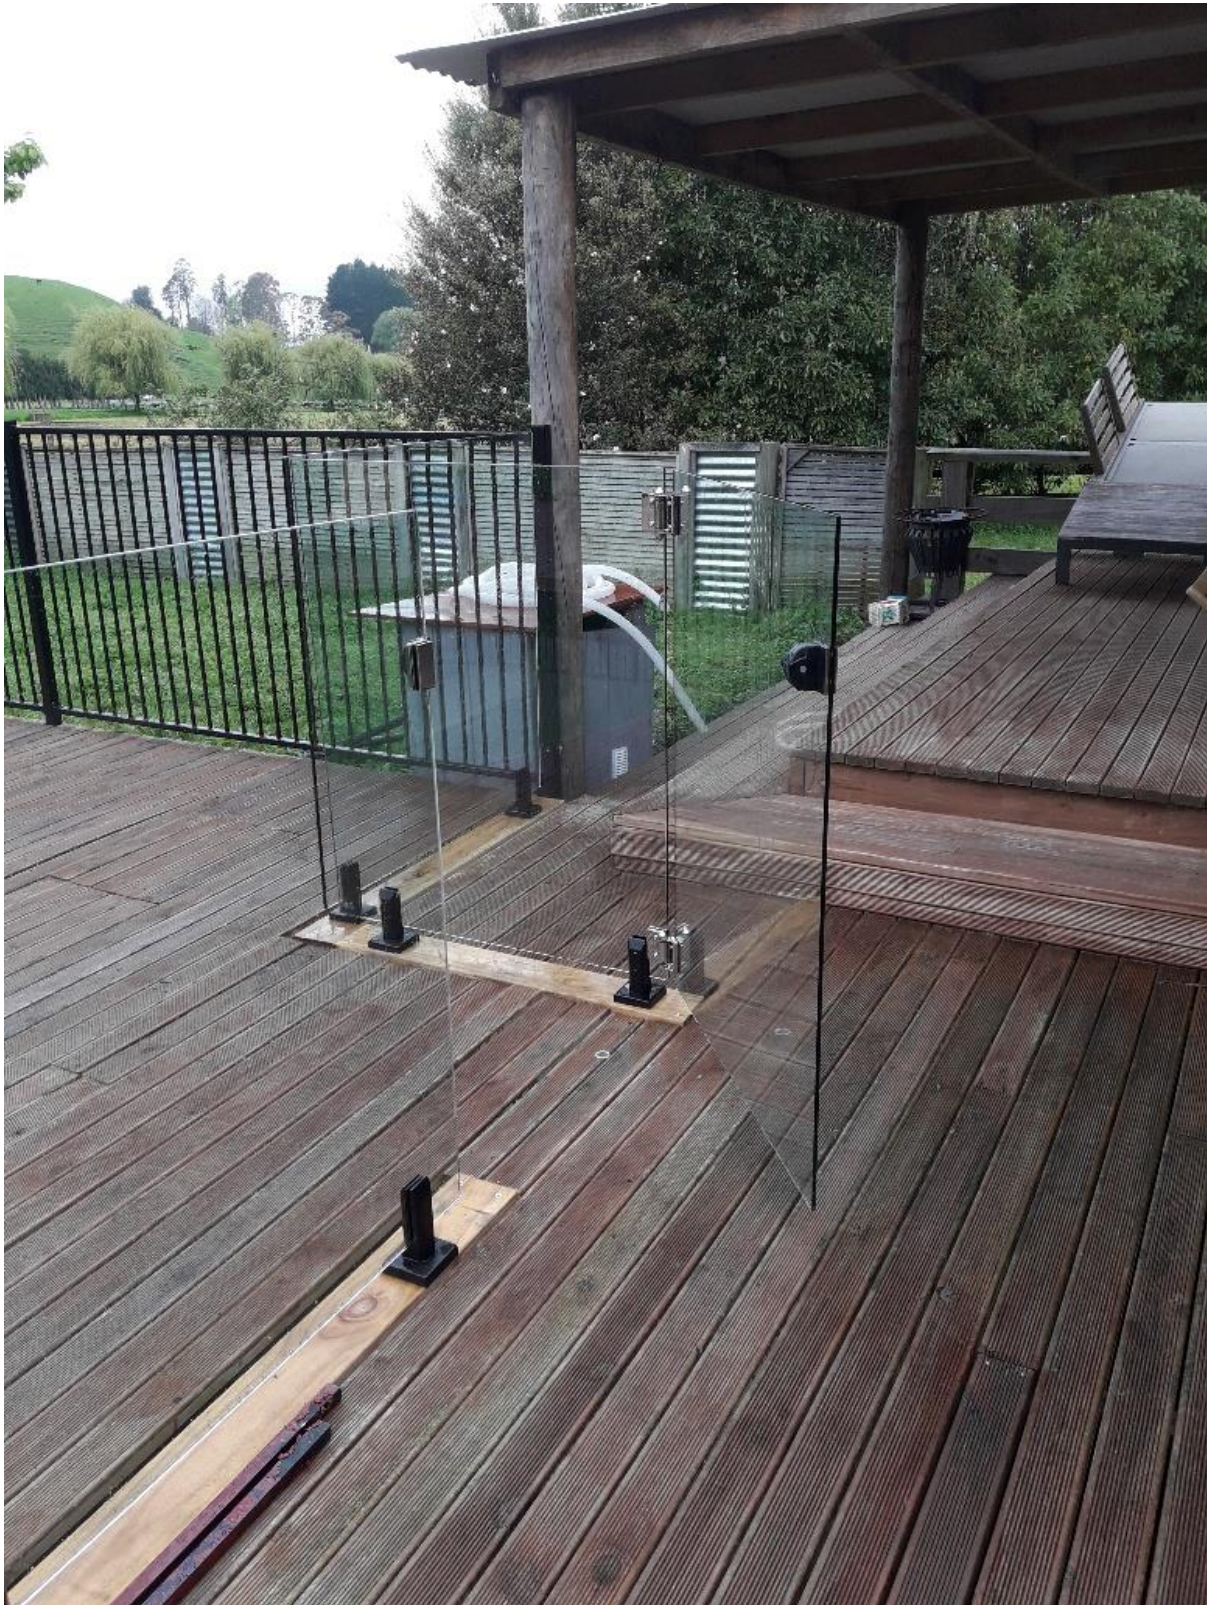
On arrival 2 x internal latching systems are in place on both North & south elevation glass gates which is the issue. The south gate now complies (self-closing/latching from 150mm min), the north one does NOT.

*Figure 3 - 7 Oct 21 - glass access gate not self-closing. **13 Jan 2022 inspection.** Still not self closing/latching. Owner advised to remediate so it does or alternatively lock it when not under direct adult supervision.*

**Action item 1:** A remediation solution was discussed to lift the gate so it does self-close or alternatively, the gate is to be locked shut on every occasion except when **under direct adult supervision**.

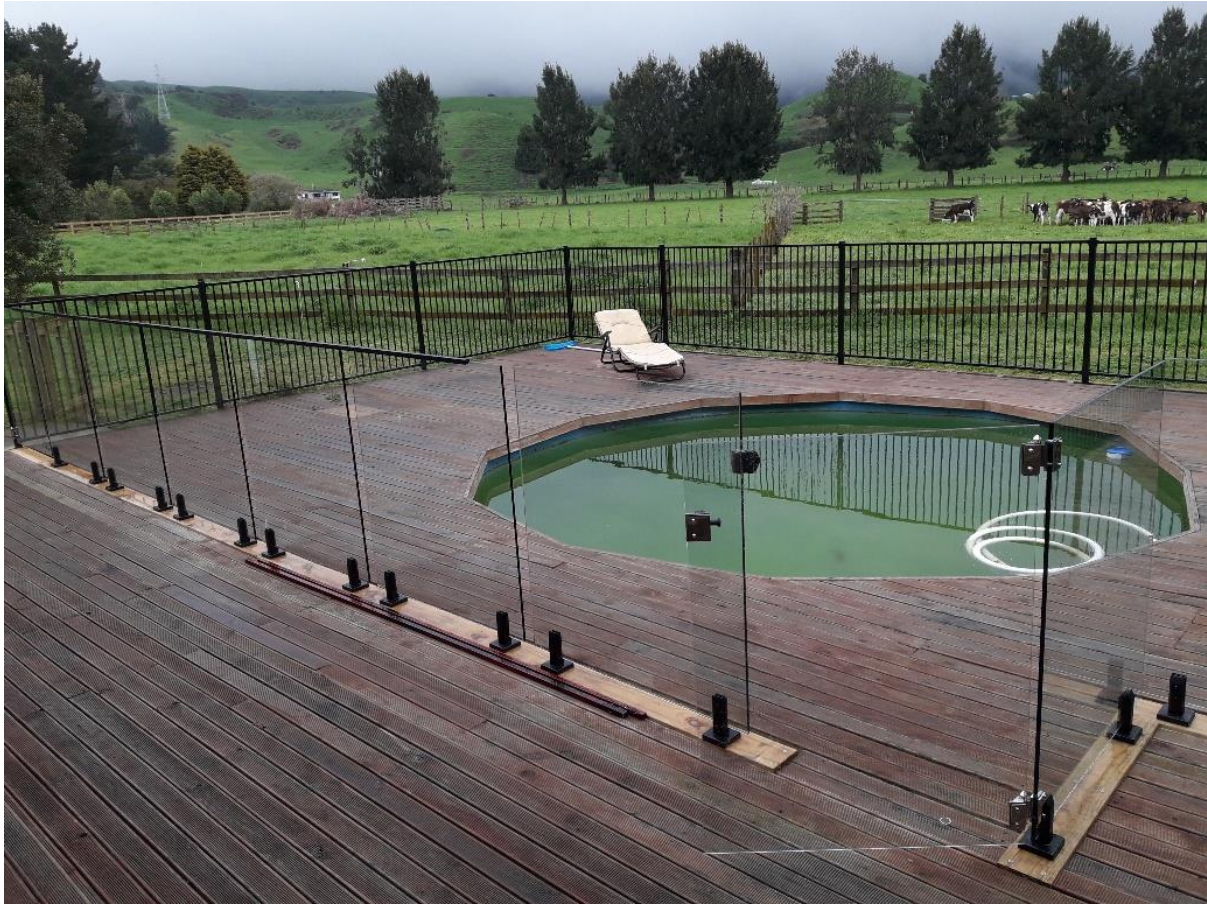
*Figure 4 - Access gate not self-closing. 13 Jan 2022 – As in Fig 1*

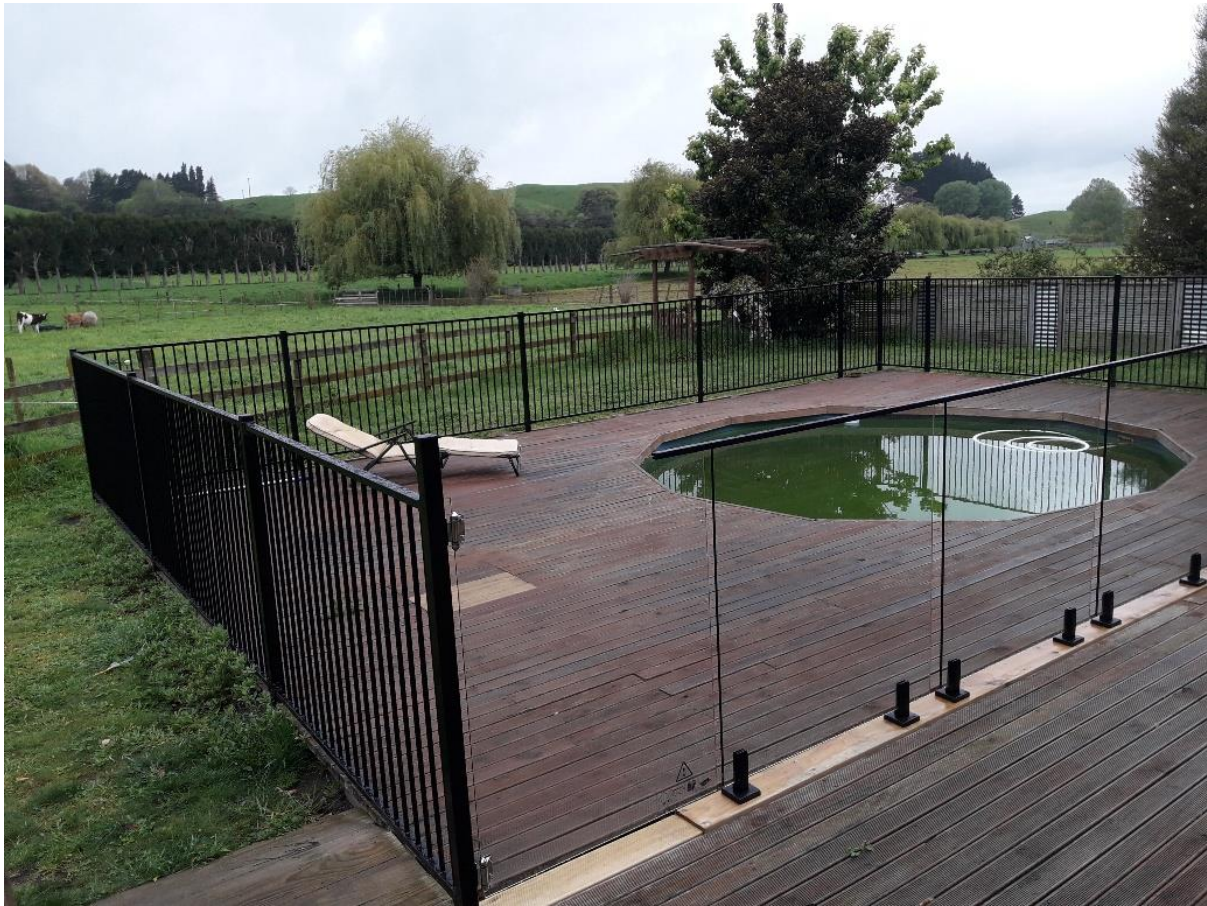
*Figure 5 - Other access gate - decommissioned to be of use. Requires latching device. 13 Jan 2022 inspection: Gate has a internally fitted and compliant functioning self-closing/latching device. This gate complies.*
