# Spa Pool Inspection Sheet

| Property Address: 37 Symond Road (Off Braemar Rd Onepū end) | Phone: - Phone: 0274 595 865 (07)3084584 |

**37 Symonds Rd – 7 Aug 23**

**37 Symonds Rd – 22 May 23**

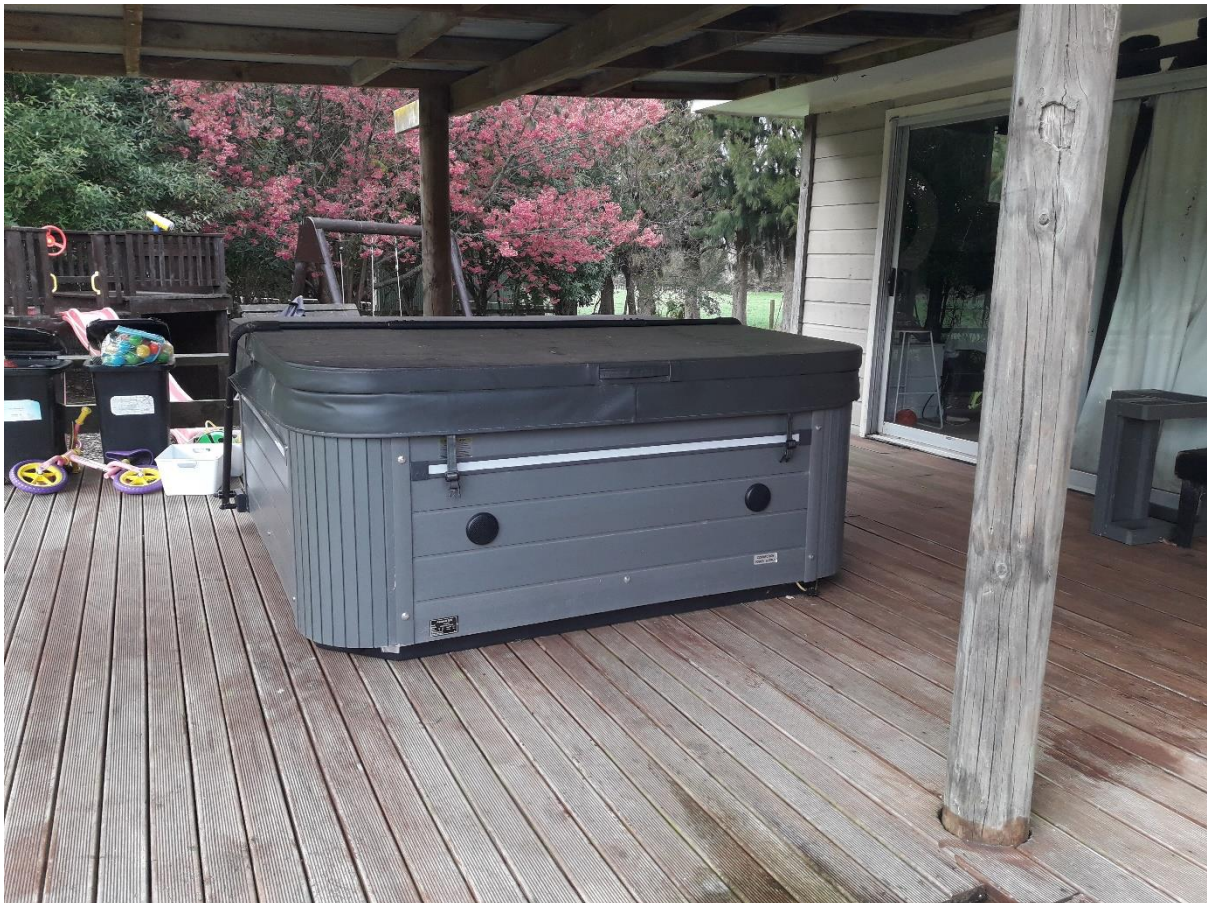
*Figure 1 - All lid securing latching straps are not fitted to the spa timber framing nor is the Warning signage displayed in the area of the spa. Another sign left with the spa on leaving.*

*Owner stated when called that her and her partner are so busy to have attended to obtaining keys for the latches (told to approach Fencing company in Gateway), screwing the latches to the spa frame and installing the Warning signage (lost the other provided one so left another on the spa for them to install in the spa area)*

**Action item 1: Attach the spa pool lid locking straps to the spa pool timber construction and ensure that the straps are locked when the pool is not under direct adult supervision.**

**Action item 3: Install in the area of the spa, the provided Warning signage.**

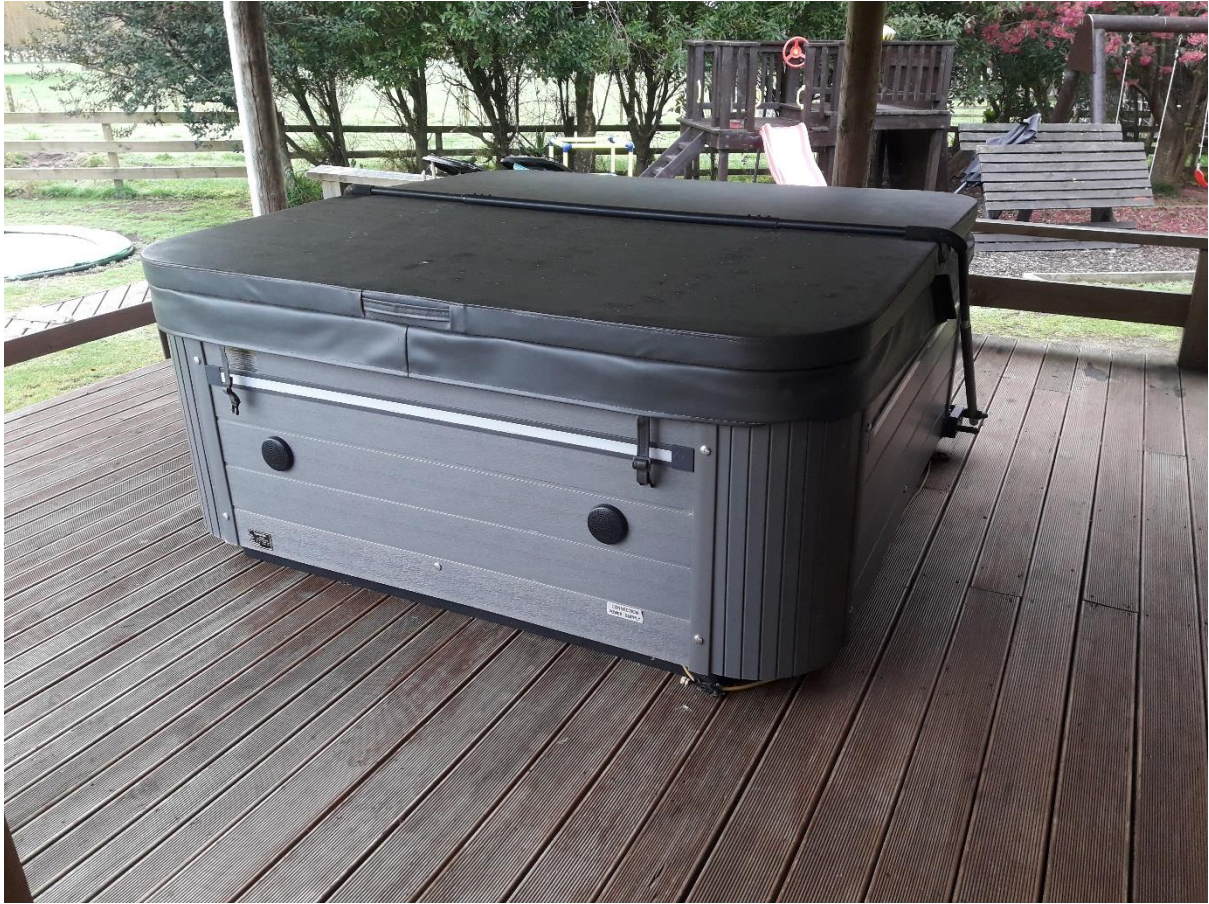
*Figure 2 - spa lid barrier arm not secured at this inspection*

**Alternatively, ensure that the spa lid locking bar is engaged and locked to ensure the lid(s) cannot be lifted and the pool accessed when not under supervision.**

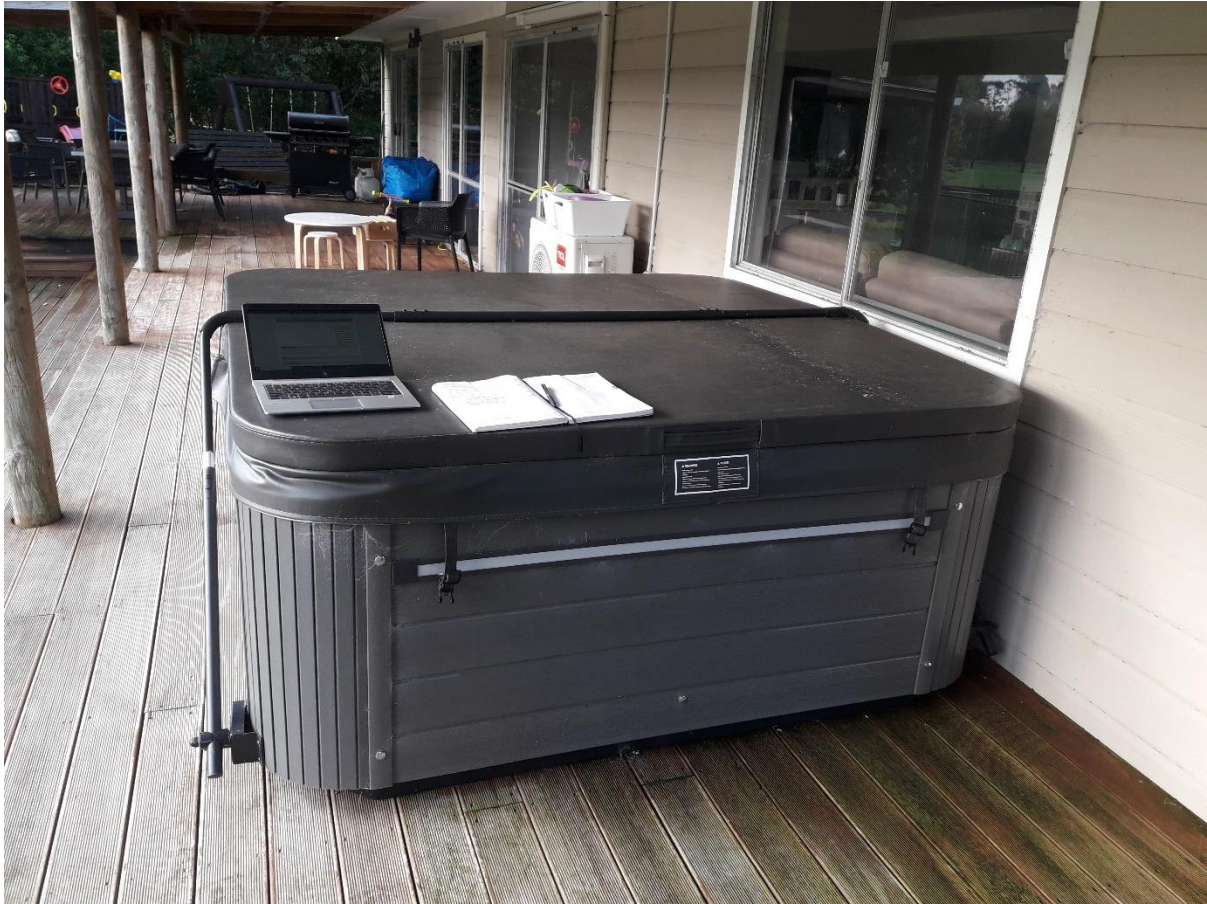
**NOTE: The access steps as found, lid not secured as the locking straps are not connected to the spa structure, the full pool and no visible Warning signage.**

*Figure 3 - Locking bar not secured permitting access. No Warning signage, locking straps not fixed to*

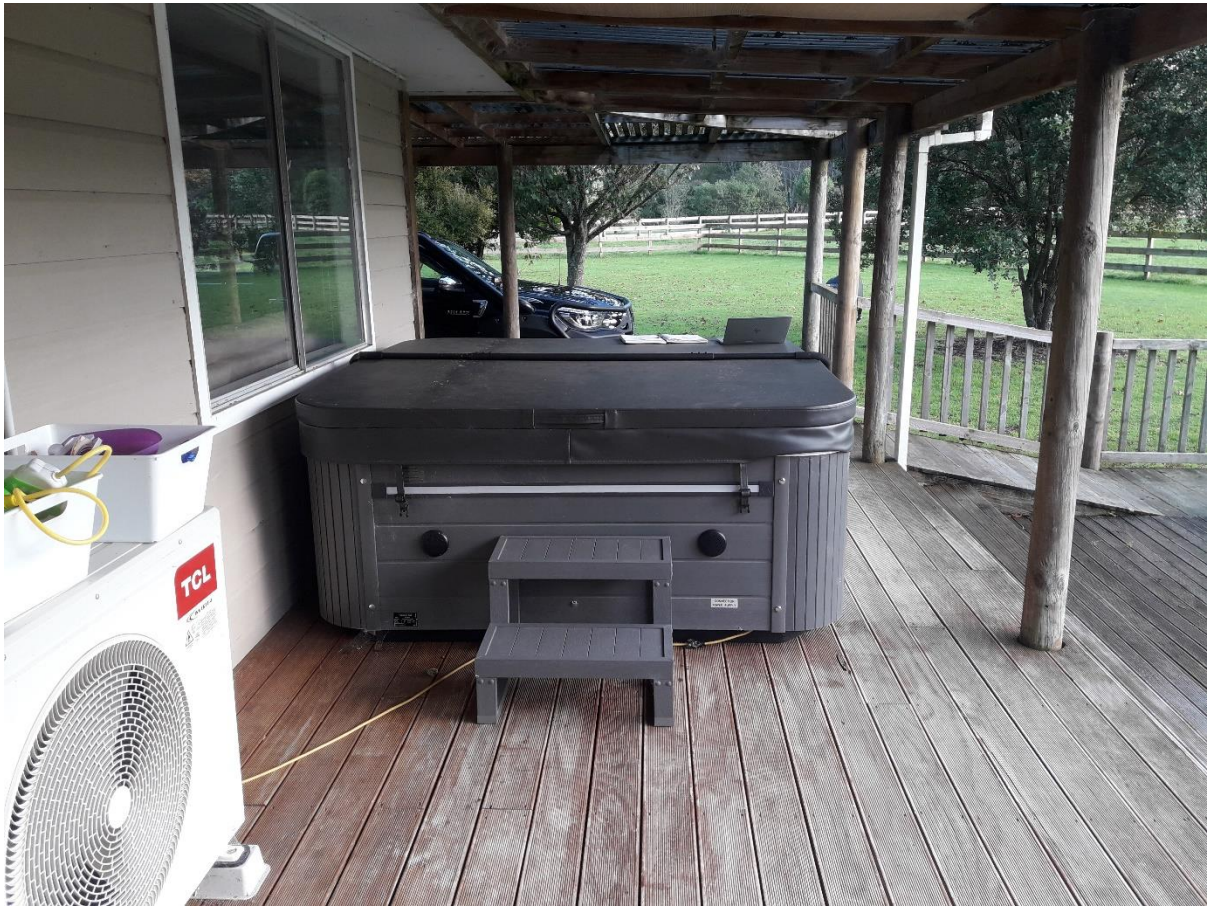
| SPA POOLS | 1 <sup>st</sup> | 2 <sup>nd</sup> | 3 <sup>rd</sup> | INSPECTION NOTES |
|---|---|---|---|---|
| There are no external objects or projections within 760mm of the top edge that could assist with climbing. | F | | | Access steps in place at this inspection – photos. |

*Figure 4 - Access steps in place. locking straps not secured.*

**Action item 2: Ensure that the pool access steps are not within the immediate area of the spa when it is not under direct supervision (removed at this inspection).**

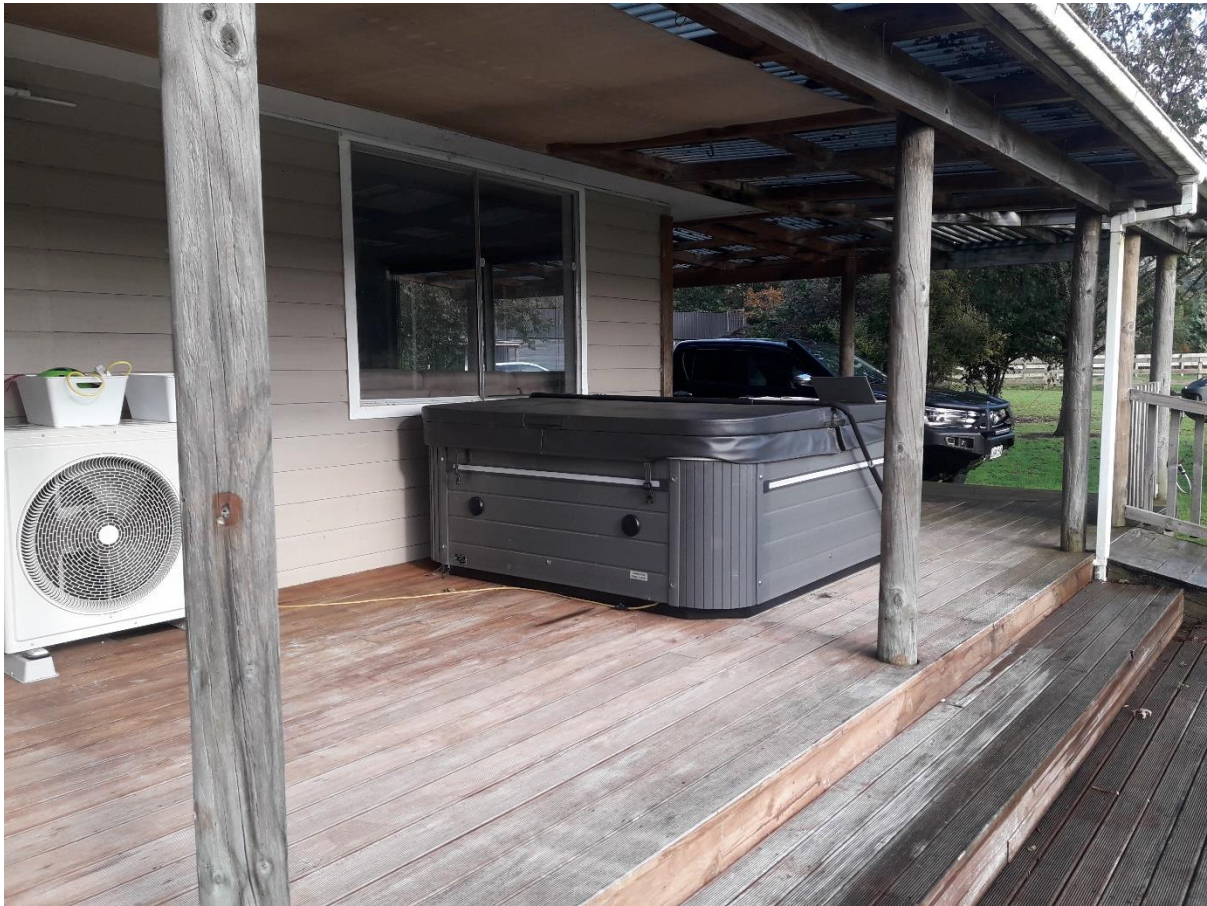
**Secondly I removed the access stairs.**

*Figure 5 - Steps removed at this inspection - (to other side of the heat pump).*

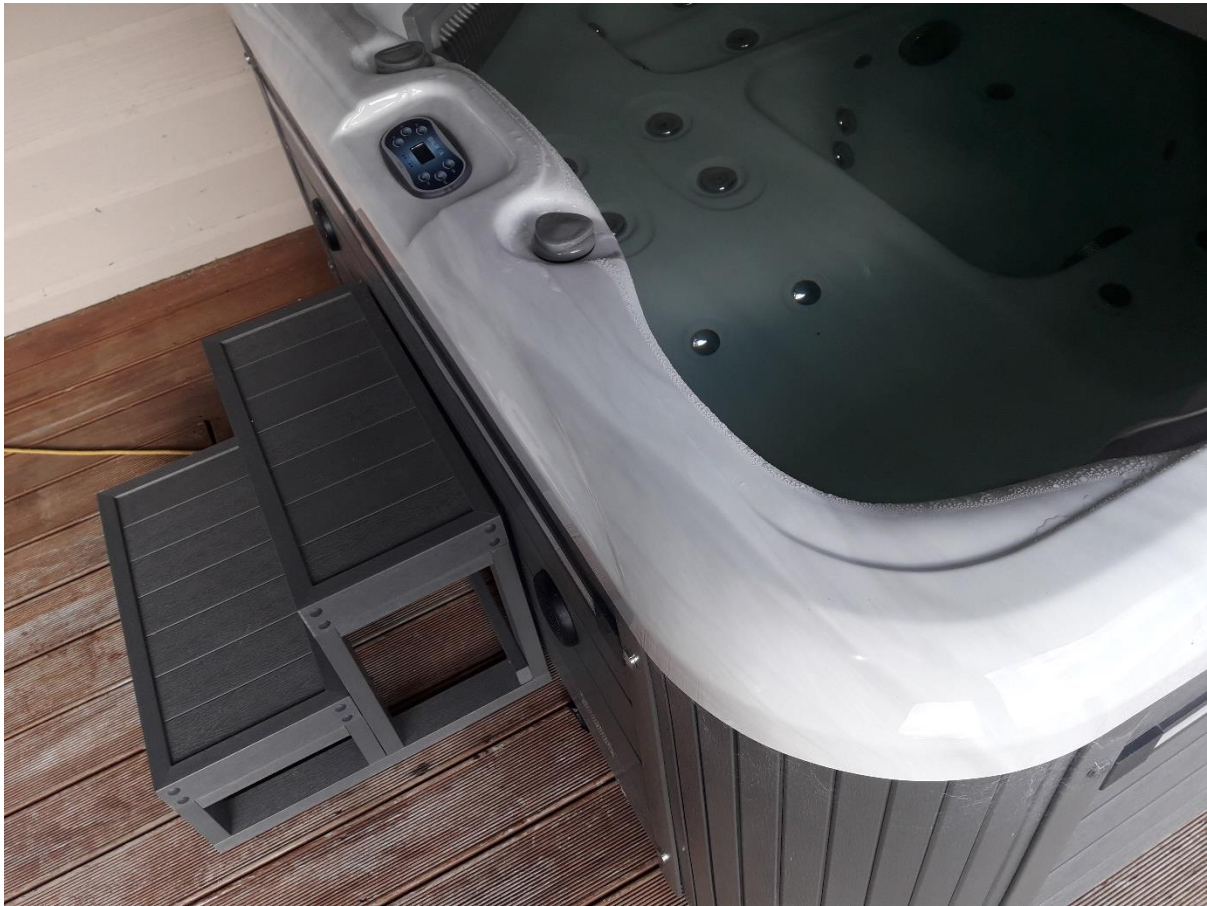
**Firstly, I lifted the North end of the cover easily to expose the interior, which was full of warm water.**

*Figure 6 - Pool accessed at this inspection. Full of water.*
