| Property Address: 37 Symond Road ( <b>Off Braemar Rd Onepū end</b> ) | Inspection Number: | Phone: 0274 595 865 (07)3084584<br>Email: <a href="mailto:paige.olsen@outlook.com">paige.olsen@outlook.com</a><br><a href="mailto:hoaani.merritt@outlook.co.nz">hoaani.merritt@outlook.co.nz</a> |
| <b>ALL POOLS</b> | 1 <sup>st</sup> | 2 <sup>nd</sup> <b>INSPECTION NOTES</b> |

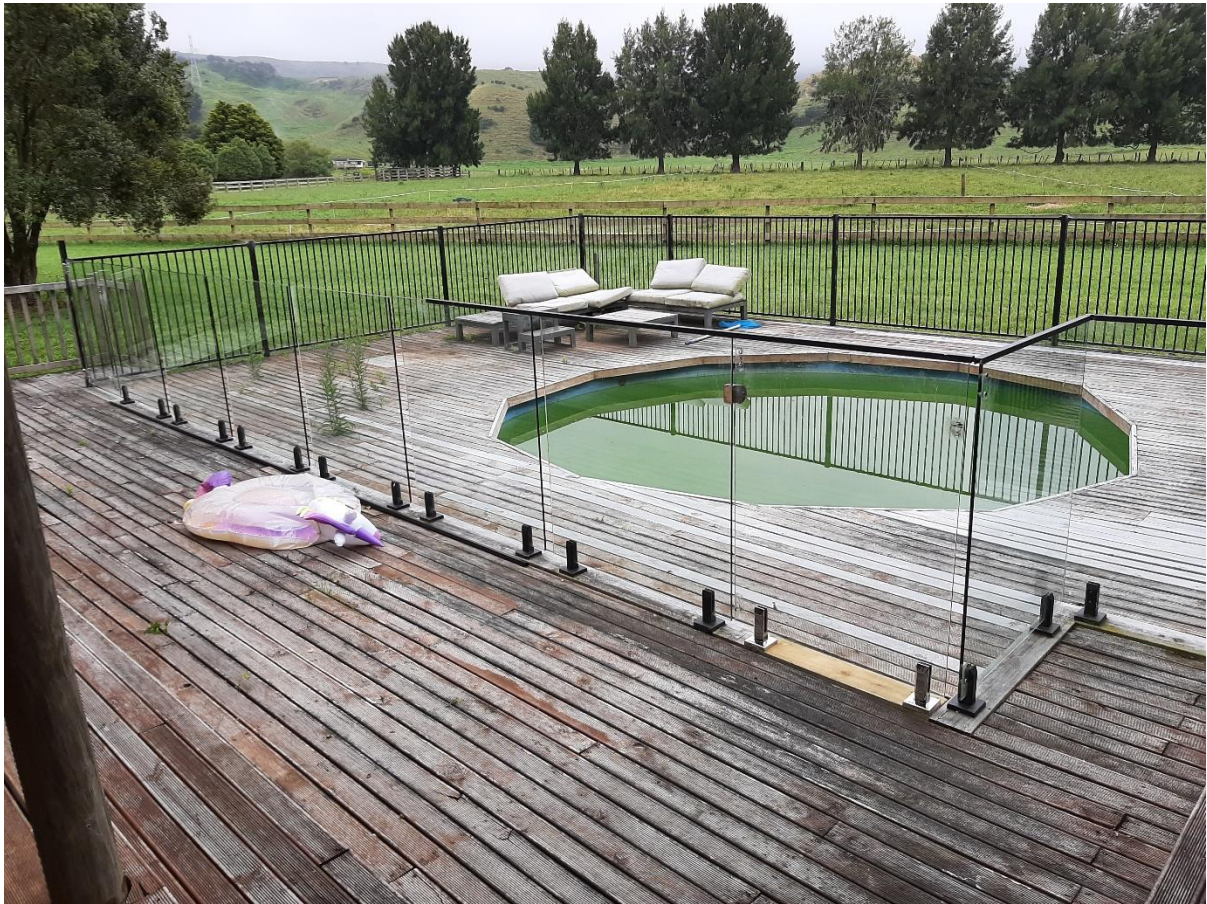
One of the two pool access gates has been remediated to no longer be able to be used as an access gate(photo refers). The other gate complies on the day of this inspection.

*Figure 1 - north elevation gate has been remediated to no longer be able to be used as an access gate into the pool area as can be seen.*
