Geotechnical Report

849 State Highway 1, Kaikoura

June 2023

Our ref: 9295

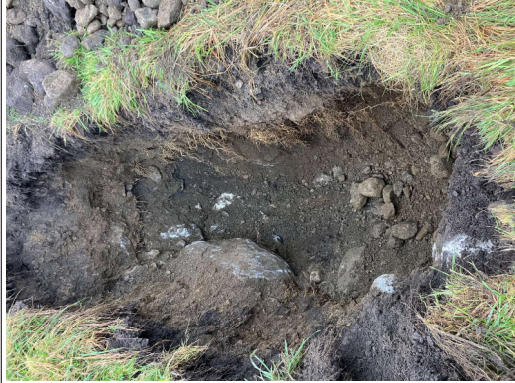
Sandy TOPSOIL with gravel and occasional cobbles

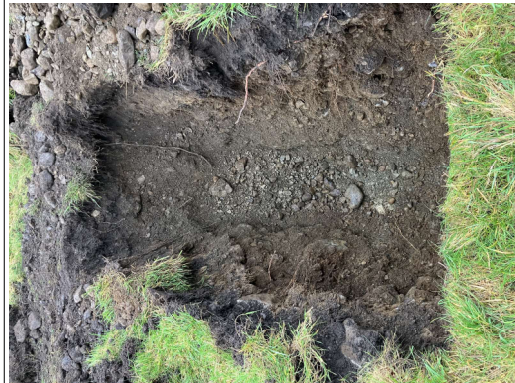
DEPTH (mm)	GRAPHIC LOG	DESCRIPTION	PHOTOGRAPH
0			
100		Sandy TOPSOIL with gravel and occasional cobbles	
200		Gravely SAND. Sand is fine to coarse. Gravel is fine to coarse, angular to sub-rounded, cobbles < 150mm Mixed lithologies.	
300			
400			
500			
600			
700		Gravely SAND. Sand is fine to coarse. Gravel is fine to coarse, angular to sub-rounded, cobbles and boulders sub rounded <400mm Mixed lithologies.	
800			
900			
1000			
1100			
1200

NOTES:
Groundwater was not encountered.
