NZ Residential Property Inspection Report

Inspection Date: Wed, 17 Apr 2024

Property Address: 7/58 Papanui Road, Merivale, Christchurch
8014, New Zealand

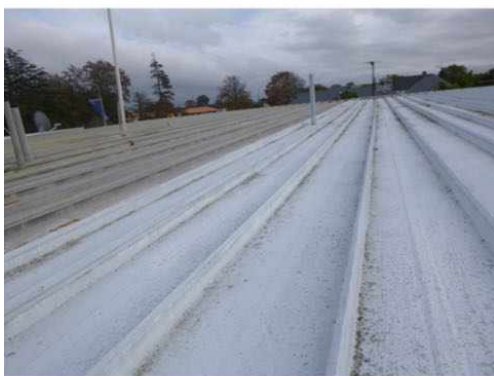
Defects 3.01

Finding: Roof - Condition

Information: The visible profiled roof sheets appeared in good condition. As did the gutters and downpipes. All penetrations and flashings appeared installed and sealed adequately.

One area of surface rust was identified. If left unmanaged, this could allow water ingress to the internal roofing structures, potentially leading to secondary damage of building elements. Accelerated deterioration of the roofing sheets and any associated building elements is also likely to occur. It is advised that a professional painter be consulted to carry out works such as the application of rust-retardant surface protectors and roof paint, in the near future.

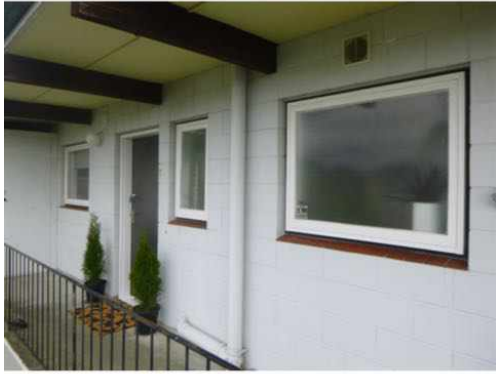
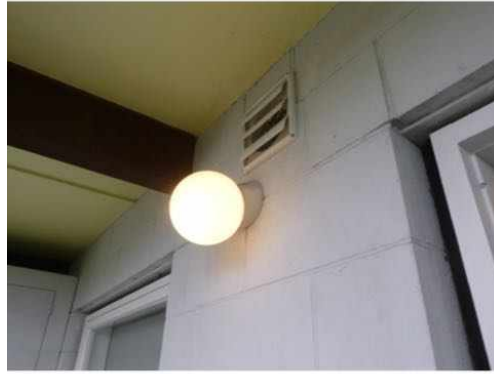
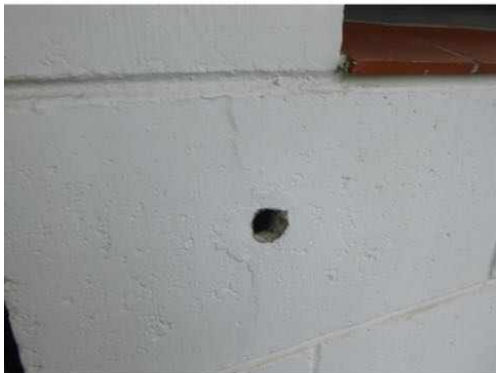
Defects 3.02

Building:	Main Building
Location:	All External Areas
Finding:	Exterior cladding
Information:	The concrete block cladding was in good condition overall, and has been constructed to a good trade standard. The exterior joinery is painted timber frame with single glazing, and timber reveals. All windows and doors were flashed and sealed adequately.

One small hole was identified. This should be sealed.

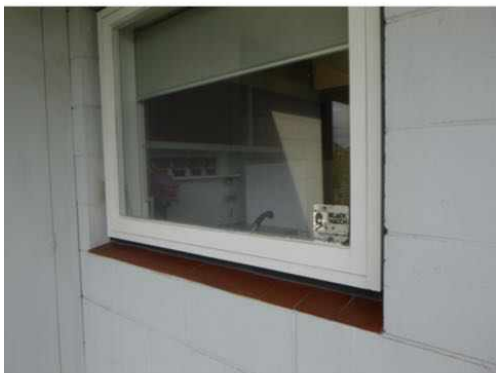
Defects 3.03

Building: Main Building
Location: Kitchen
Finding: Sill tiles - loose
Information: The exterior tiles on the kitchen window sill were loose.

They can be re-glued in place.

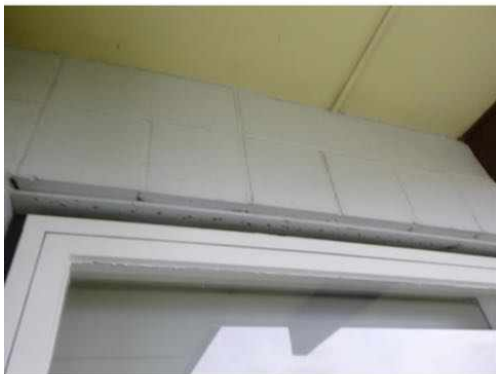
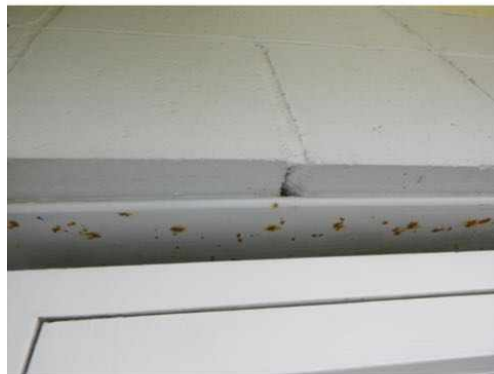
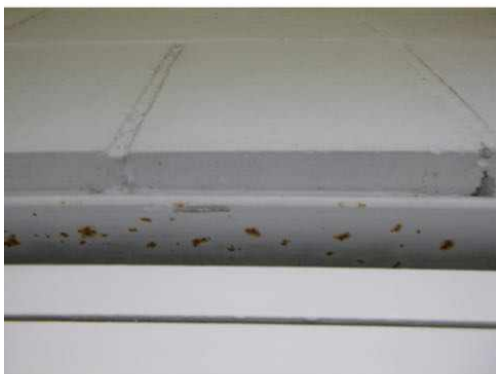
Defects 3.04

Finding: Window lintel - Rust

Information: Areas of surface rust were identified on the steel lintel above the kitchen window.

A qualified painter be consulted to carry out works such as the application of rust-retardant surface protectors and paint.

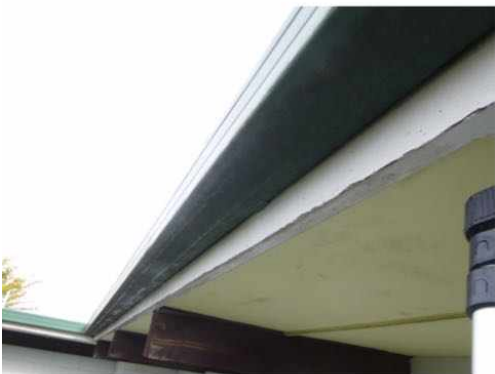
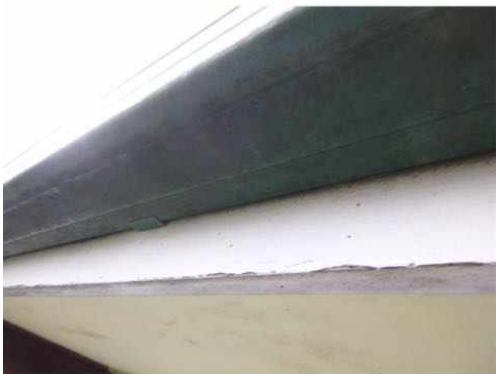
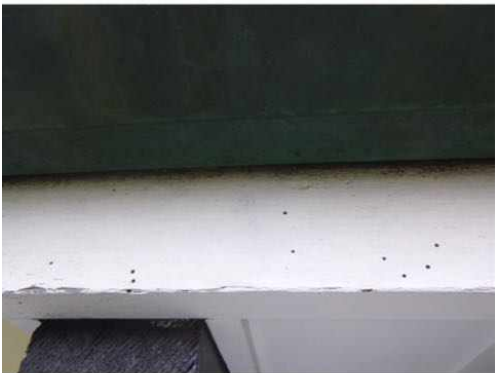
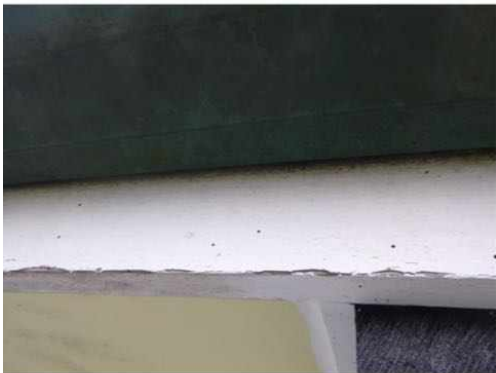
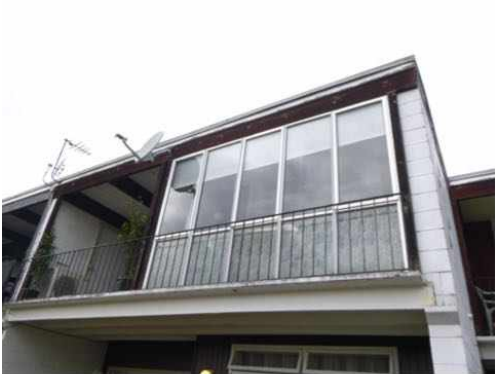
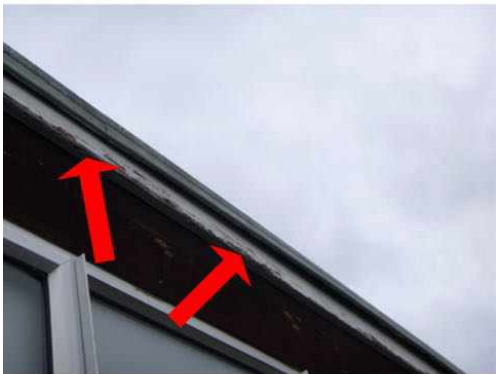
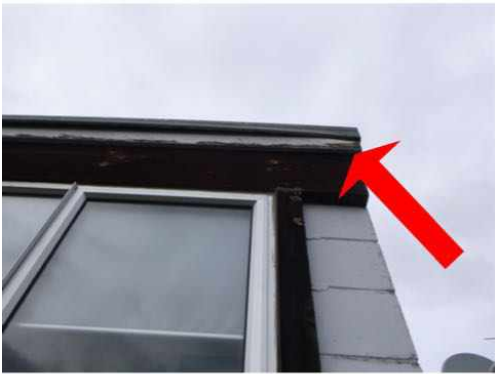
Defects 3.06

Building:	Main Building
Location:	All External Areas
Finding:	Paint finish - Deteriorating
Information:	The paint finish on the timber fascia was found to be deteriorating. Paint deterioration is generally classified as an appearance defect. However, the substandard appearance may also be indicative of poor surface preparation and substandard workmanship.

A painting contractor should be appointed to perform necessary works to aid the appearance of the affected area and to ensure that the area is protected against further deterioration. Alternatively, the homeowner following manufacturer instructions may be able to provide this service.

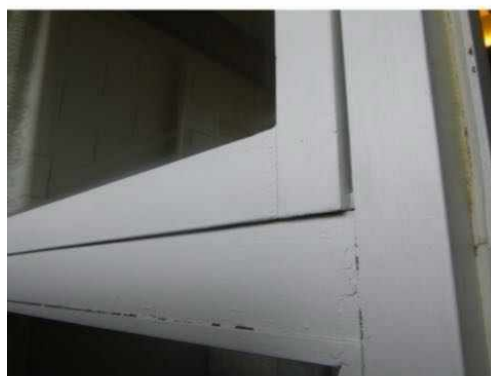
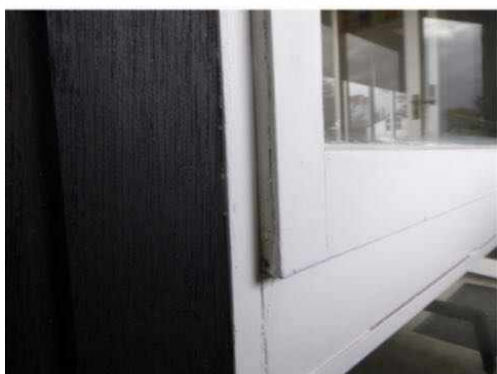
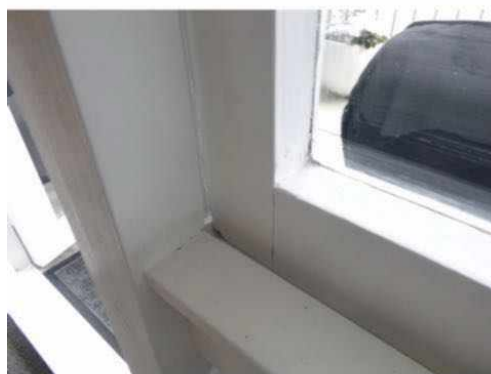
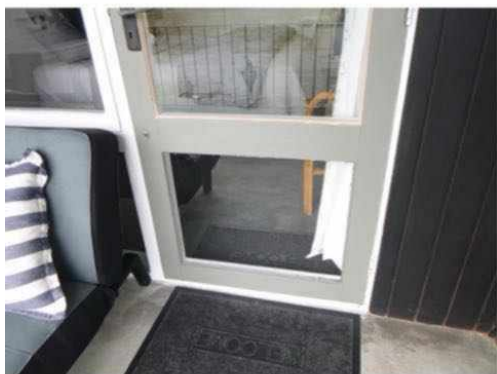
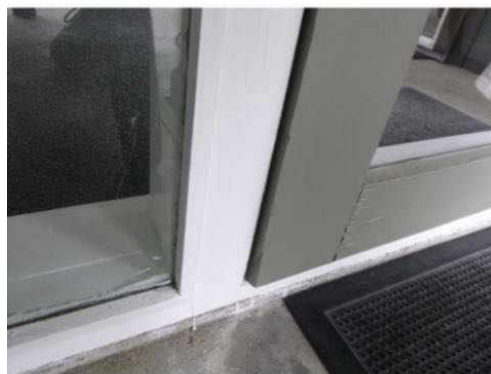
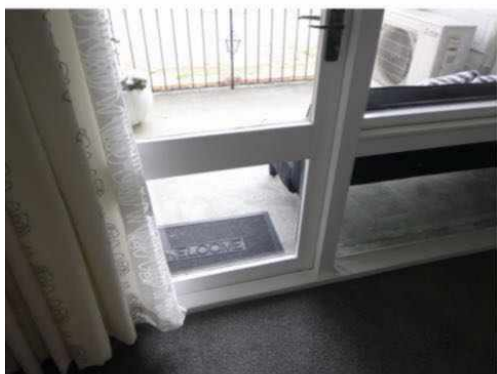
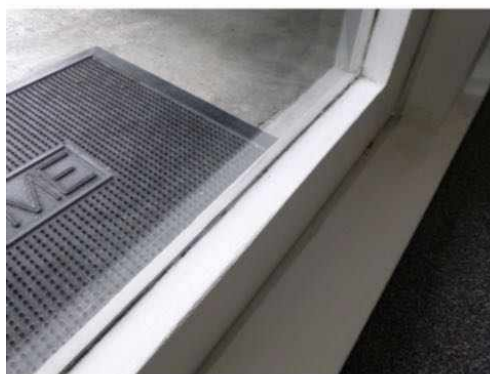
Defects 3.07

Building: Main Building
Location: Bedroom
Finding: Window and door - Jamming
Information: Binding and/or jamming of the bedroom window and door was evident during standard operation. This defect inhibits the functionality, as well as creating potential for secondary defects to associated building elements, and drafts as they don't fully close.

A qualified carpenter or general handyperson should be appointed to perform minor rectification works at client discretion.

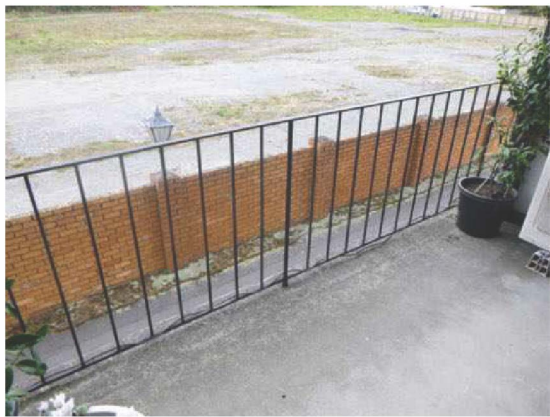
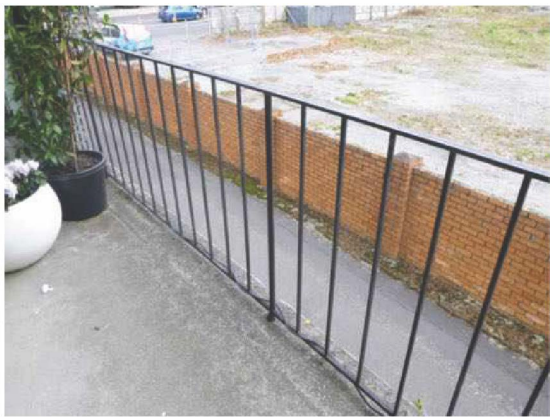
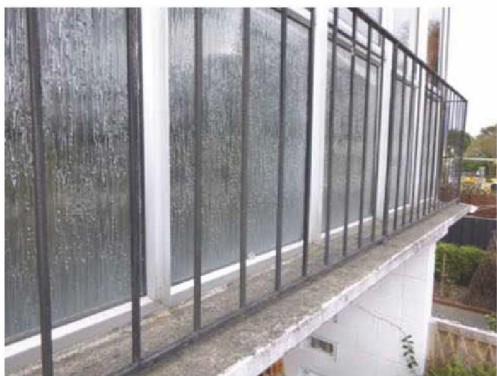
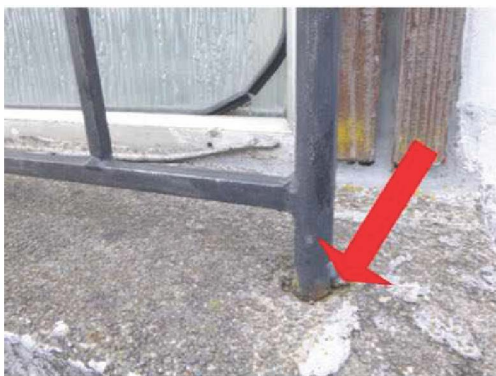
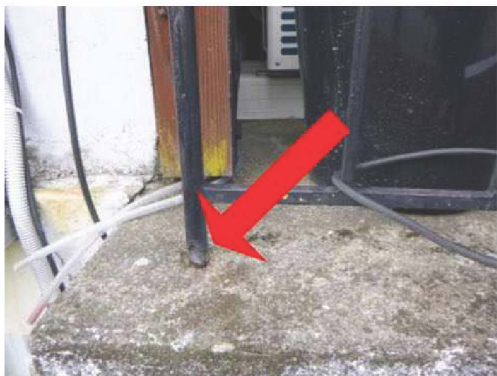
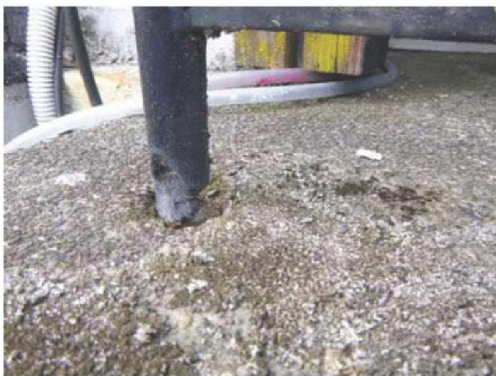
Defects 3.08

Building:	Main Building
Location:	All Areas
Finding:	Balustrade - Suspected Non-Compliance
Information:	The balustrade in this area was found to not be meeting the present building regulation requirements. The height of a barrier should be a minimum of 1000mm from the floor.

The two end posts of the balustrade have rusted through and are movable.

This defect creates a potential safety hazard and should be rectified as to ensure the safety of the area and to meet present building standards and regulations.

A registered builder should be contacted to discuss possible rectification solutions.

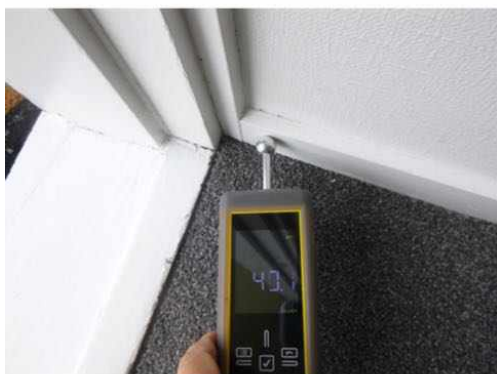
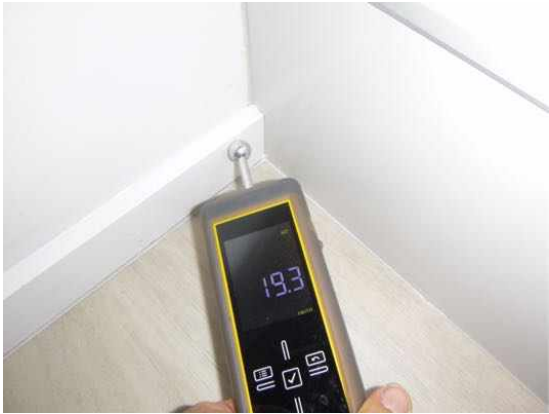
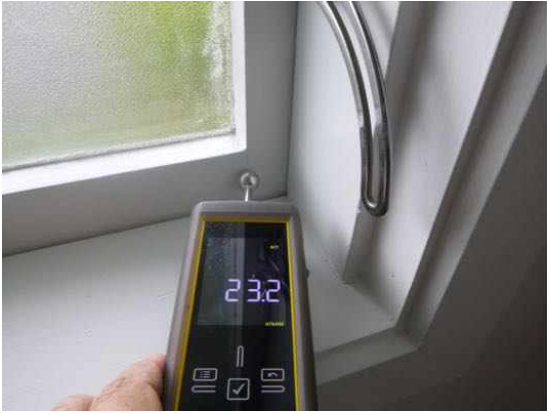
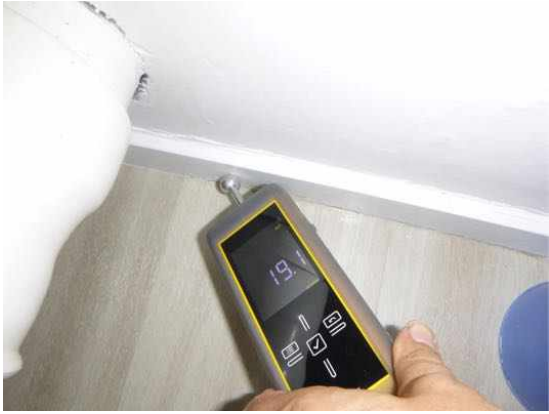
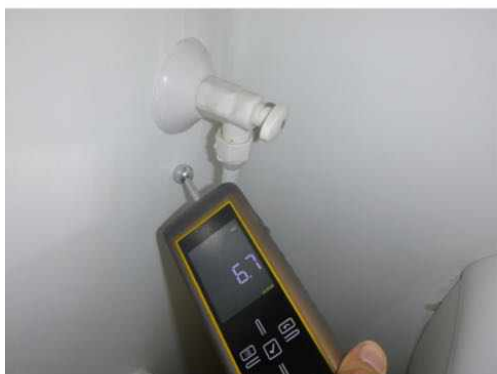
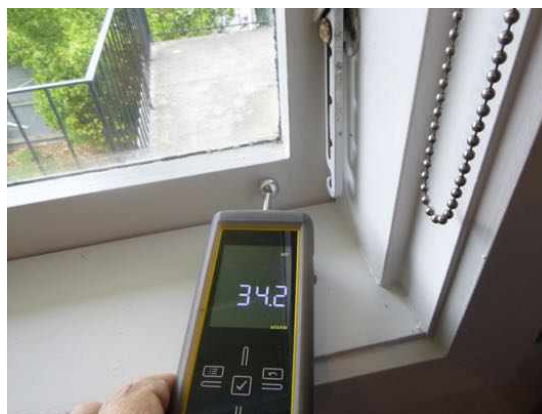
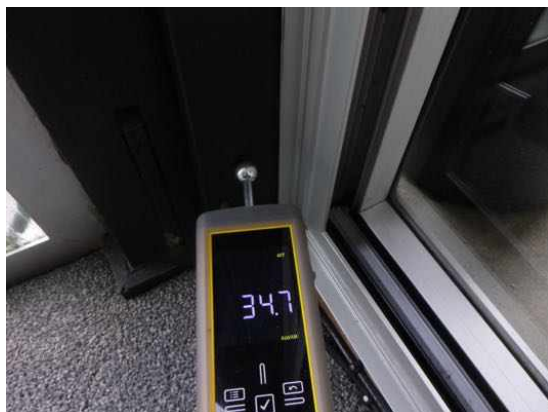
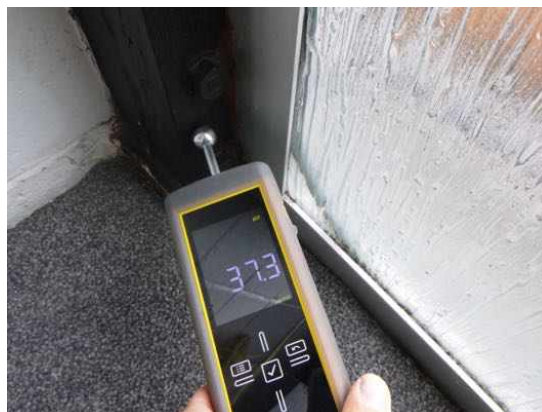
Building: Main Building
Location: All Areas
Finding: Moisture Readings
Information: Moisture readings were taken using a Trotec T660 capacitive non-invasive moisture meter. No indications of any elevated moisture levels were detected.

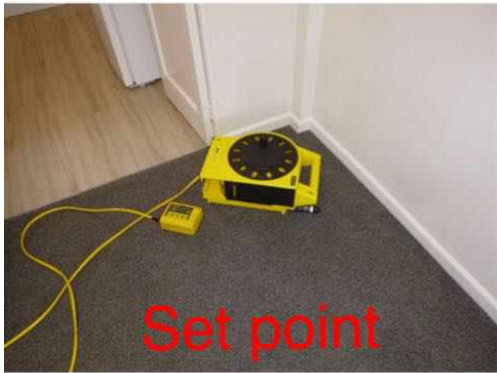
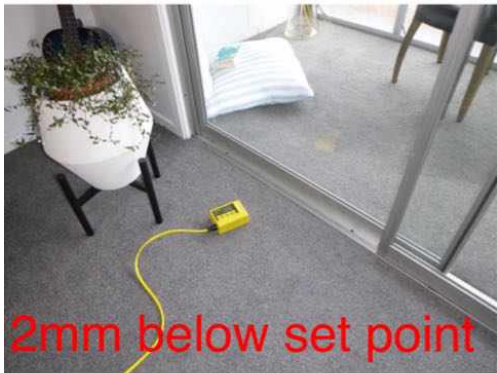
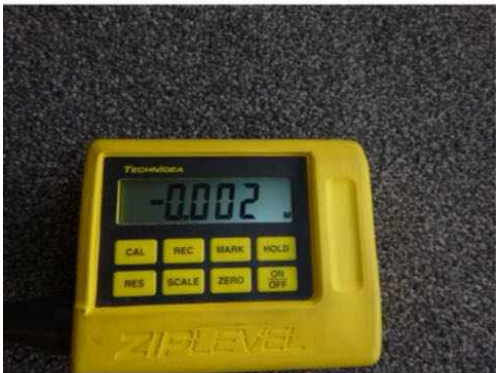
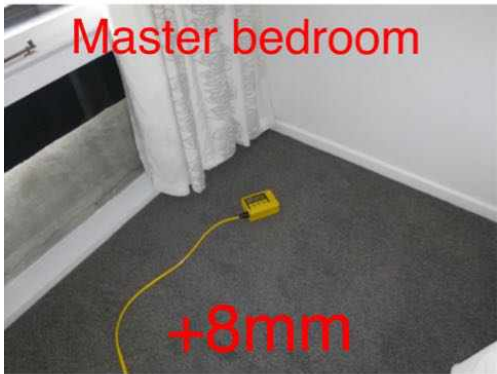
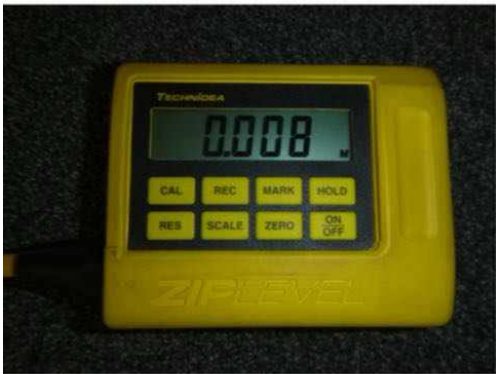
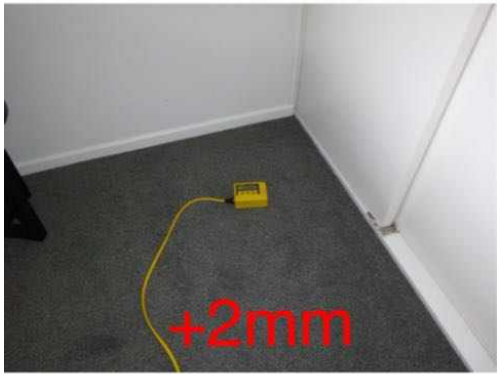
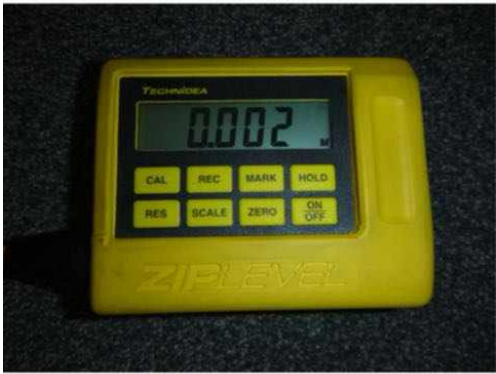
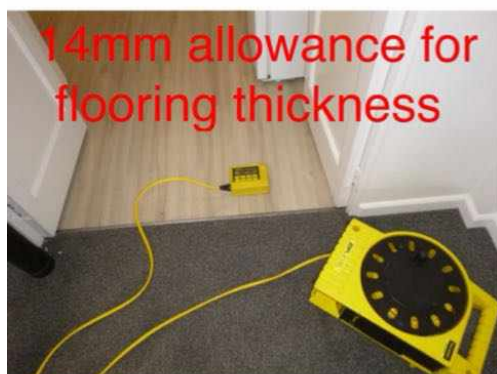
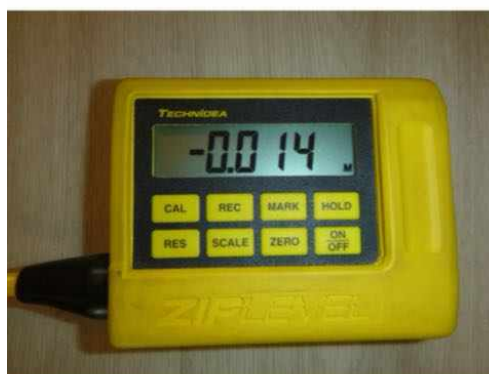
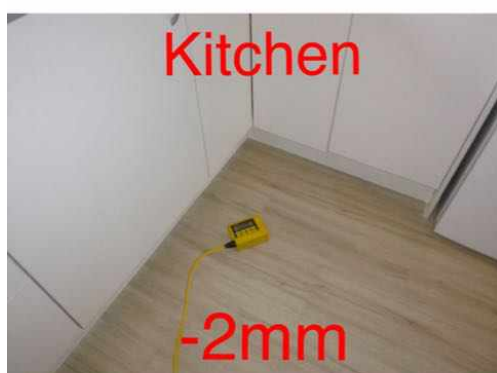
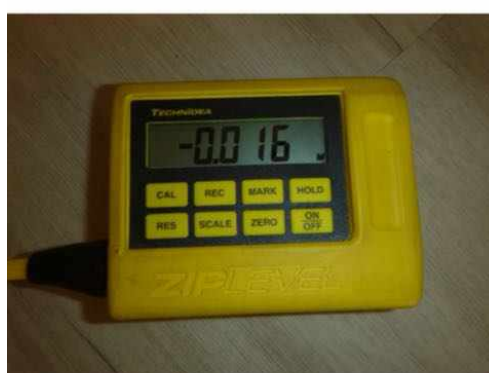
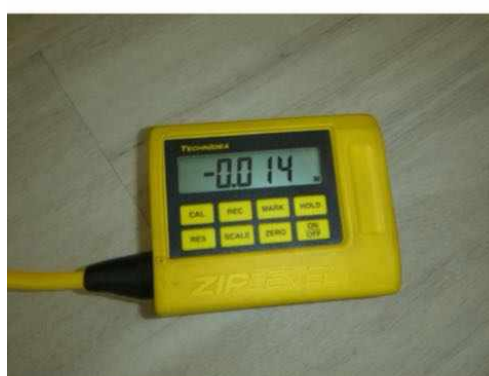
This falls within the MBIE guidelines of 50mm over 10 metres.

All levels are within the MBIE guidelines over a short distance, being less than 0.5% or 10mm over 2 meters.

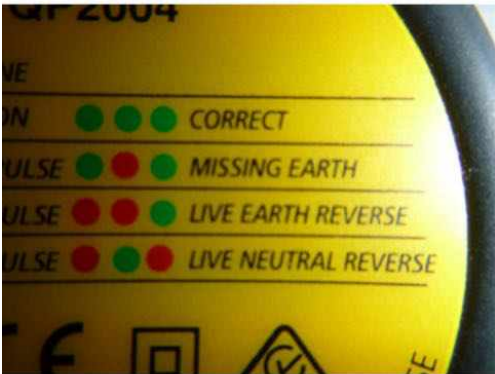
No issues were found during the inspection.

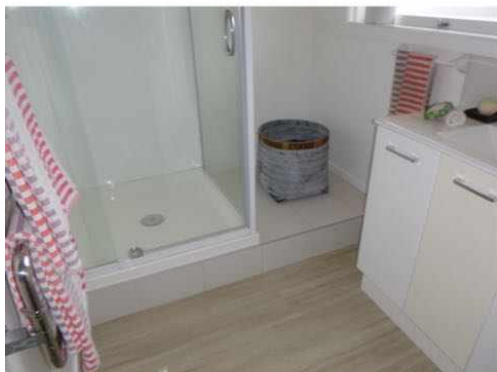
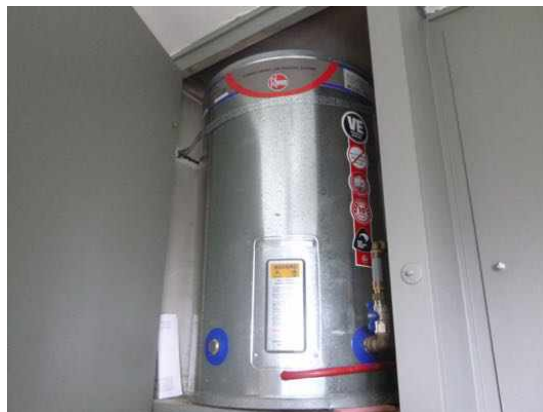
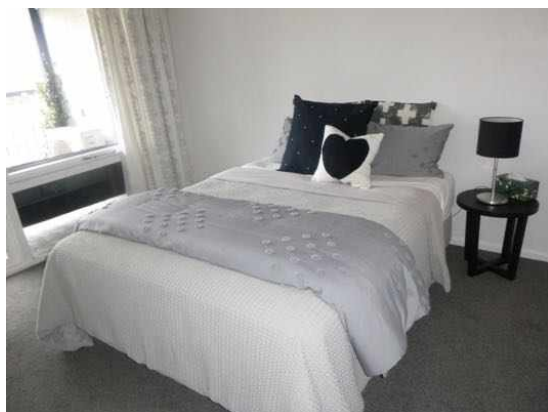
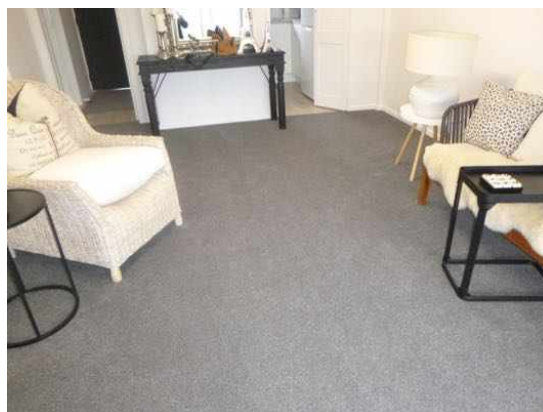
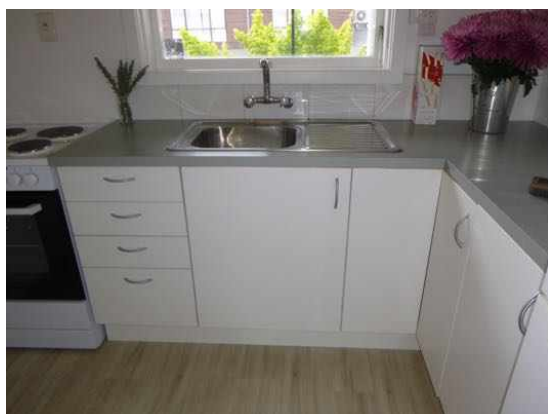
Finding: Additional Photos - Obstructions and Limitations

Information: These photographs are an indication of the obstructions and limitations which can impede a full inspection of the property at the time of inspection. These obstructions can hide an array of defects.

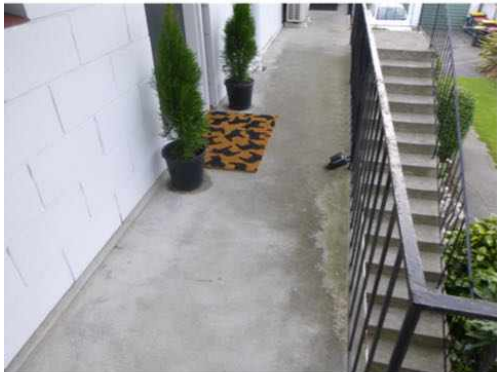
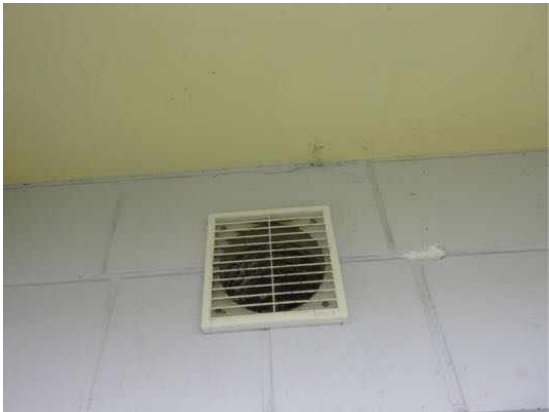
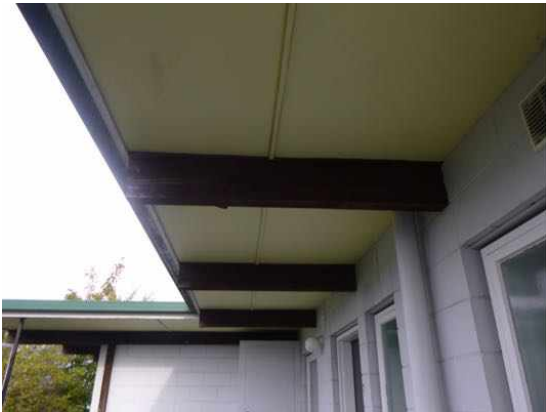
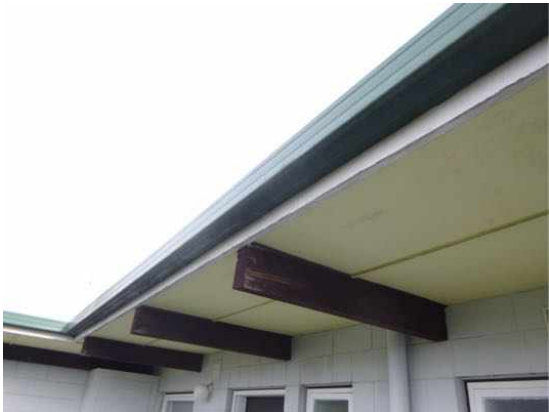
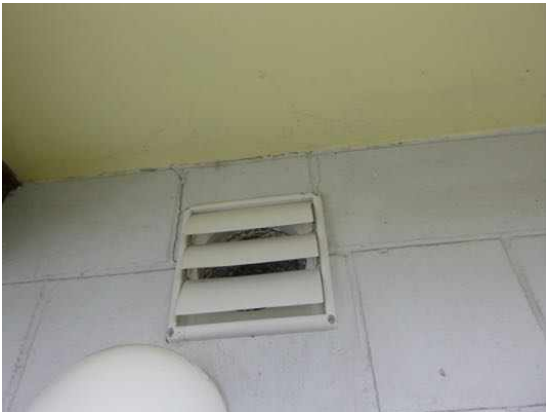
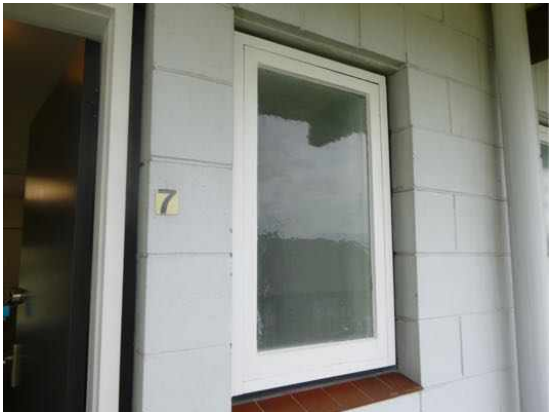
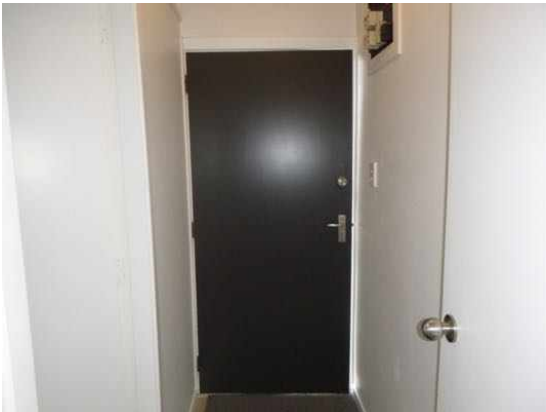
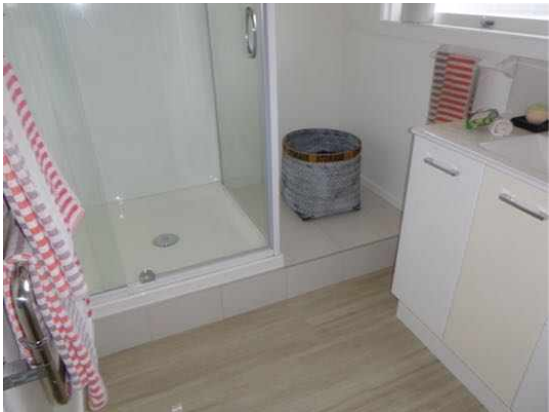
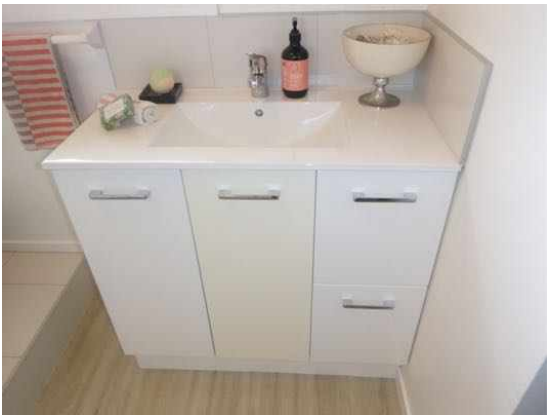
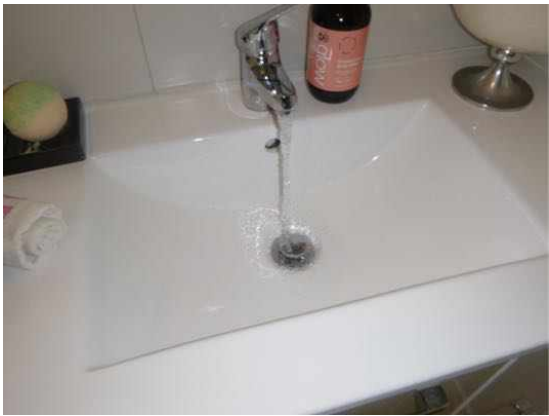
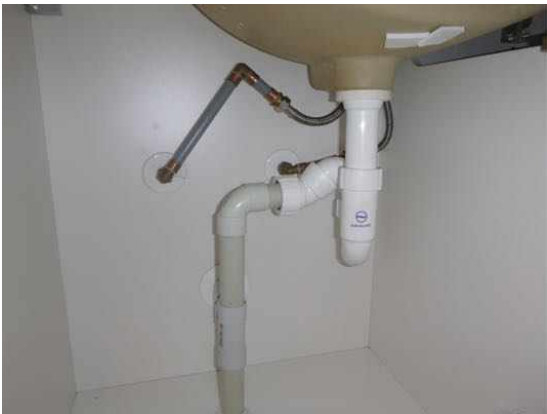
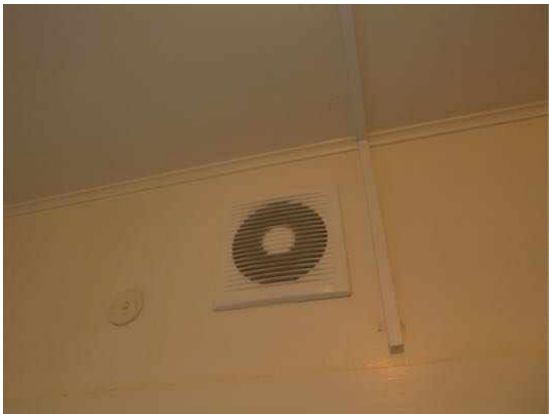
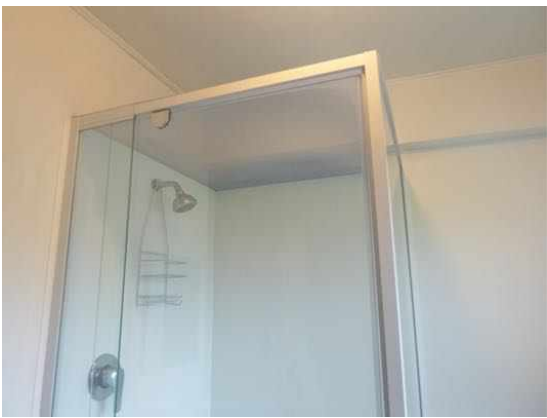
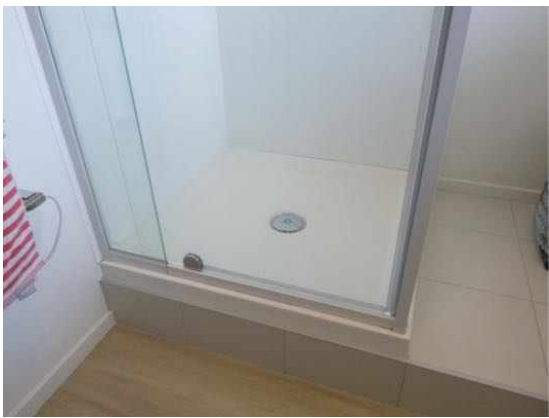
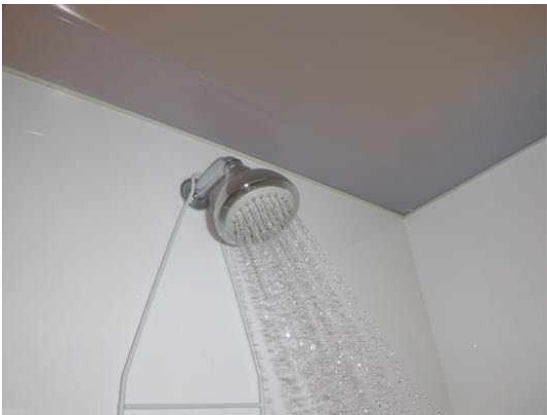
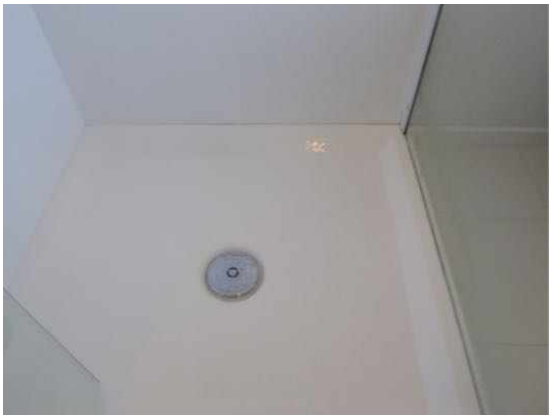
Information: Additional photos are provided for your general reference, and can be considered to

be in good condition.
