**171 TAYLOR
STREET,
CAMBRIDGE**

**PRELIMINARY
GEOTECHNICAL
ASSESSMENT**

PROJECT NO: HD1934
KOTARE CONSULTANTS
REFERENCE: PCR
09 APRIL 2021

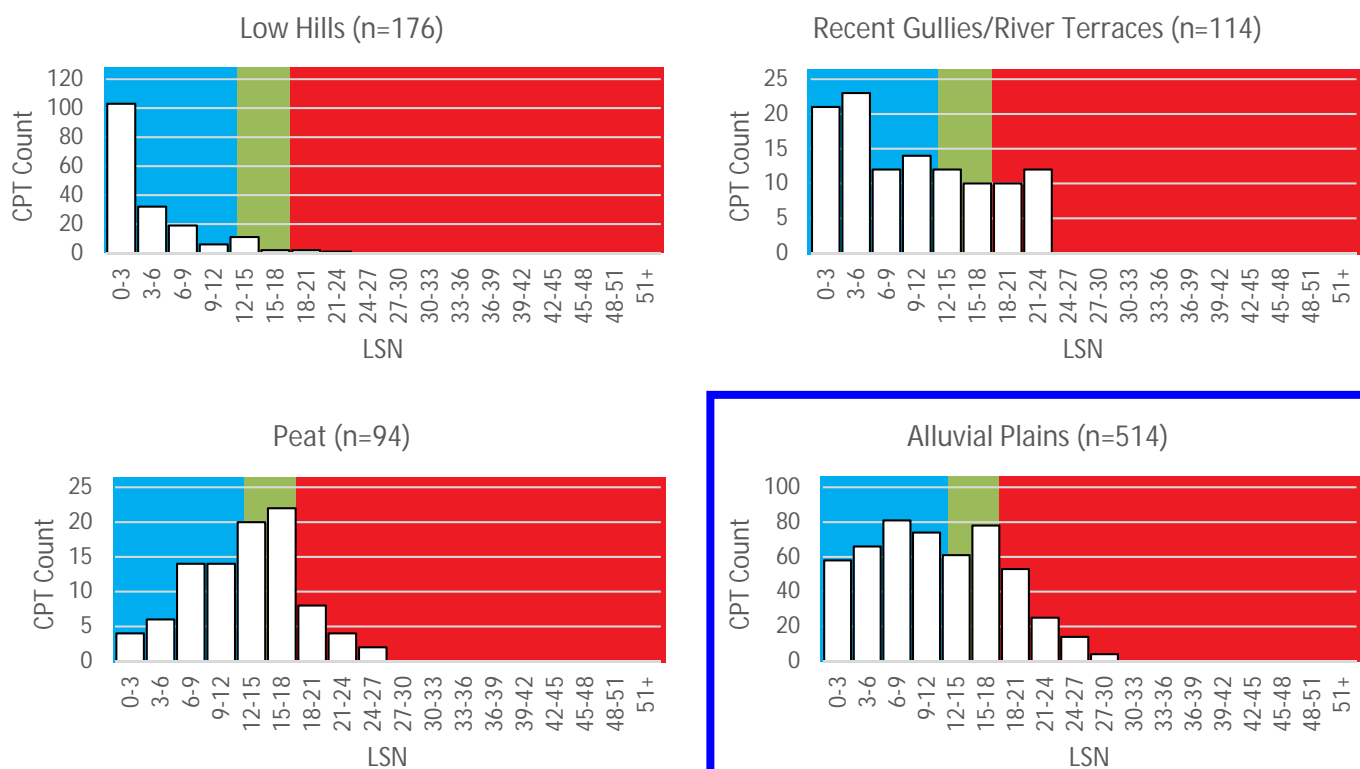
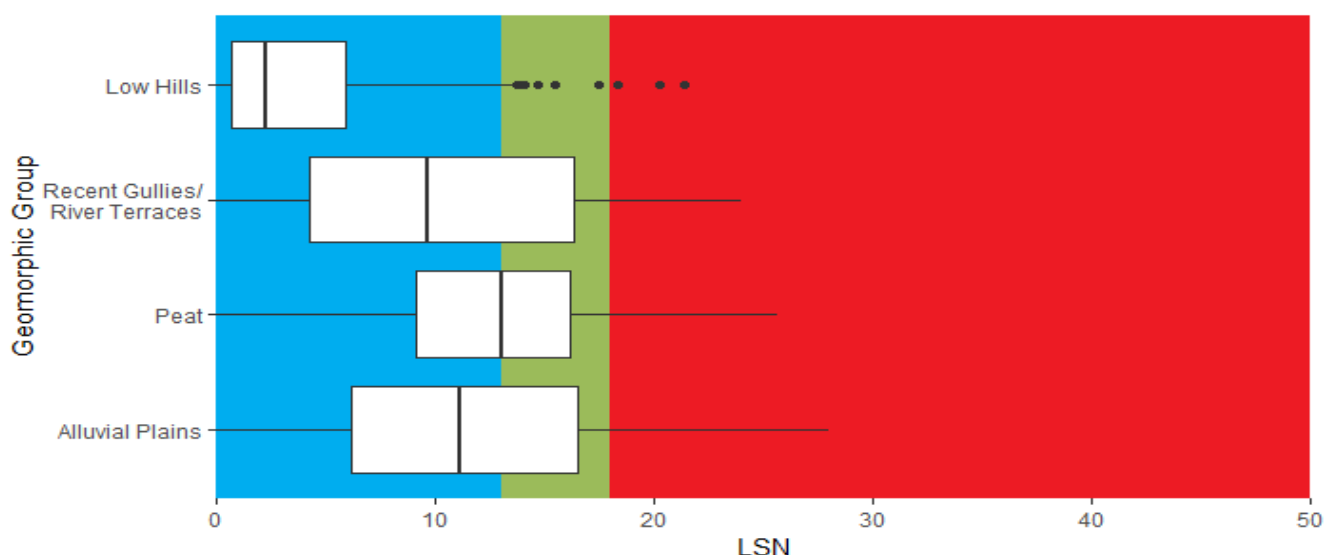
Scenario: 1000 yr ARI (Mw=5.9,PGA = 0.28g) 4m GWD

As discussed above, the groundwater at the site is expected to be at depths greater than 4 m bgl. Using the 1/1000 year analysis in the desk study, for an expected groundwater of 4m, the degree of liquefaction induced ground damage is likely to be none to minor.

Degree of liquefaction induced ground damage	Characteristic LSN values ($P_L=15\%$)
None to Minor	0-13
Minor to Moderate	13-18
Moderate to Severe	>18

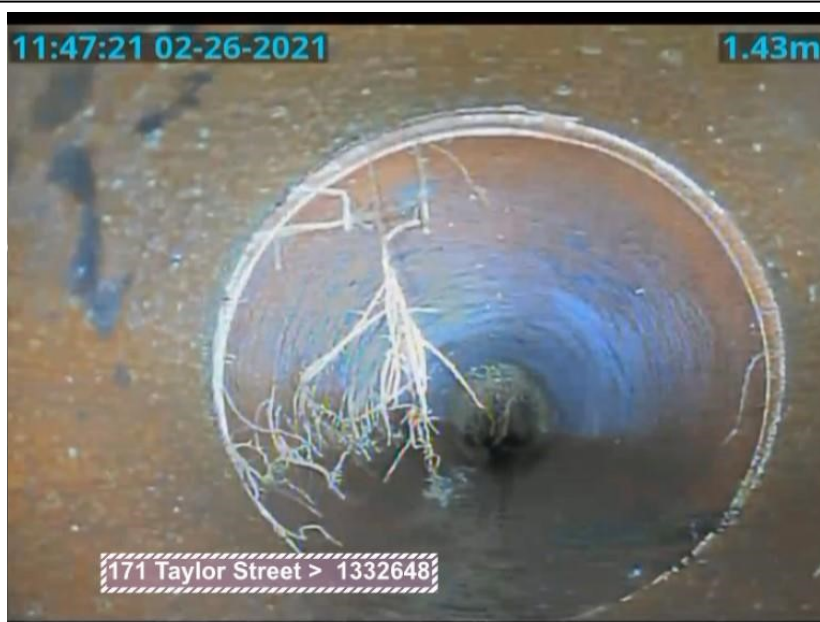
2.31m (23.18m)	5 RIS	00:21	Root Intrusion, Small, 8-3 o'clock			
2.86m (22.63m)	2 JFL	00:27	Joint, Faulty, Large, 12-12 o'clock, Circumferential crack in joint zone and root intrusions.

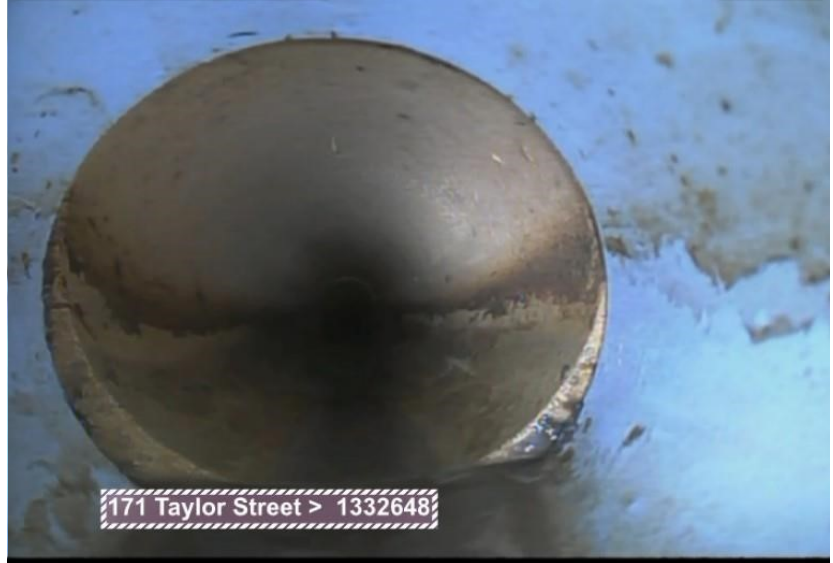
8.24m

Construction Feature, 11-1 o'clock Inspection Lid.
