**GEOTECHNICAL SUITABILITY OF PROPOSED HOUSE SITE
25 DARWIN ROAD, OUTER KAITI, GISBORNE
GEOTECHNICAL INVESTIGATION REPORT**

Report Prepared for: Malcolm Galloway

Date: 31/05/22

AG Ref: 0150 - 1

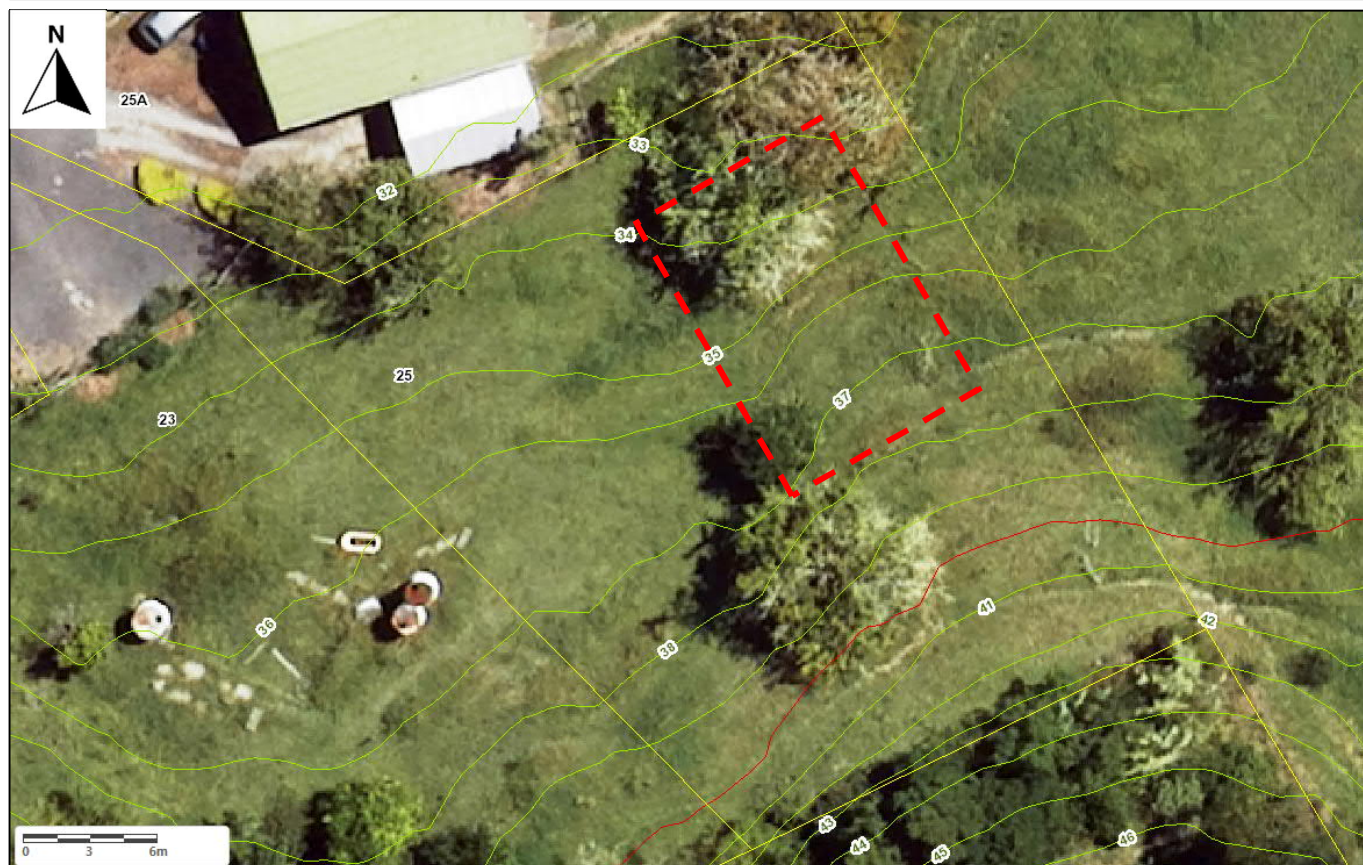
An approximately 140m² house site on the backbone of the spur within the east part of the lot is proposed. It needs to be appreciated that this does not preclude possible development in other parts of the property but forms the focus of this report to confirm the viability of one site for residential development within the lot. Extension of the site proposed, or alternative sites, may be viable.

Figure 3: Indicative location of possible house site location (red dashed outline). Image source: Tairawhiti Maps¹.
