ALLIED GEOTECH LTD

**GEOTECHNICAL SUITABILITY OF POTENTIAL HOUSE SITE  
23 DARWIN ROAD, OUTER KAITI, GISBORNE  
GEOTECHNICAL INVESTIGATION REPORT**

Report Prepared for: Malcolm Galloway

AG Ref: 0150 - 2

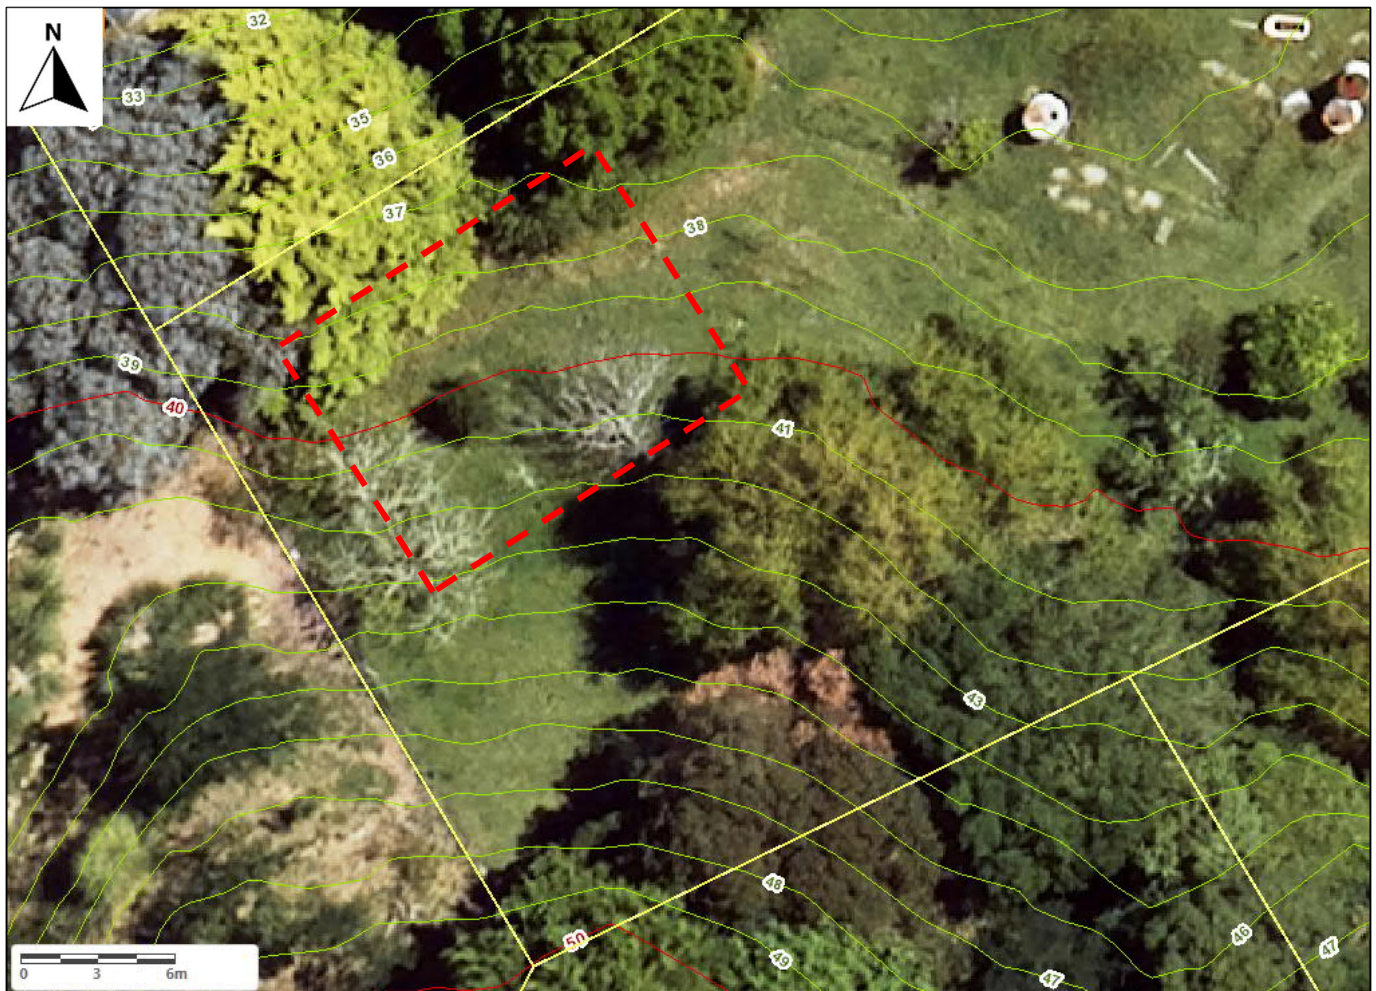
Figure 3: Indicative location of possible house site location (red dashed outline). Property boundary location indicated with fine yellow line. Image source: Tairawhiti Maps<sup>1</sup>.

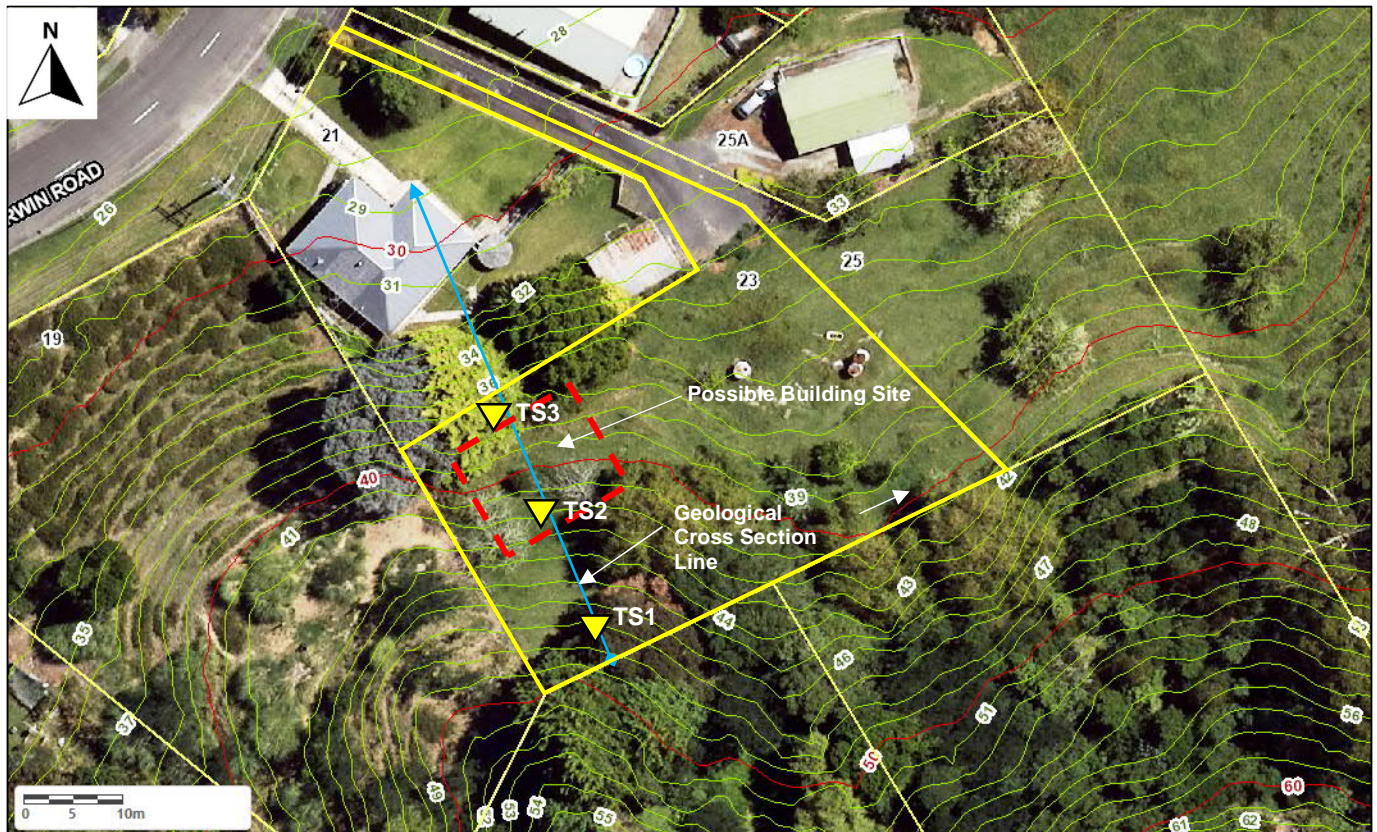
Figure 5: Geotechnical Investigation Plan. Property boundary line indicated with bold yellow line. Approximate position of proposed building site indicated with bold dashed red outline. Slope profile used in numeric stability analyses indicated with blue line. Each test site (yellow triangle) correlates to a hand auger and dynamic cone penetrometer test location. Fine green and red lines correlate to LiDAR contour lines at 1m intervals. Image source: Tairawhiti Maps<sup>1</sup>.
