CASH SETTLED CLAIM(S)

Date: 17 Sept 2010Author: BRYAN STAPLESClaim No.: 2010 1062485Claimant: KAIAPOI WORKING men's ClubSituation of Loss: 101 Raven Quay
KAIAPOILA: BRYAN STAPLESEstimator: DOUG TREDUNICK

Increased Flooding Vulnerability (IFV) Engineering Assessment

Property address	101 RAVEN QUAY, KAIAPOI 7630
Property ID (QPID)	1143960
Master claim number	CLM/2010/055441
Date	11 May 2017
Claim issue number	1

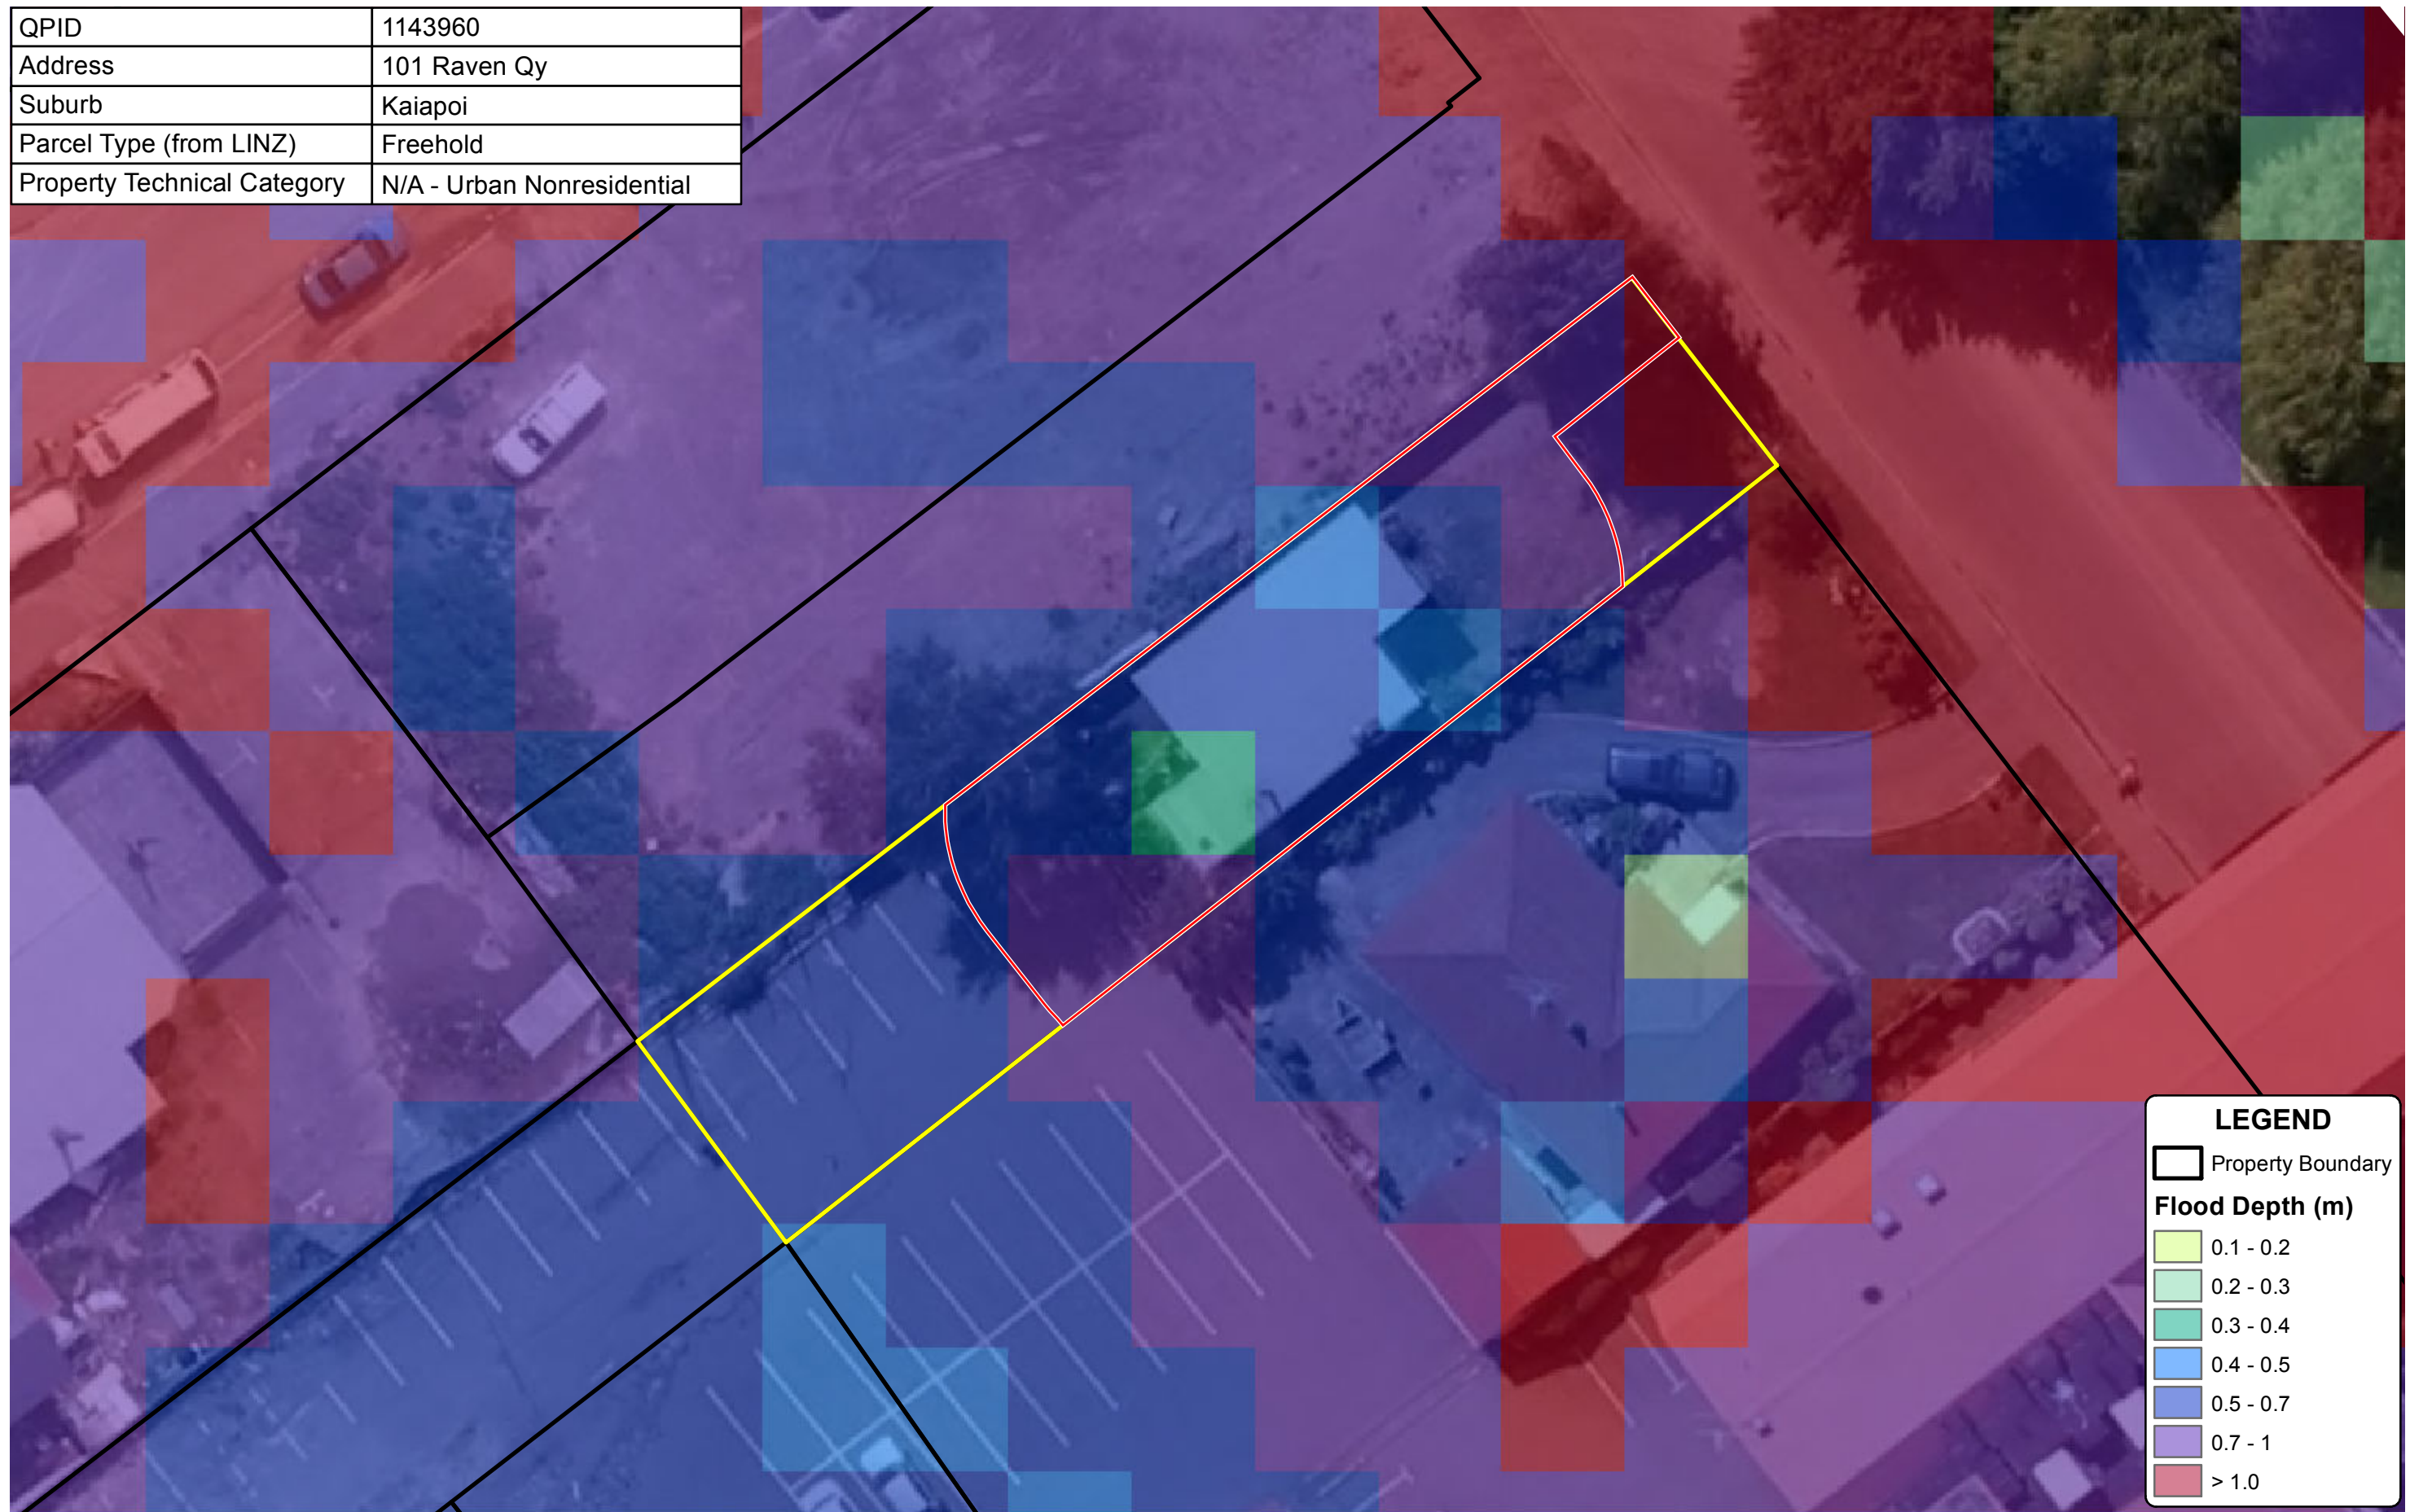
FIGURE No.	Figure 2	Rev.	1
------------	----------	------	---

Map 1 shows exacerbated flood depth caused by the Canterbury earthquake sequence. The exacerbated flood depth is used as a measure of IFV. The exacerbated flood depth is defined as the increase in flood depth due to onsite land subsidence.
