**5-202 Hinemoa St, Birkenhead,  
Auckland**

**REPORT TYPE:** Pre-Sale Building and Weather Tightness  
Inspection

**DATE OF INSPECTION:** 10/03/2025

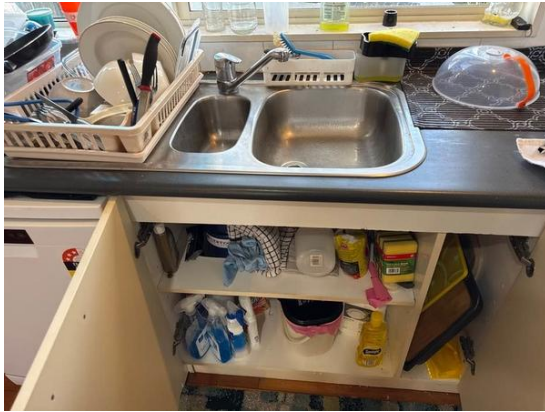
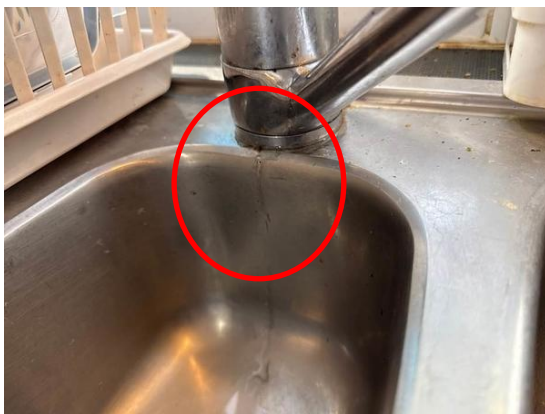
The kitchen sink plumbing appears to be in good working order; the kitchen tap is leaking at the join and there is a large amount of water damage behind the sink that will require remedial attention (photos 11 to 13). The rangehood is ducted correctly (photo 14).

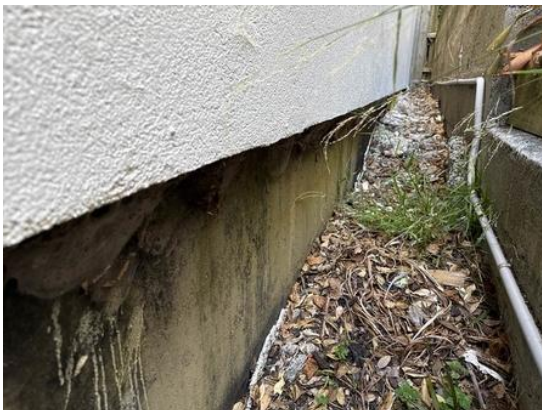
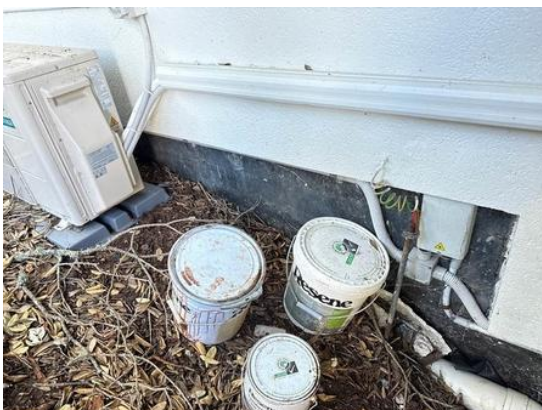
The dwelling has concrete slab floor and foundation with sufficient clearance between the bottom edge of the cladding and the finished ground level throughout the dwelling (photos 23 to 28).

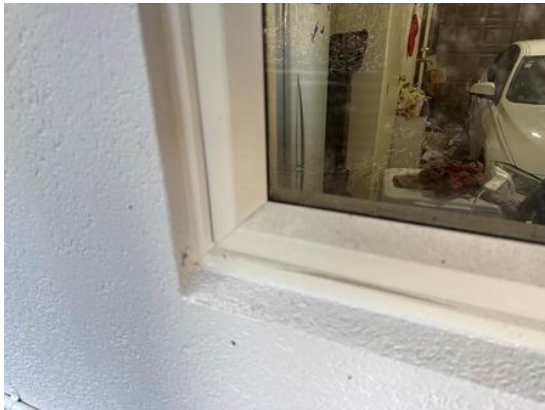
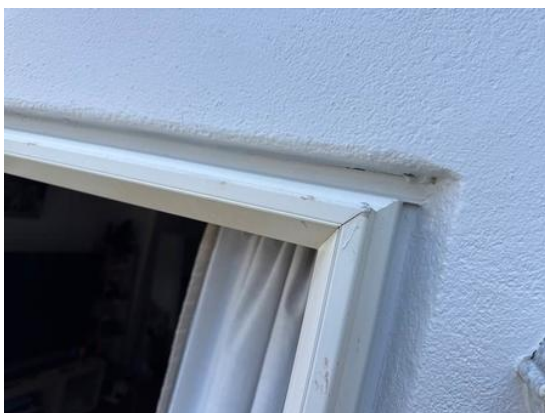
There are head flashings apparent above the windows (photos 29 and 30). The joinery and joinery to cladding junctions are in good condition throughout the dwelling (photos 31 to 34).

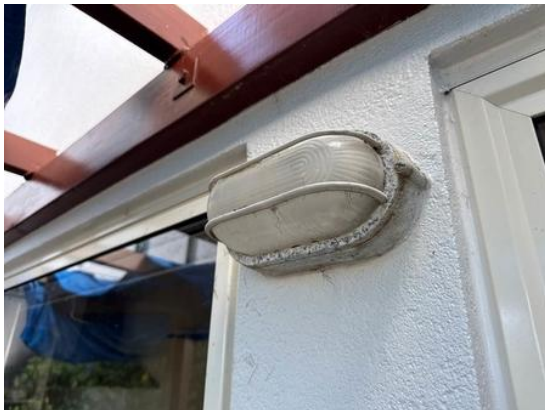
Photo 37

The external light fittings to wall cladding junctions are in good condition (photos 36 to 38).

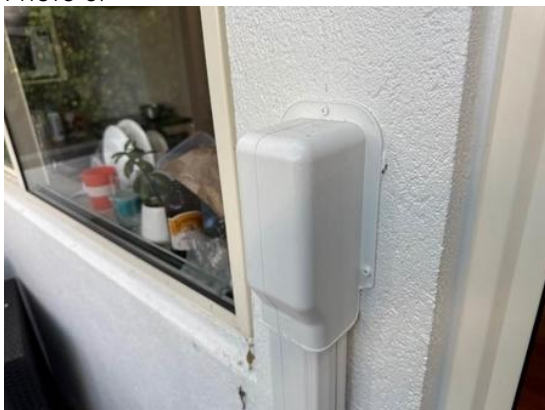
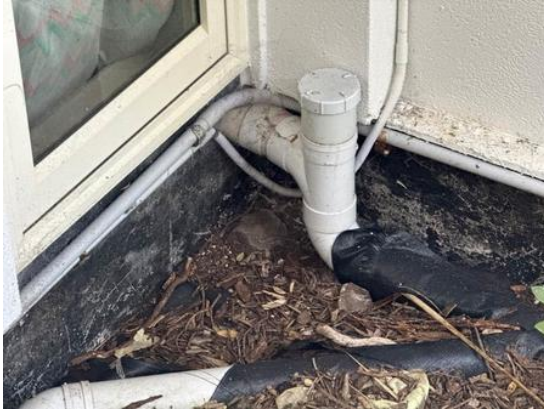
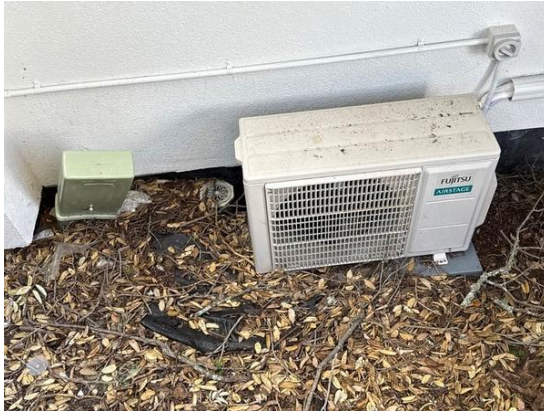
The external taps and pipework to wall cladding junctions are in satisfactory condition (photos 39 to 43).

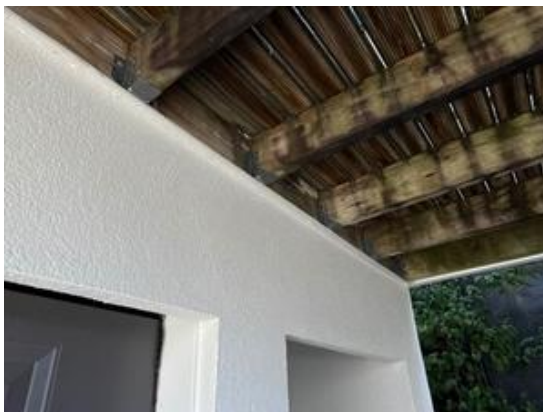
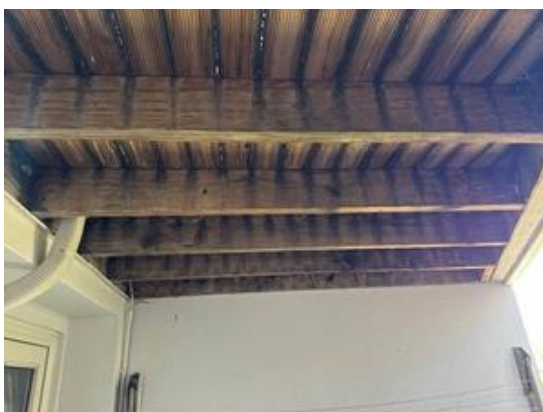
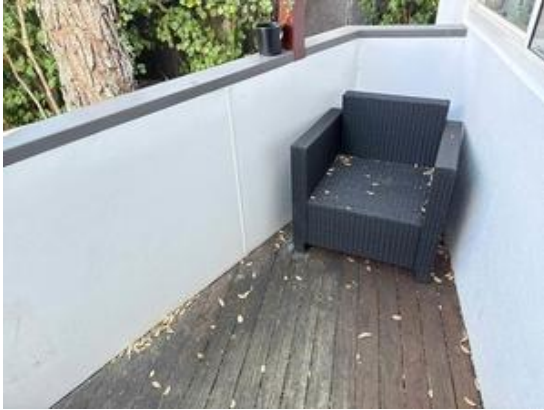
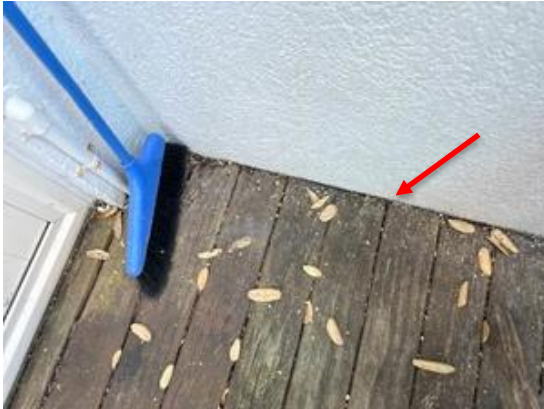
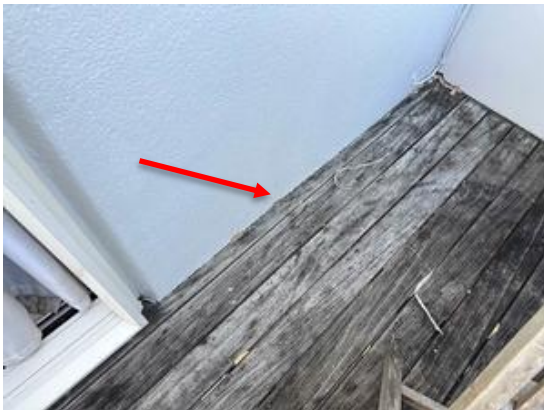
There is a timber deck that is in good condition, with a flashing detail in place; however, there is no cladding clearance at the deck junction (photos 48 to 59).

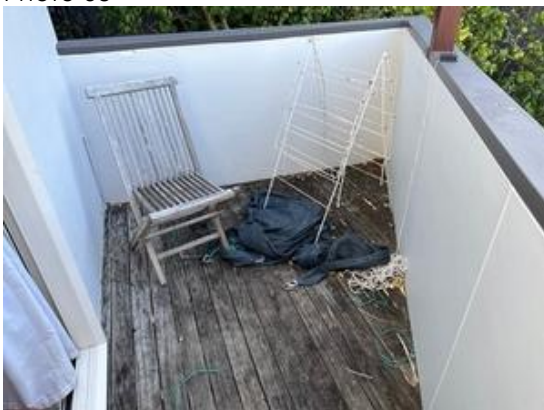
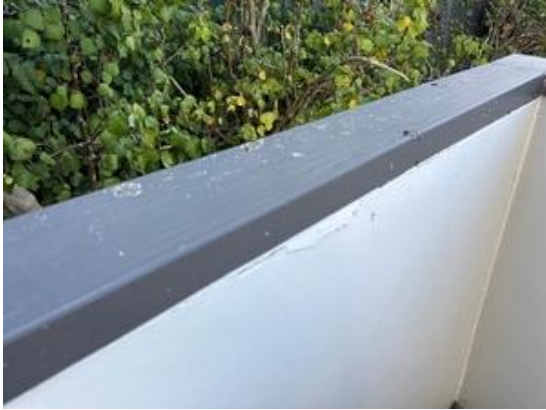
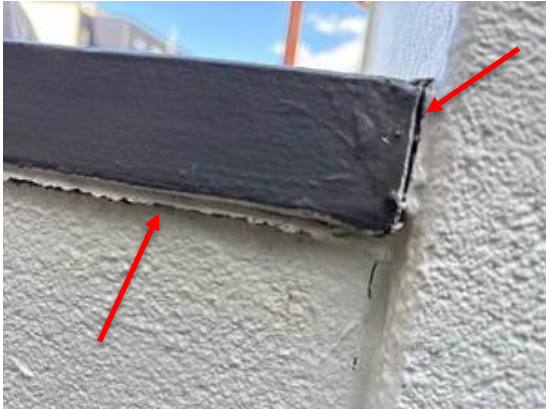
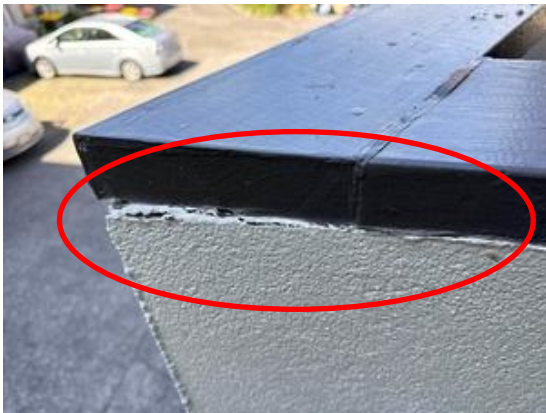
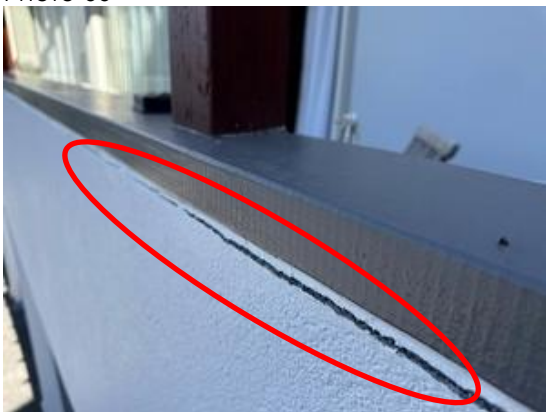
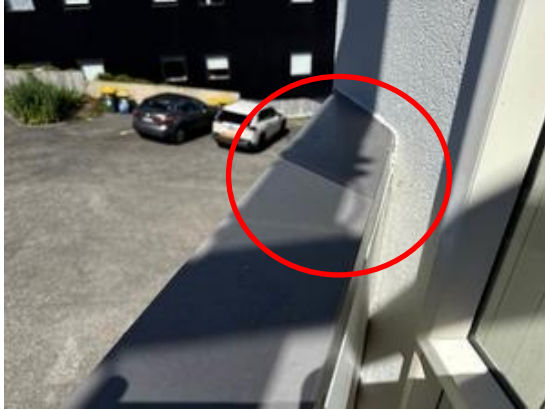
There is a mix of solid plaster and timber balustrades in place; There is cracking at the timber capping detail junctions, as well as cracking at the cladding junctions of the front balustrades that need remedial attention (photos 60 to 71).

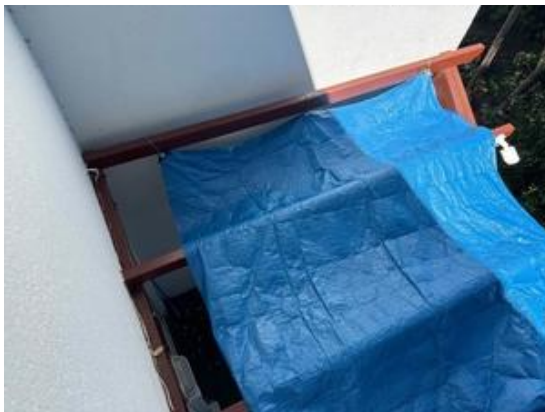
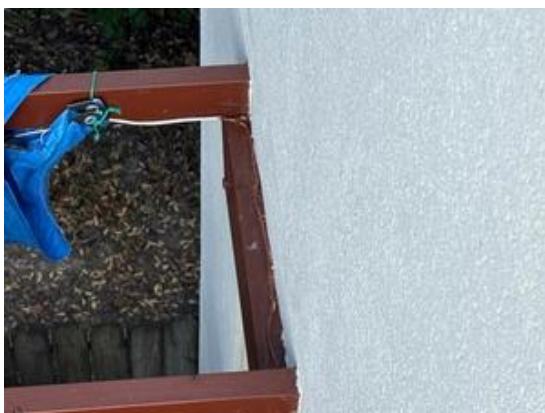
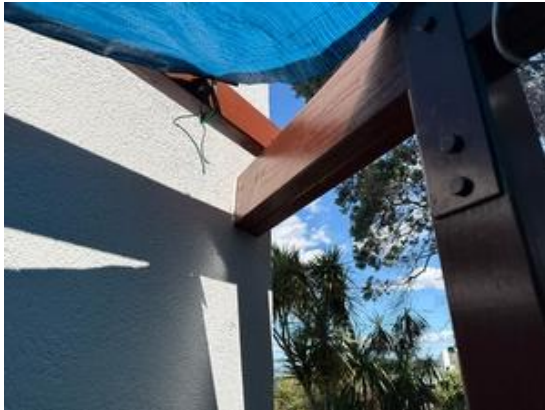
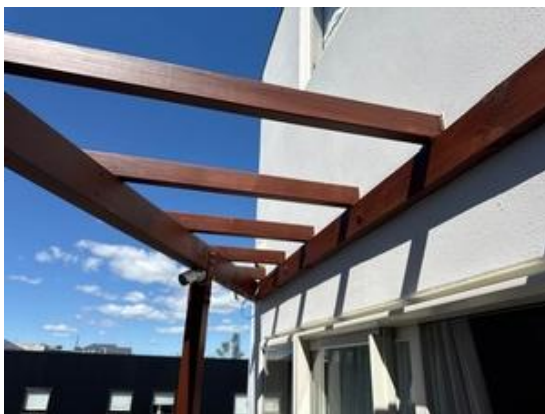
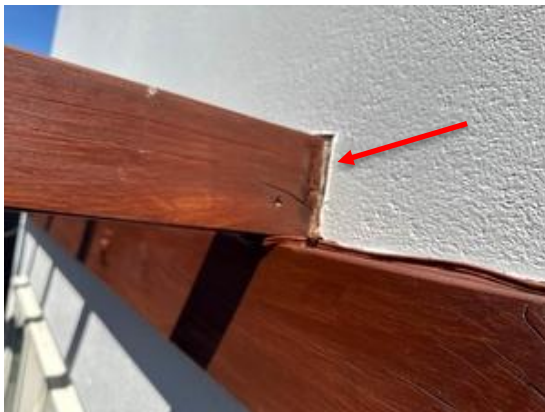
There is a direct-fixed timber framed pergola over the front and back decks that are generally in good condition; The wall junctions need to be sealed and kept well sealed at all times (photos 72 to 83).

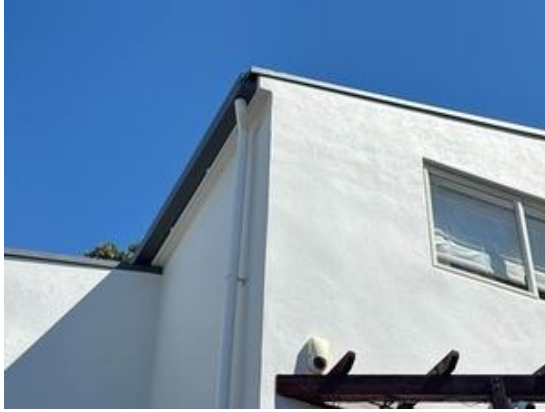
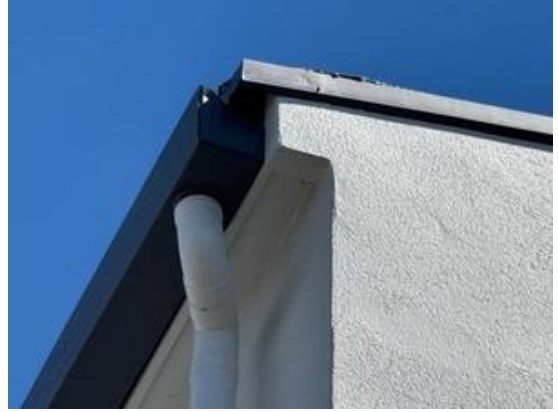
The downpipes and gutters appear to be satisfactory throughout the dwelling (photos 84 and 85).

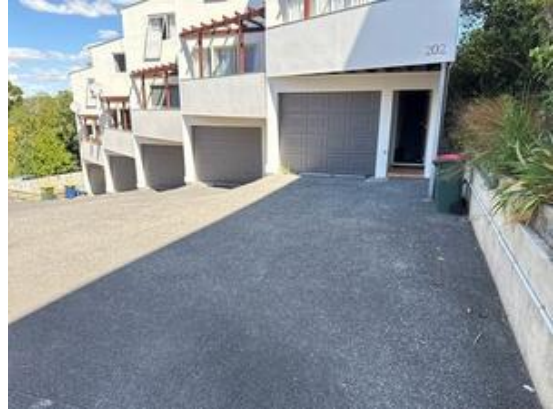
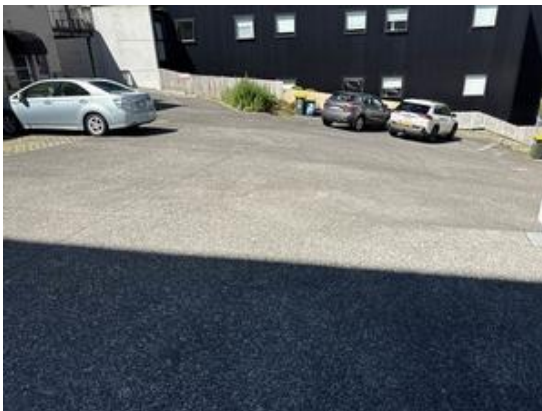
The shared driveway and pathways are in good condition (photos 90 to 93).
