RED LBP PRE-PURCHASE REPORT

PRE-PURCHASE BUILDING REPORT

Property Address	16 Kitchener Place, Opawa, Christchurch 8023
Client	White Sparrow Homes Ltd.
Date of Inspection	21st April 2026
Time	9:30 am
Inspector	Andy Vann National Certificate in Carpentry, Licensed Building Practitioner.
LBP Number	BP135432
People Present	Inspector
House Occupied	Staged

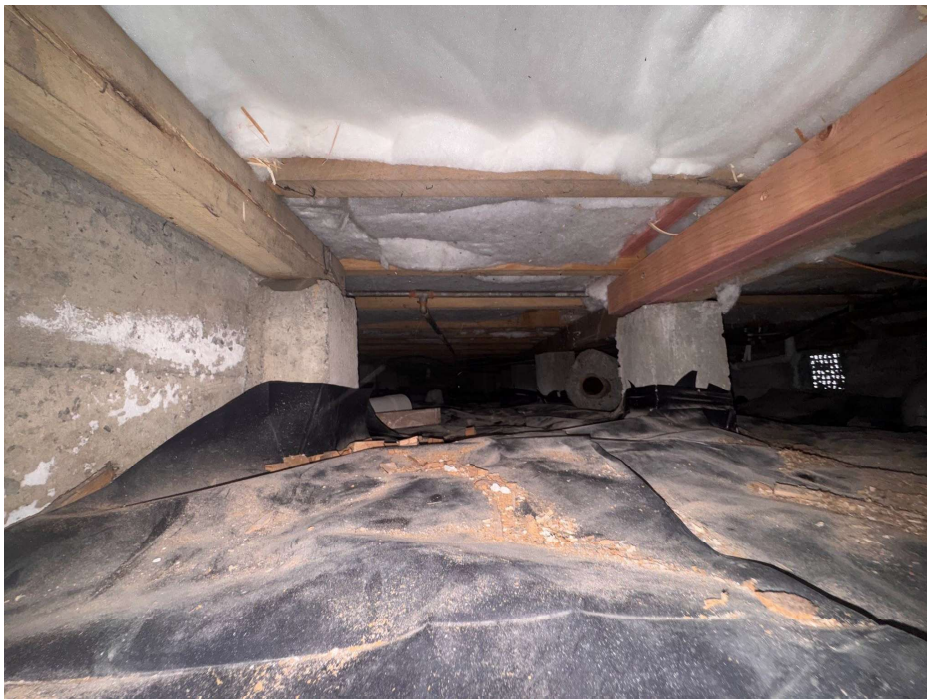
Polyester insulation and polythene ground moisture barrier installed.
