RED LBP PRE-PURCHASE REPORT

PRE-PURCHASE BUILDING REPORT

Property Address	18 Kitchener Place, Opawa, Christchurch 8023
Client	White Sparrow Homes Ltd.
Date of Inspection	21st April 2026
Time	12:00 pm
Inspector	Andy Vann National Certificate in Carpentry, Licensed Building Practitioner.
LBP Number	BP135432
People Present	Inspector
House Occupied	Staged

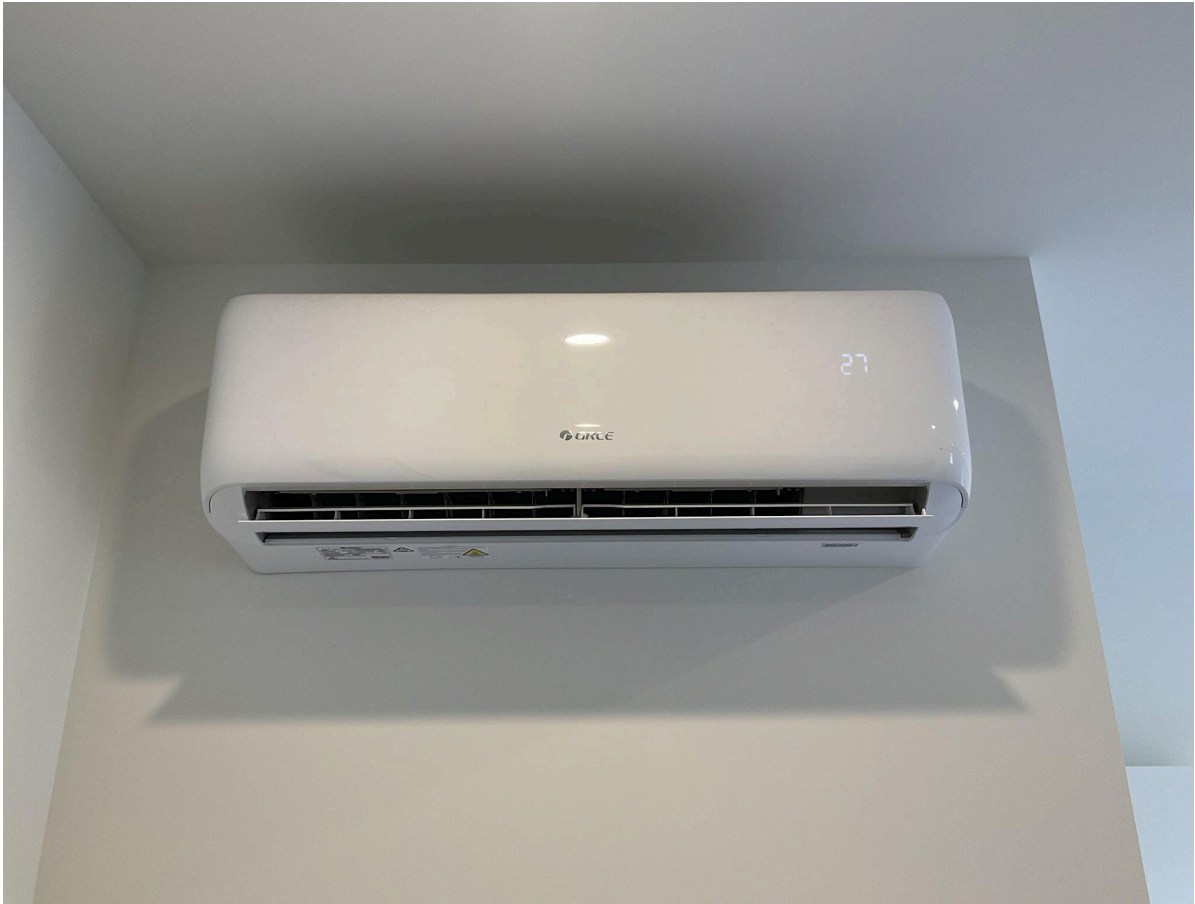
Gree high wall heat pump located in the living room 5.8KW
