Consent No: **24009002**  
 Applicant: **Shannon Marie Burgess**  
 Site Address: **7 Whitehaven Street, Weston**  
 Work Type: **Construction of a 4 bedroom, 2 bathroom dwelling with media room and attached garage.**

Inspection Type: **Final - Residential**  
 Inspection Status: **Fail**  
 Inspected By: **Gordon Innes**  
 Inspection Date: **16 January 2025 10:54 AM**  
 Duration: **60 minutes**

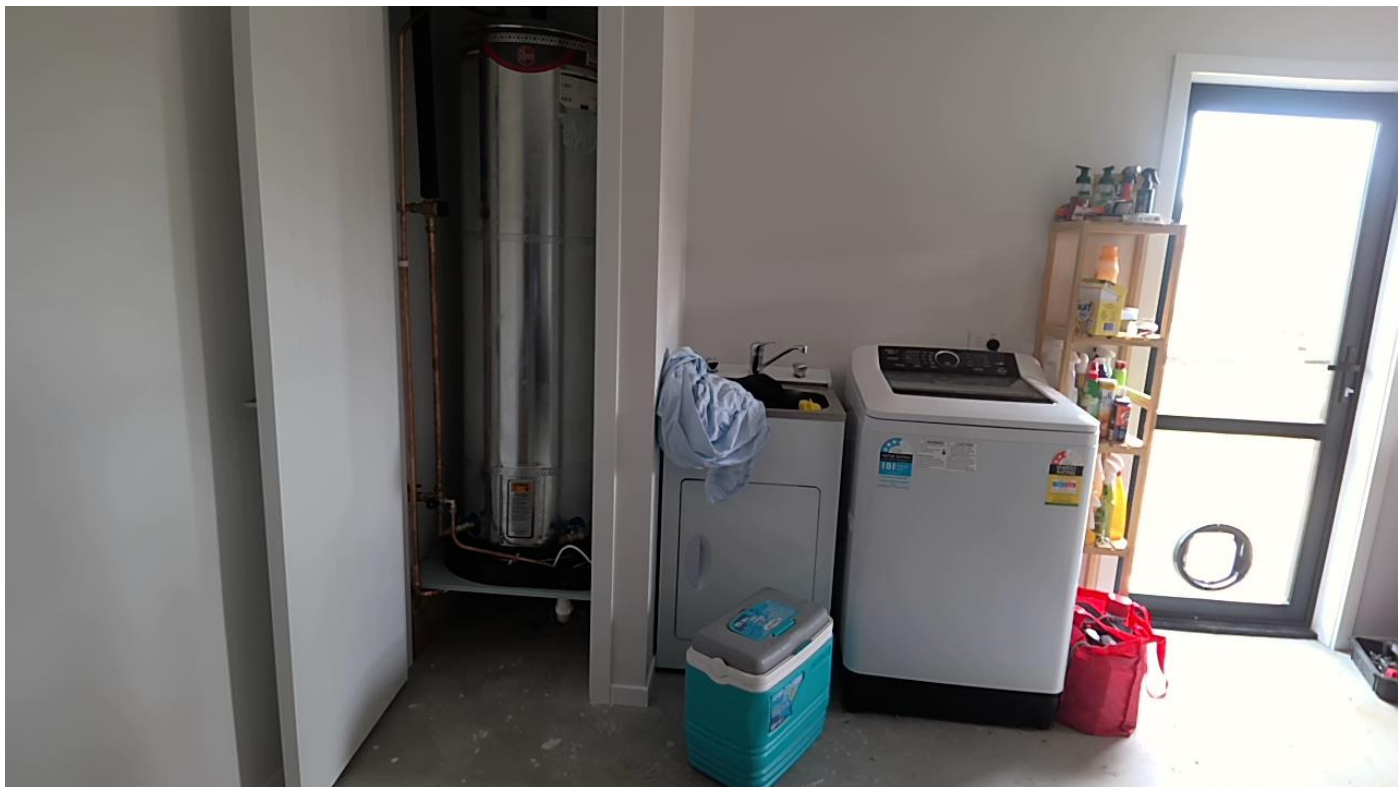
**Laundry and cylinder**  
Taken at 10:45 AM on Thursday 16/01/2025

| <b>Relief pipe has fall to exterior and discharges in a suitable location that will no cause a hazard or damage building elements.</b> | | |
