## Visual Non-Invasive Property Inspection

| Inspection Date | 31/07/2026 |

Address 197 williams Street Kaiapoi

### INSPECTION INSTRUCTIONS Visual Non-Invasive Pre-Purchase Property Inspection

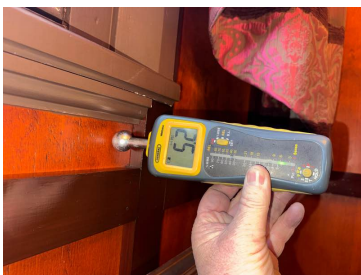
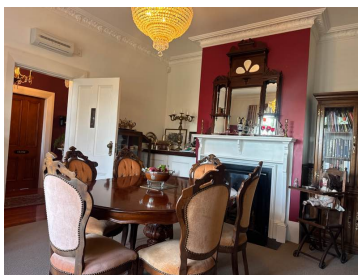
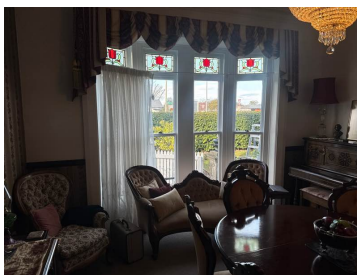
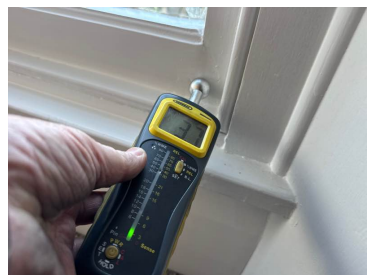
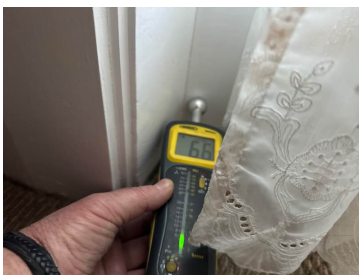
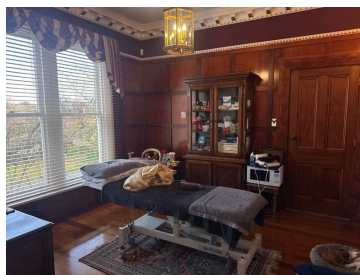
Games room

| Comments | <p>Hallways, Living Areas, Office &amp; Games Room</p> <p>The interior living areas of the dwelling are presented in very good condition and have been well maintained. The home comprises an open-plan kitchen and living area, a separate formal dining room, a large hallway and stairwell, a spacious sunroom, an office, and an additional room currently used as a games room (pool/snooker room).</p> <p>All floor finishes, including varnished timber flooring, tiled areas, and carpeted surfaces, were observed to be in very good condition. Wall and ceiling linings also appeared clean, tidy, and well maintained throughout.</p> <p>The dwelling has been tastefully renovated over the years and presents in a clean, finished condition. Internal doors, accessible windows, and ranch sliders operated smoothly at the time of inspection, with no significant issues observed.</p> <p>The office and games room were both observed to be in very good condition, consistent with the remainder of the dwelling, with all surfaces clean, tidy, and well maintained.</p> <p>Moisture testing to accessible exterior wall areas returned readings below 17 (green), indicating dry conditions. No visible water staining, moisture damage, or signs of water intrusion were observed.</p> <p>No significant defects were identified within the living areas, hallway, stairwell, dining room, sunroom, office, or games room at the time of inspection.</p> <p>Risk: Low</p> |
