**Information request – 427 Armagh Street, Linwood, Christchurch 8011**

## TR001: Technical Report – Desktop Technical Review & Structural Inspection

## **Canterbury Claims – Assessment Report**

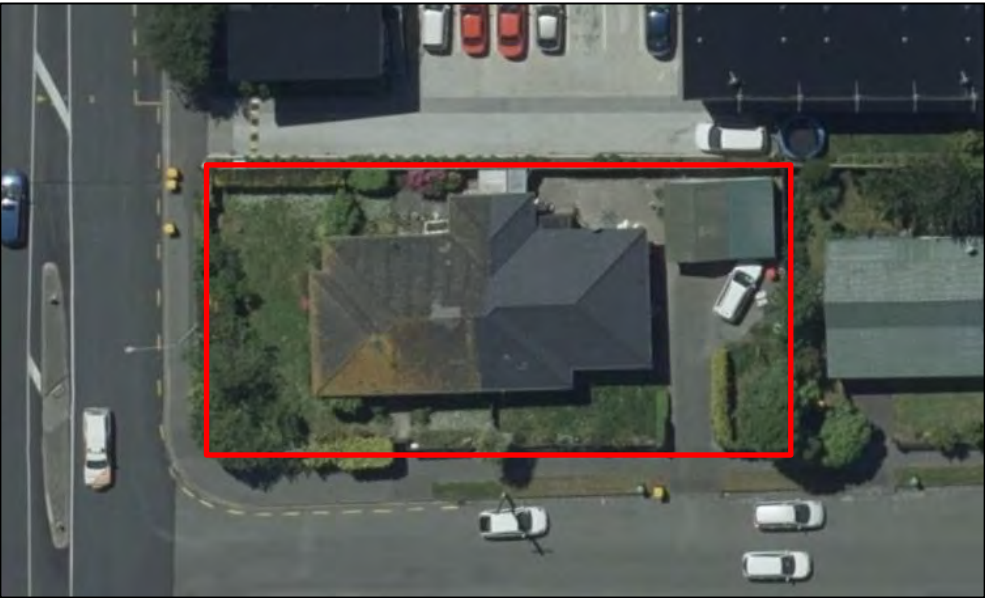
Photo 1G – 2015-2019 aerial imagery shows the chimney has been removed down to roof level.

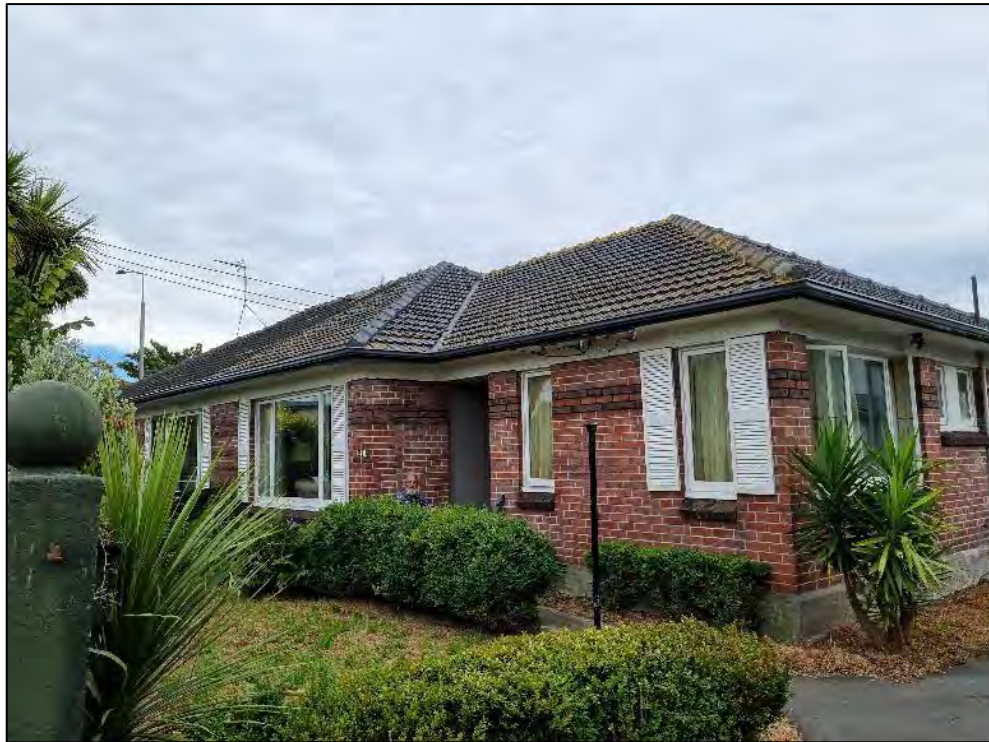
Photo 2A – South elevation (street facing).

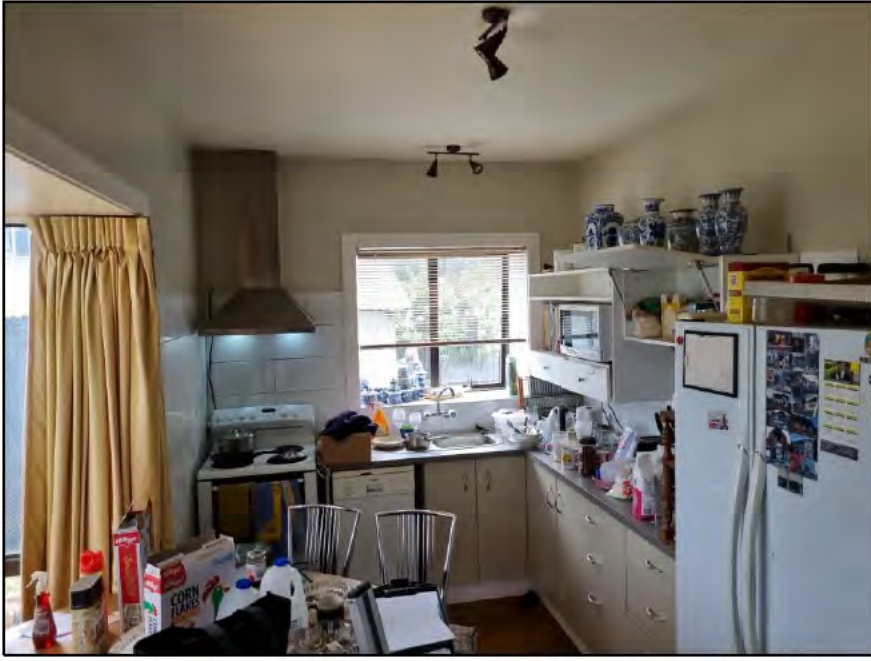
Photo 4A –Kitchen floors , ceilings and built in benchtops all fall to the north.

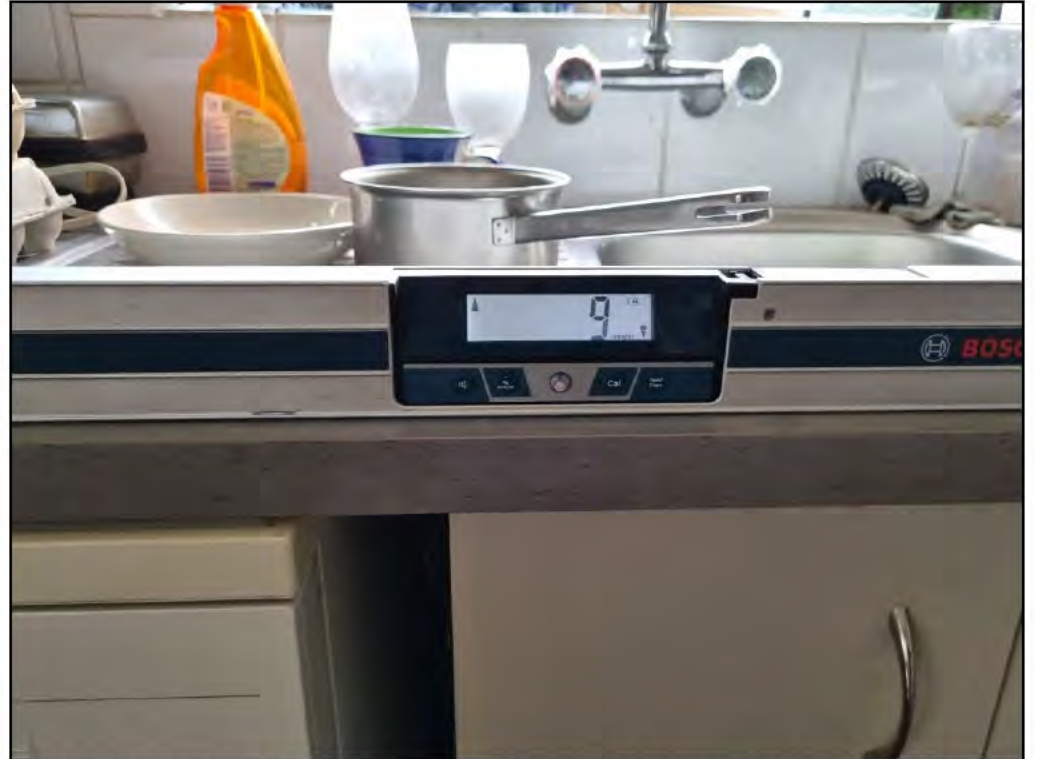
Photo 4B Kitchen bench along the eastern wall falling to the north by 9mm/m , following the floor and ceilings.

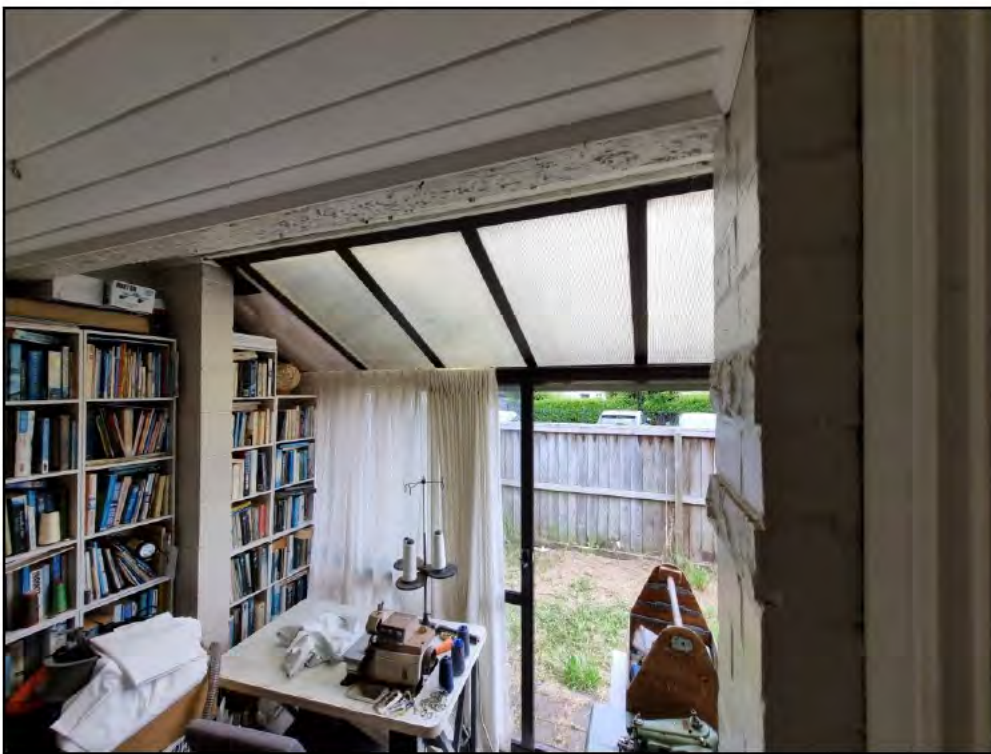
Photo 4C – Porch area used as storage.

REMOVE SLABS. REPLACE THE PORCH SLAB IN 427 ARMAGH STREET AFTER THE FOUNDATION LIFT IS COMPLETE.

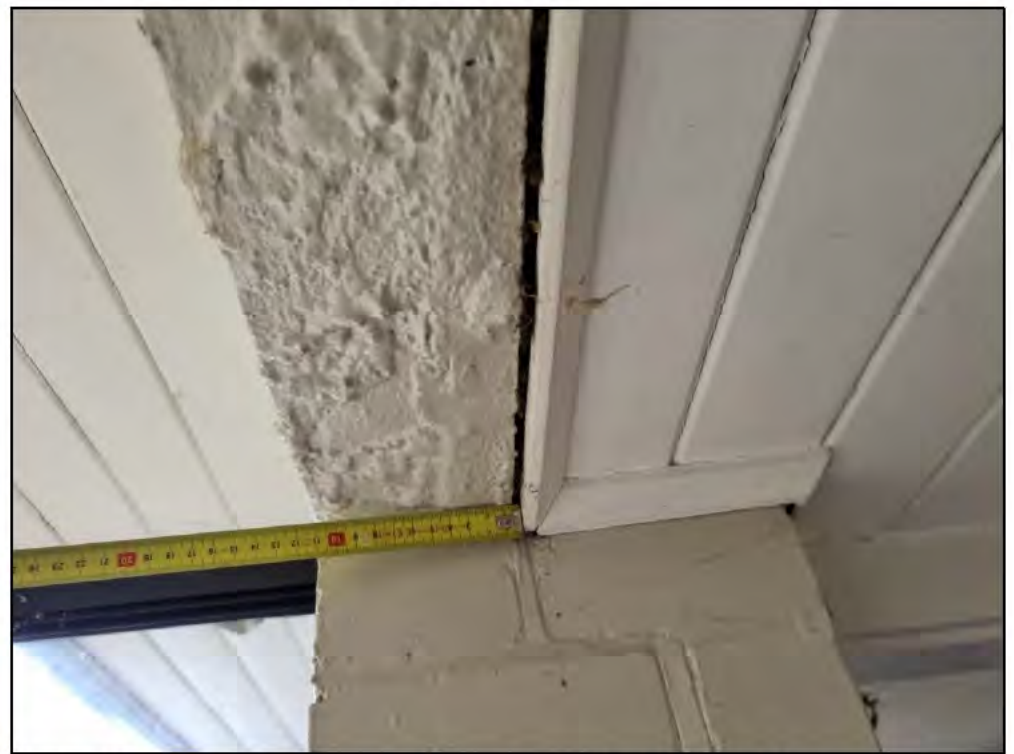
- The porch is founded on a concrete slab-on-grade and is a step down from the kitchen and laundry floor level. The slab was scanned using a Hilti PS50 Multidetector and no reinforcing was detected. Photo 4D shows minor separations between the concrete lintel and the soffit framing.
- The partition wall dividing the two dwellings forms the west and north wall of the laundry. The post-earthquake scopes allowed for mortar crack repairs to the blockwork and for the wall to be repainted which suggests some differential settlement occurred along this wall during the CES. No cracks were identified along the visible area of wall during the NZCSE assessment.

Photo 4D –Minor separation between the timber trim and the concrete lintel above the porch.

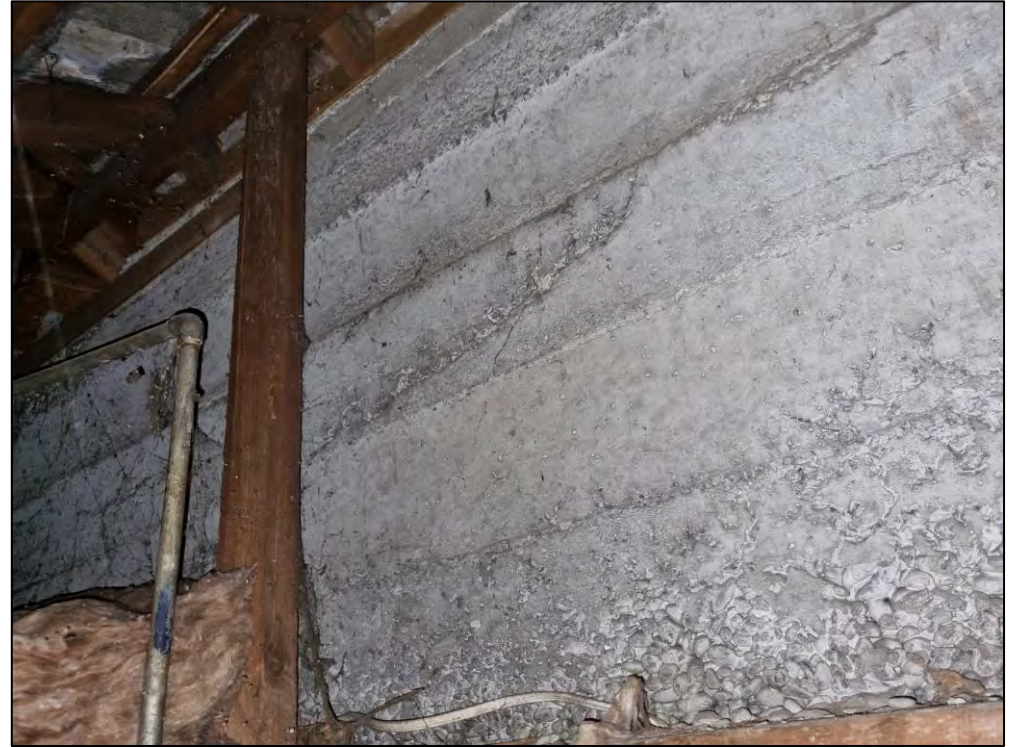
Photo 6B – Partition wall is partly constructed from poured in situ concrete above the ceiling line. Concrete pour joins ( cold joins) can be seen.

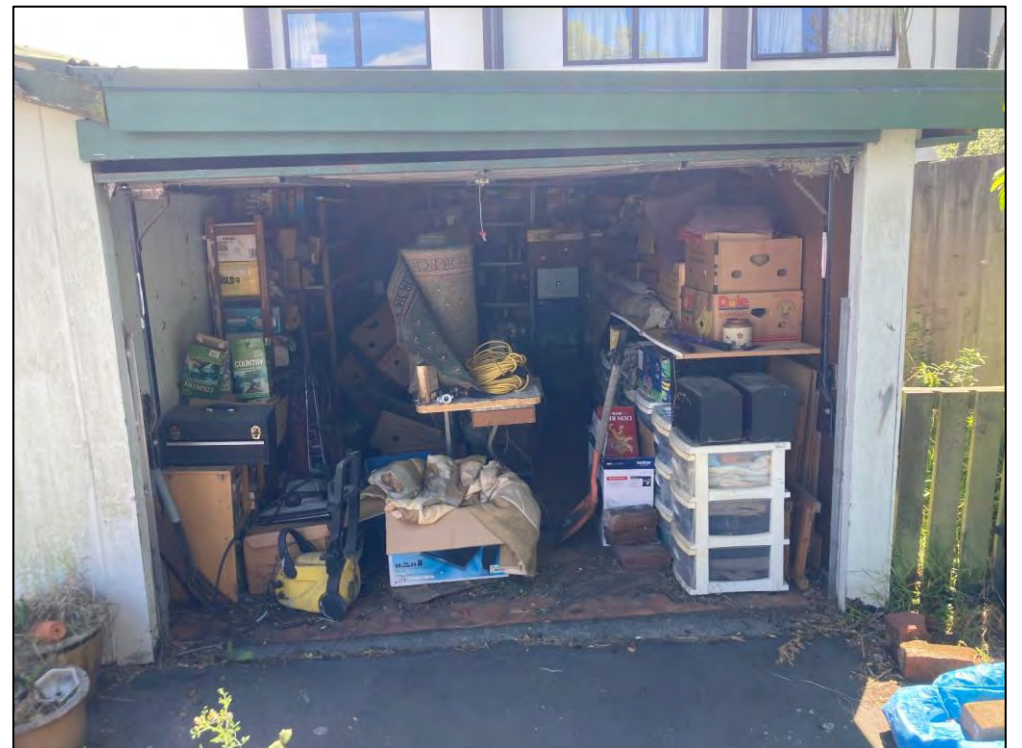
Photo 7B – Garage was full of storage at the time of the assessment. Door head was measured to be level over sloping concrete slab.

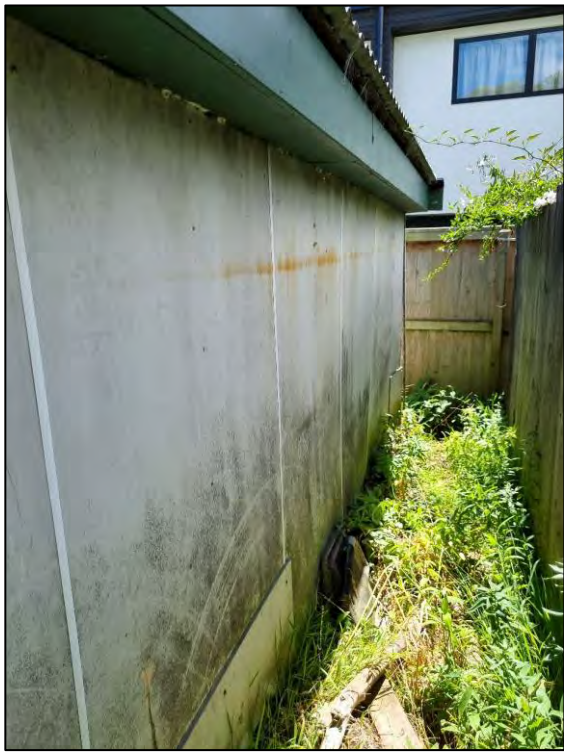
Photo 7C –Garage east elevation . Cladding is undamaged,. No stormwater guttering has been fitted.

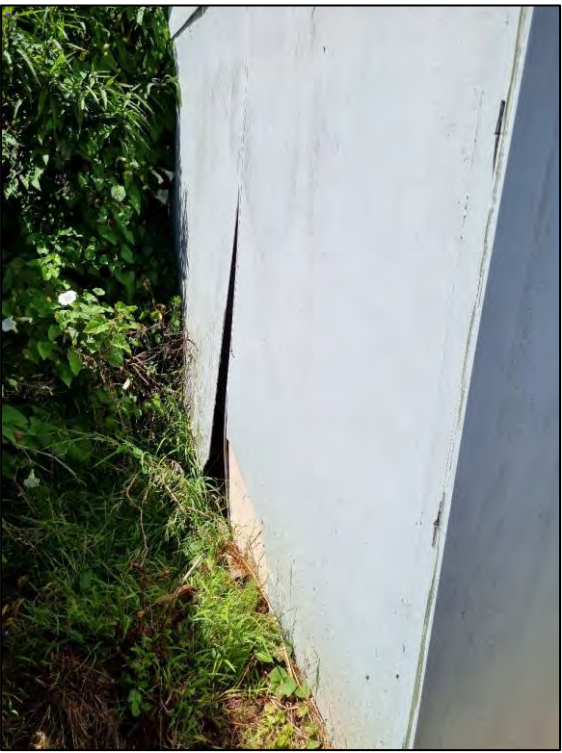
Photo 7D – North Elevation. Cladding sheet need to be refixed.

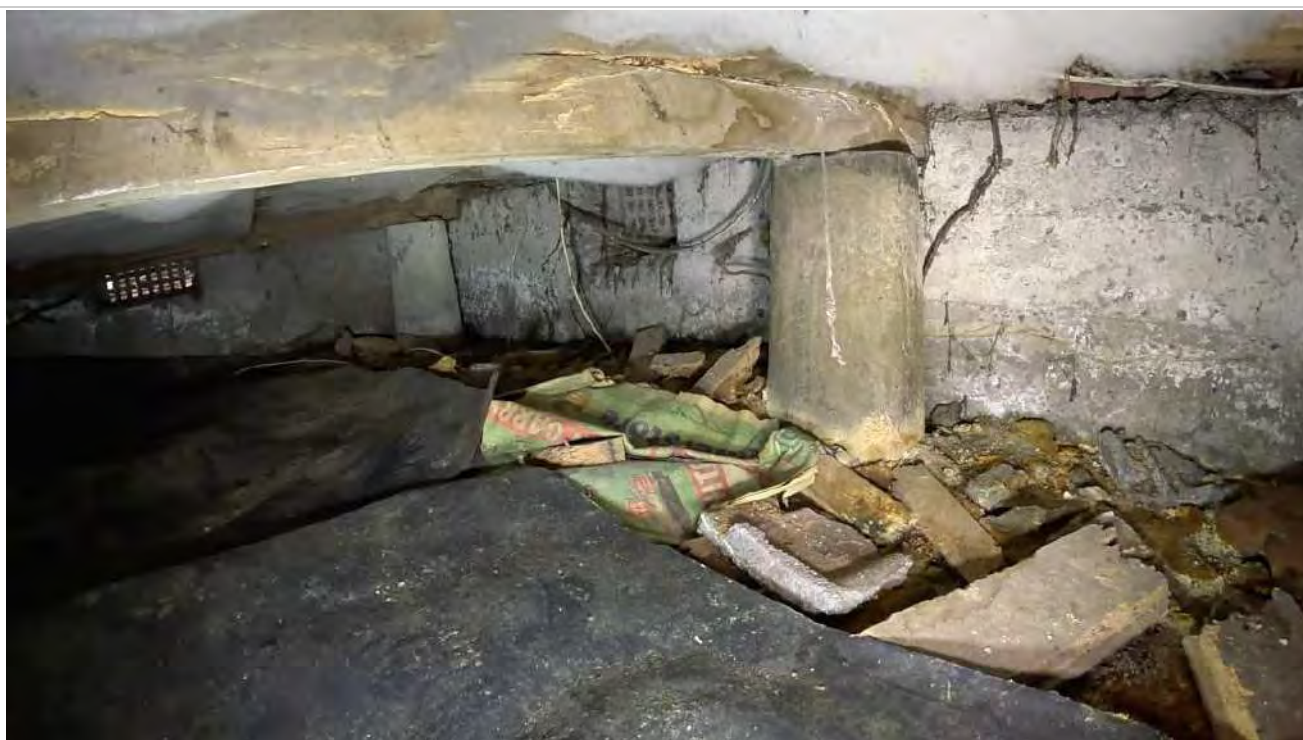
41: Precast concrete pile with no connection.

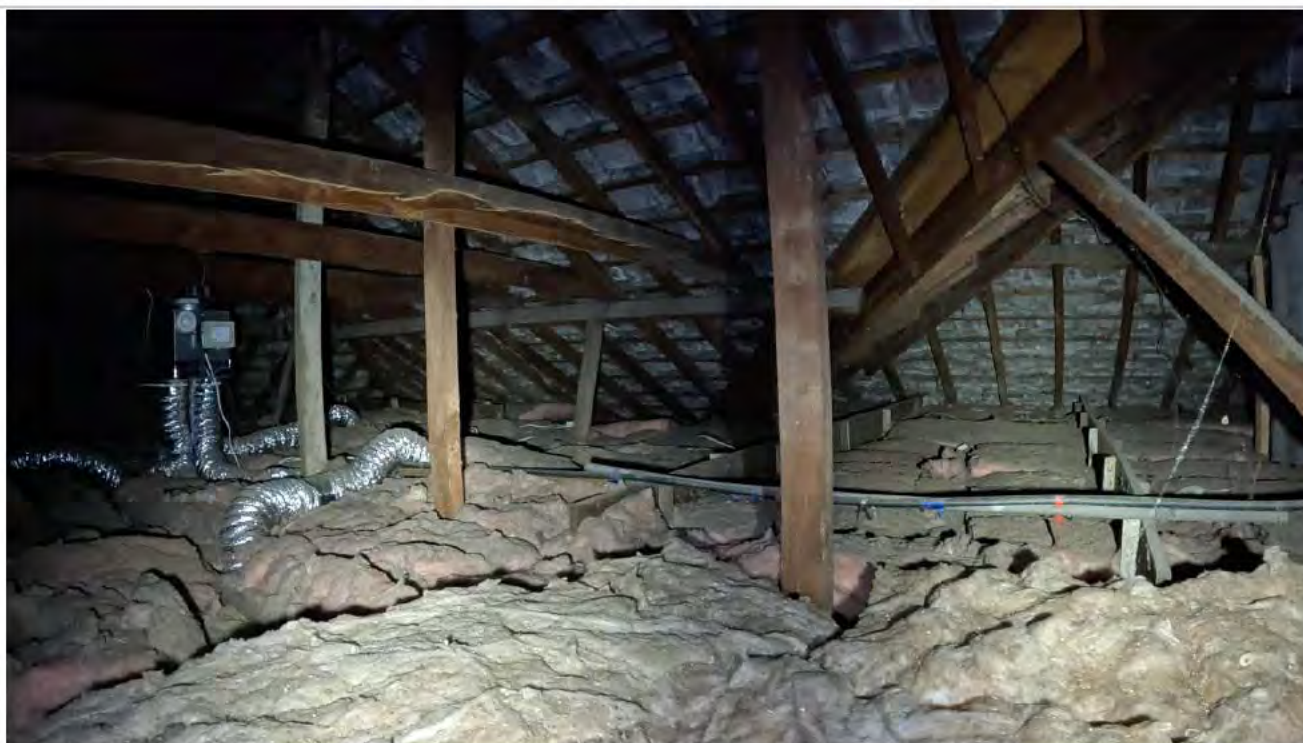
12: The support structure we see in this roof is fairly typical of a roof of this period but does leave some areas vulnerable to sagging.
