# CASH SETTLED CLAIM(S)

## Statement of Claim Checklist

Date: 22/10/10Author: Taw BatchelorClaim No.: 290 / 036482Claimant: A McCartneySituation of Loss: 4 Evans PlaceKaraparLA: Taw BatchelorEstimator: Paul Burns

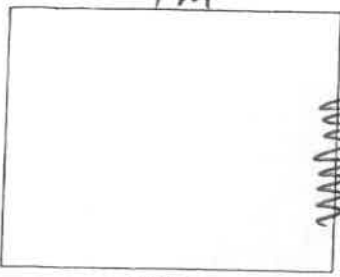
| <br>Lounge | <br>Dining Room | <br>Kitchen |

| Room | Damage | Walls | Ceiling | Floor | Description of Damage |
|---|---|---|---|---|---|
| Lounge | Y | Y | | | crack in wall lining |

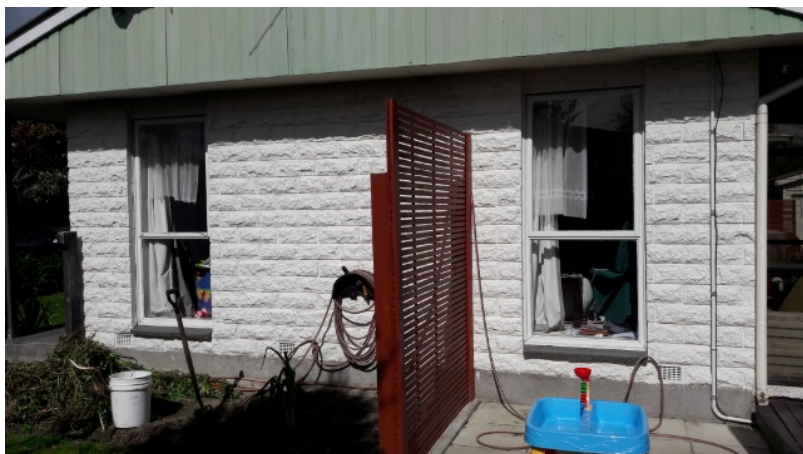
Figure 4 : North side of dwelling

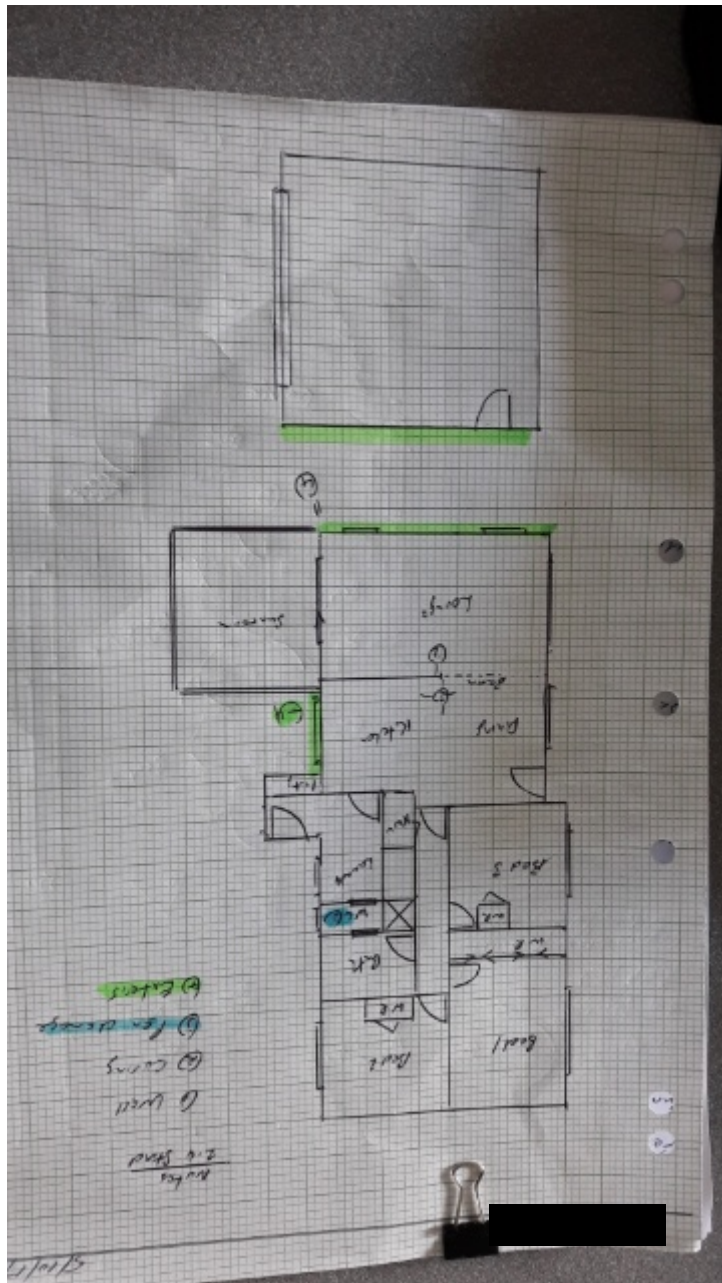
Figure 10 : Damage plan
