## Visual Non-Invasive Property Inspection

22/01/2026

720 Christchurch-Akaroa Rd

### INSPECTION INSTRUCTIONS Visual Non-Invasive Pre-Purchase Property Inspection

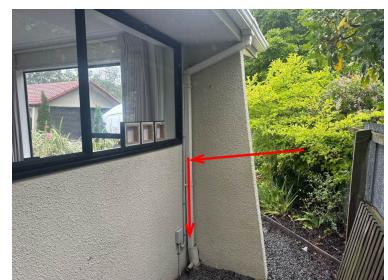
All downpipes discharging into stormwater as intended

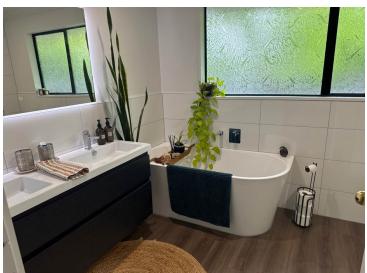
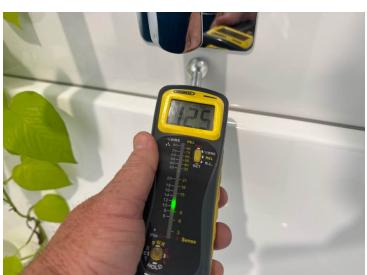
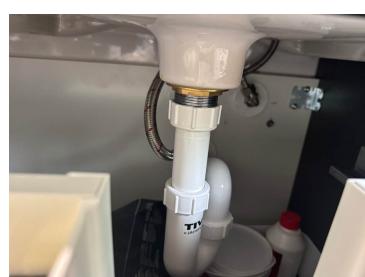
### Master Bathroom

Comments      The main bathroom is in good condition overall. Fixtures and fittings, including the toilet, vanity, shower, bath, tapware, and plumbing fixtures, were observed to be in good working order and functioning as intended. No leaks were detected beneath the vanity or to visible pipework at the time of inspection. Wall, floor, and ceiling surfaces appear clean and tidy, with no visible defects or areas of concern noted.

Moisture testing was carried out to typical risk areas, with readings below 15 recorded. A green light indication confirms dry conditions at the time of inspection.

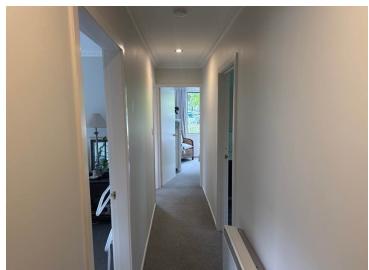
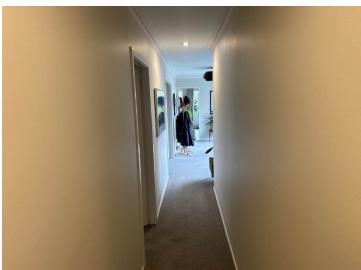
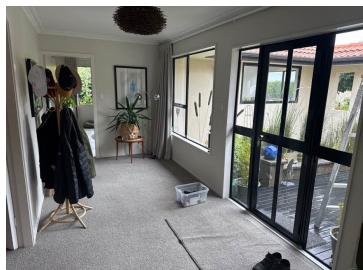
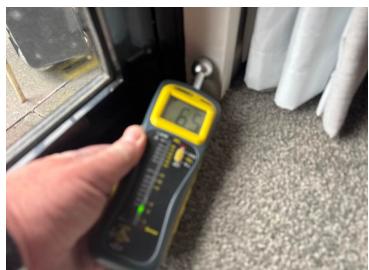
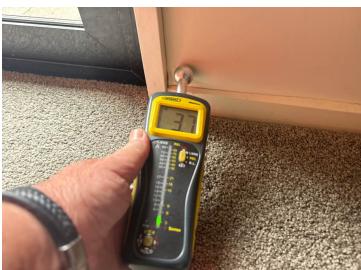
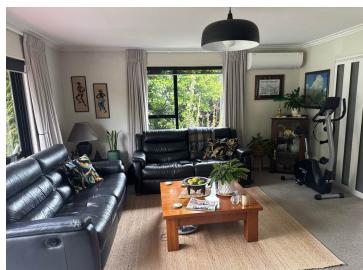
### Interior Spaces

The hallway, front door area, two living rooms, and dining area are all in good condition and appear well maintained. Walls, ceilings, and flooring throughout these areas show no visible defects, damage, or areas of concern at the time of inspection. All internal doors and windows and ranch sliders were operated and were found to open and close properly.

Moisture testing was carried out to typical risk areas, including external wall junctions, with readings below 15 recorded. A green light indication confirms dry conditions, with no moisture issues detected during the inspection.
