Unauthorised building work report for  
**Certificate of Acceptance application.**

Address 113 King Edward Street  
94/141 Pt Sec 3 Sec 177 Motueka DIST  
1956041600

Inspector Keith Langham, ASAP Building Inspections Ltd.

Date of inspection: 13 October 2021

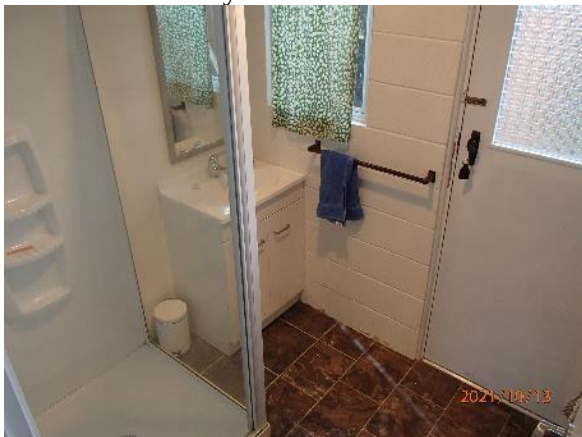
The laundry tub was relocated to a garage space on the same floor level. The original laundry room was closed off and an acrylic shower and a vanity were installed, safety glass in the window and exterior door and an extract fan/light/heat unit installed in the ceiling.

The work that required building consent is the installation of 2 sanitary fixtures in this case the shower and vanity basin.

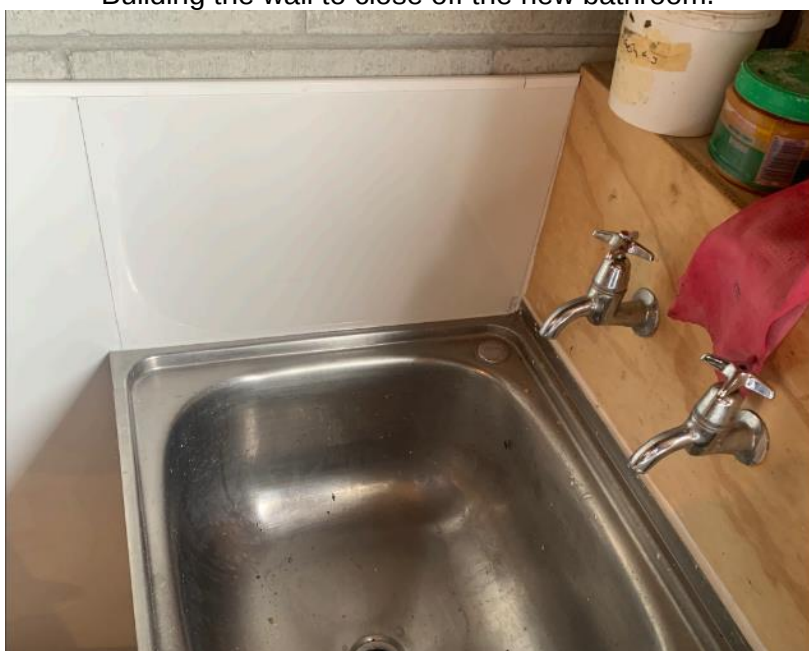
**Areas of work covered under Schedule 1 exemptions and does not form part of this Certificate of Acceptance application.**

- Relocation of the laundry tub to the garage.
- Building the wall to close off the new bathroom.
