# EARTHQUAKE RECOVERY (EQR) DOCUMENTATION

# EQR Property Overview Report

| EQC Property ID | Property Address | Vulnerable? | Property F Status | Property Finalisation Indicator | | |
|---|---|---|---|---|---|---|
| 2010124453 | 67 JACKSONS ROAD, OHOKA | | F3 - Complete & Finalised | Some Finalisation has taken place | | |

67 Jackson's Rd., Ohoka, Kaiapoi

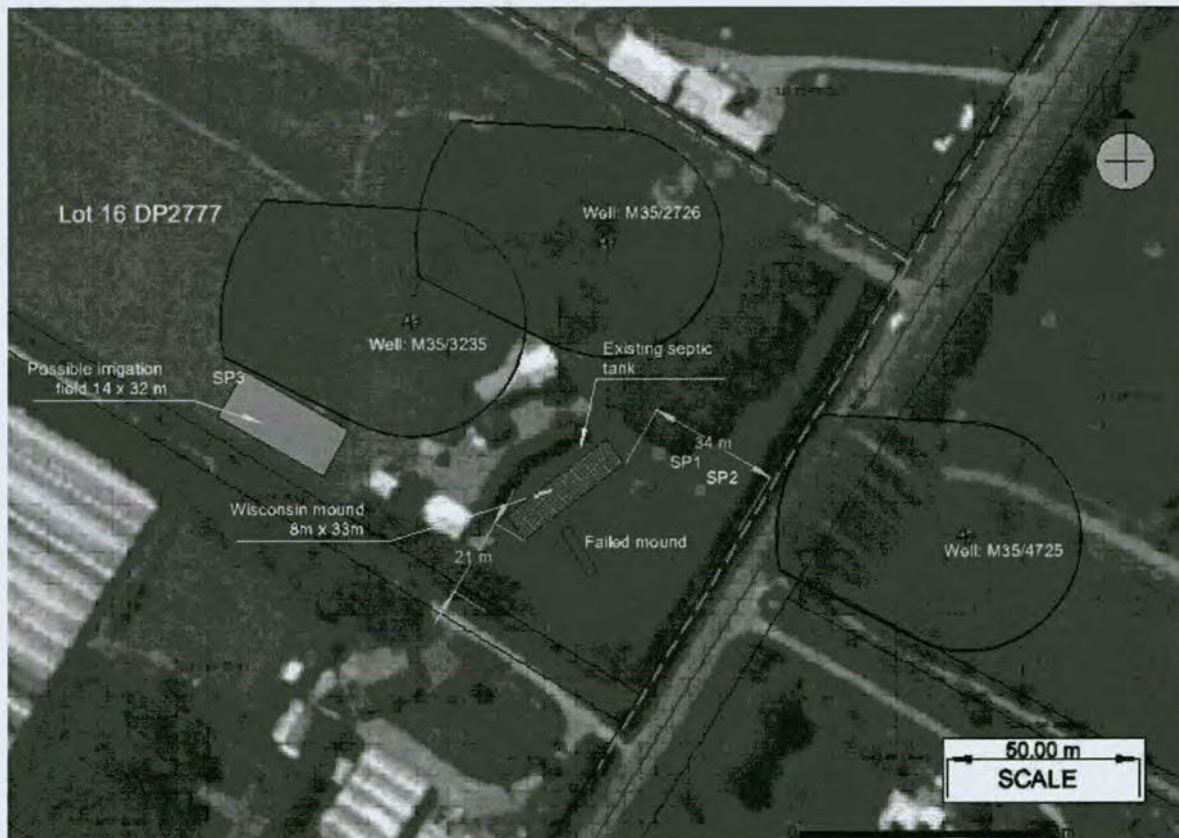
**Figure 2. Site constraints and layout**

- Ground water wells; there are three groundwater wells, two on-site that impact on the consentability of the location of the land application field. Refer to Figure 3 which shows the three exclusion zones (key holes shaded red) that limit the available area for the land application site.
- High water table – Well M35/0611 records a maximum groundwater table of 190mm below ground-level.
- Two surface drains (both highly contaminated) are located along the north-east and the south-east boundaries of the property.

Figure 2 shows the exclusion zones. It also shows location of the Wisconsin mound and a possible irrigation envelop. The option of secondary treatment to subsurface irrigation was dismissed due to land use issues.

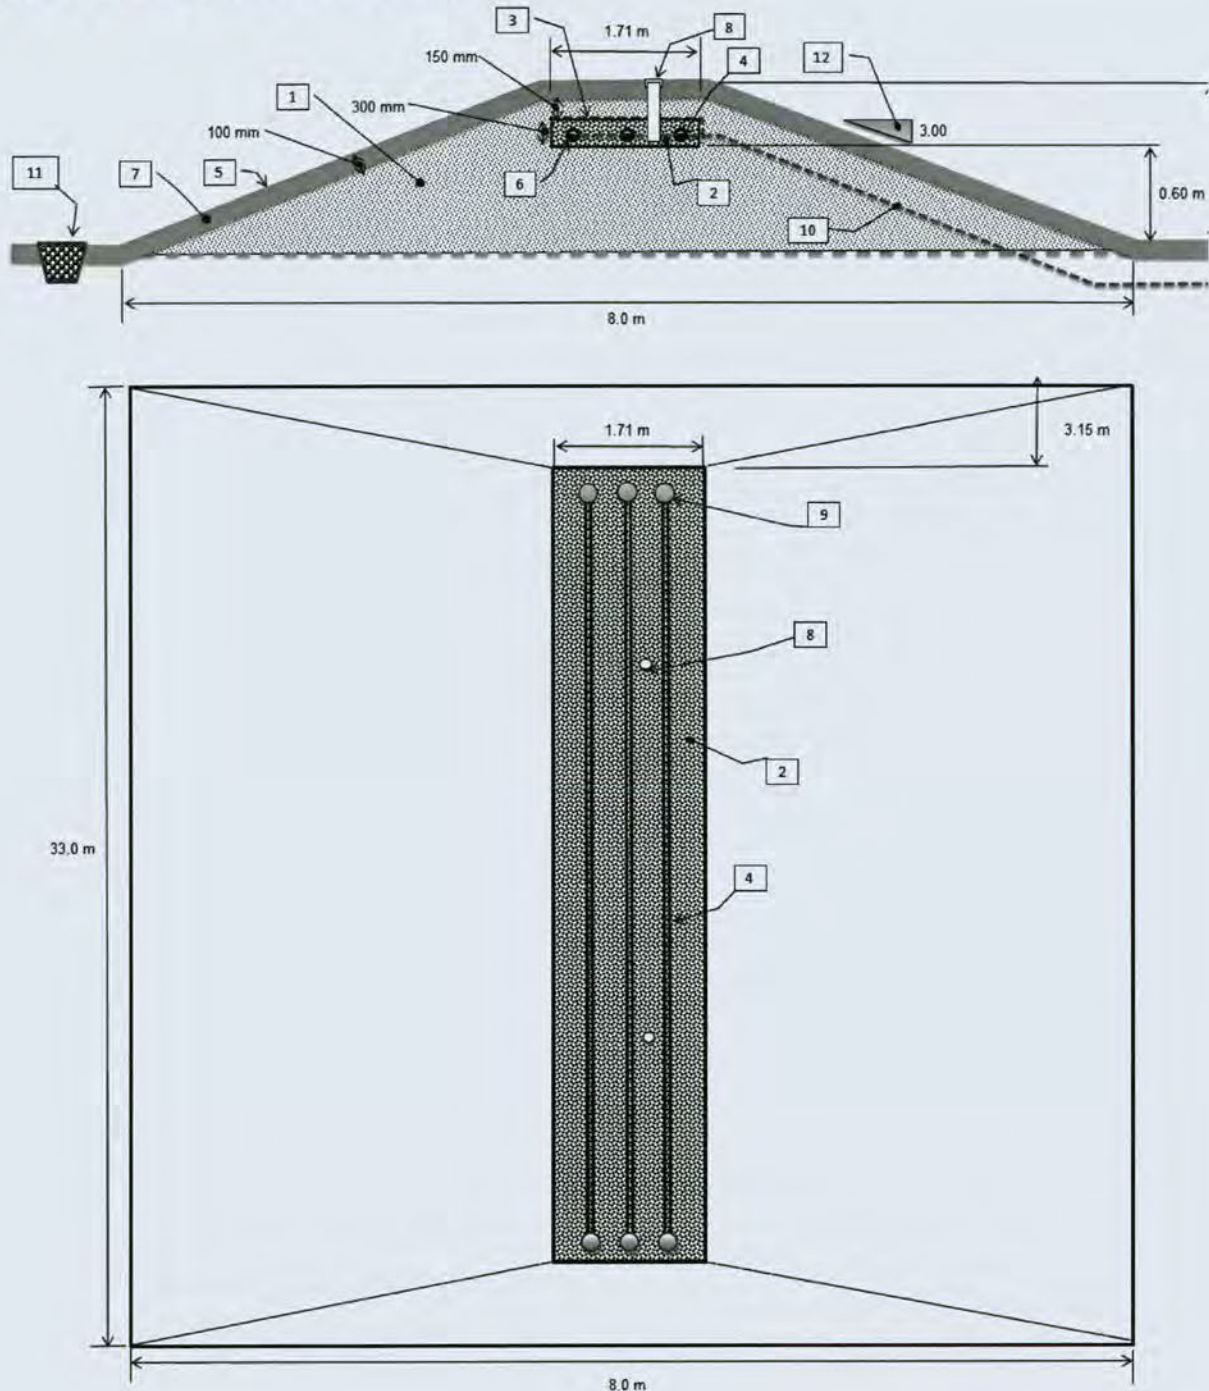
Figure 3. Details of Wisconsin mound

- Decommission the existing undersized septic tank
- Replace the with a new septic tank (plus filter) with a working capacity of at least 4500 L.
- Provide dose loading to a Wisconsin mound with plan area of 33m by 8m (Refer to Figure 3).

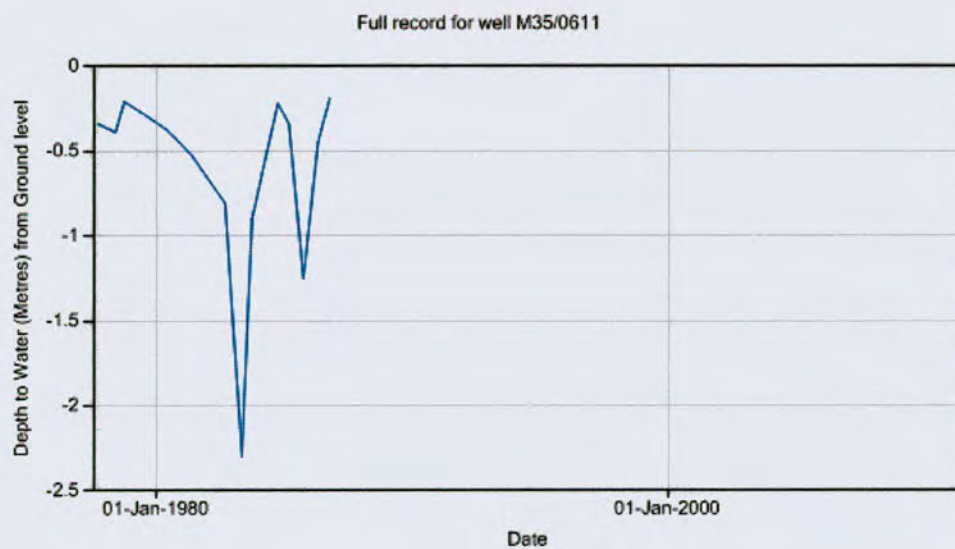
Figure 2. Water table level in M35/0611 – about 200m NW of EST bed.
