# Thermal Imaging Inspection Report

## VISUAL NON-INVASIVE THERMAL IMAGING PROPERTY CHECK

### 10 Thomas Lane, Rangiora

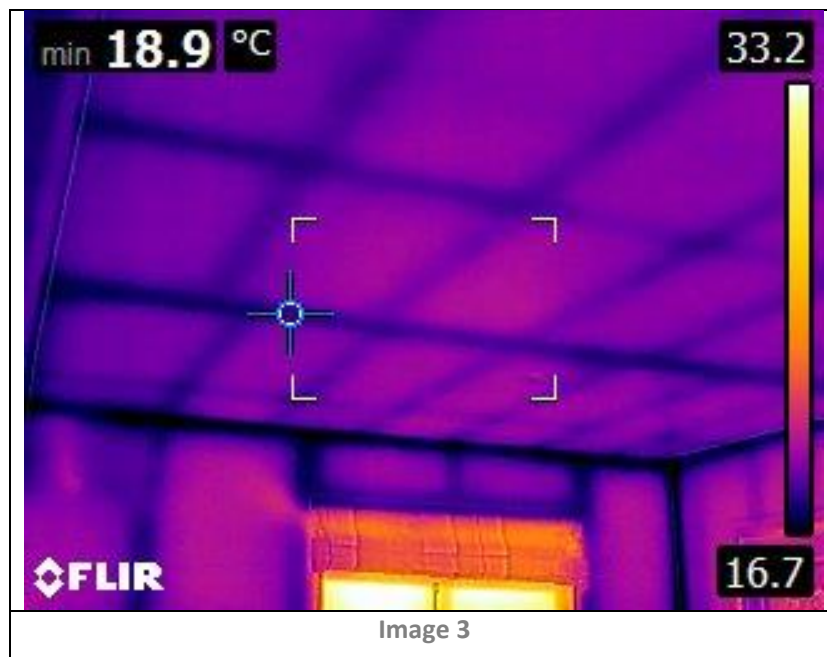
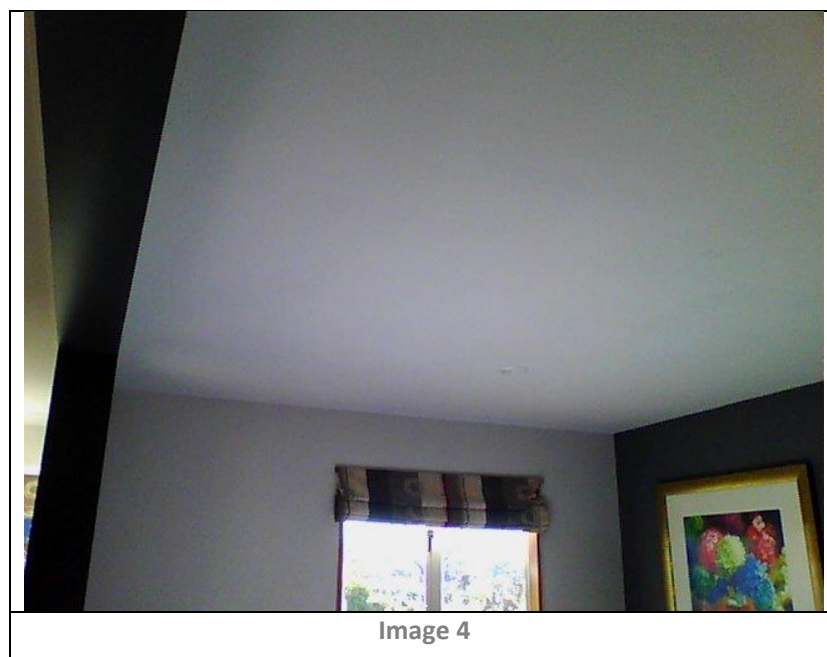
Image 5 - All accessible suspicious darker areas identified on thermal images were double checked with our moisture meter to ensure they were not returning elevated readings.
