# KIWI HOUSE INSPECTIONS

## Independent Building Inspection Report on 21 Devon Street, Mangawhai

INDEPENDENT BUILDING INSPECTION  
21 Devon Street

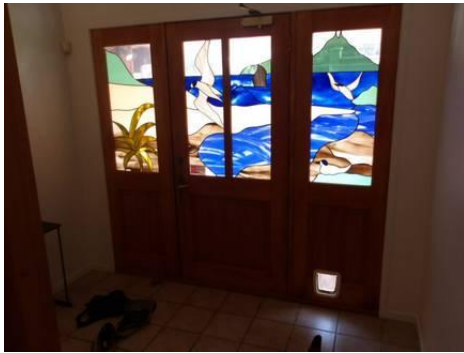
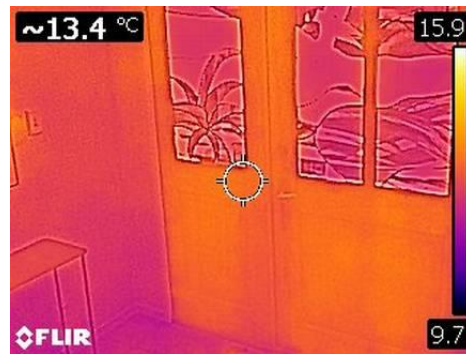
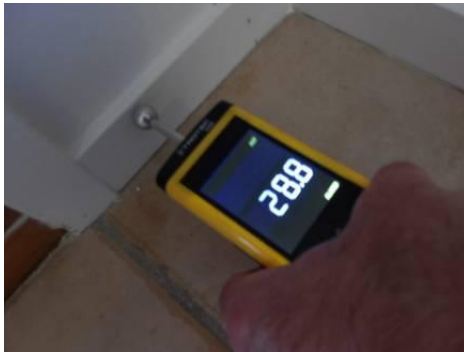
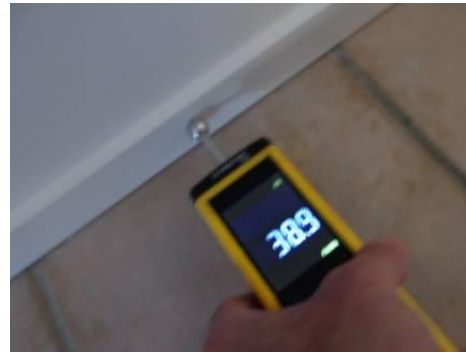
***Entrance: Acceptable***

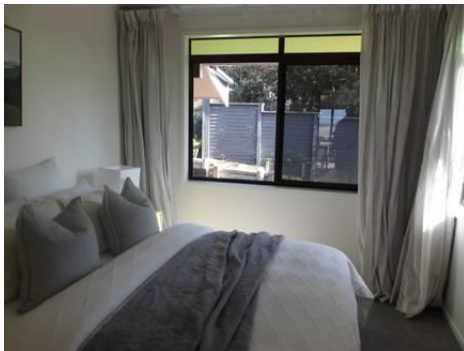
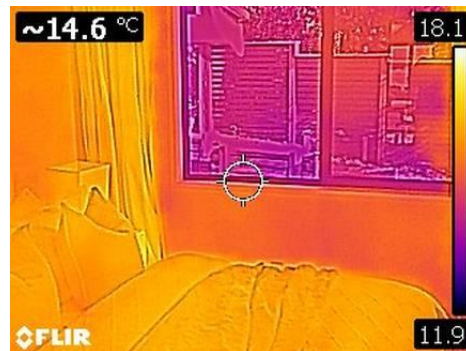
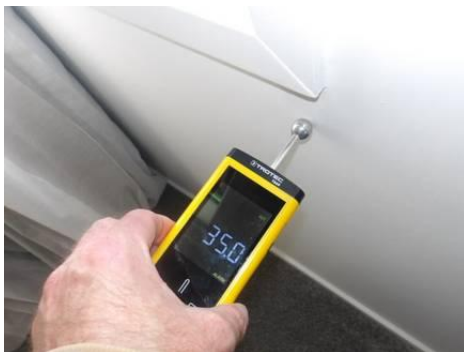
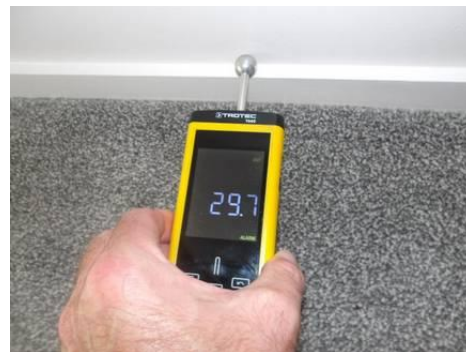
***Bedroom 1: Acceptable***

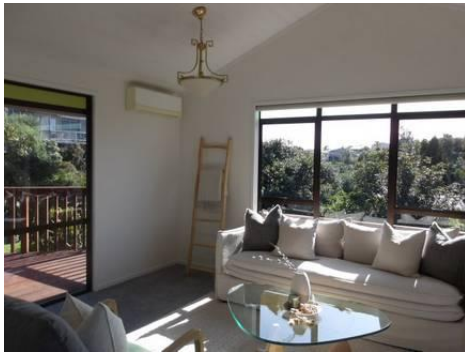
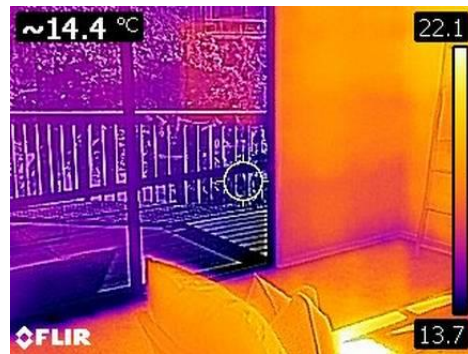
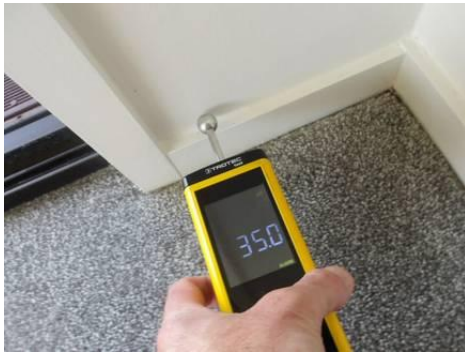
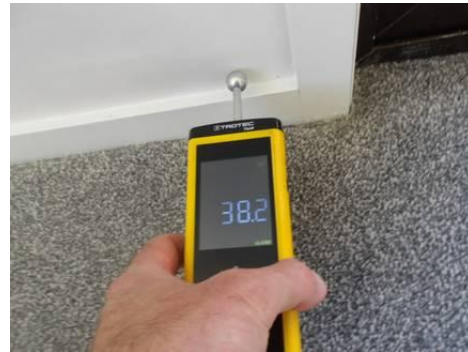
### ***Main Living: Acceptable***

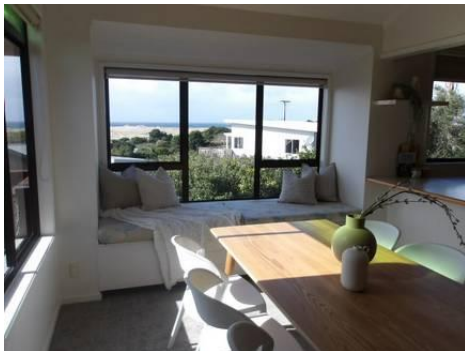
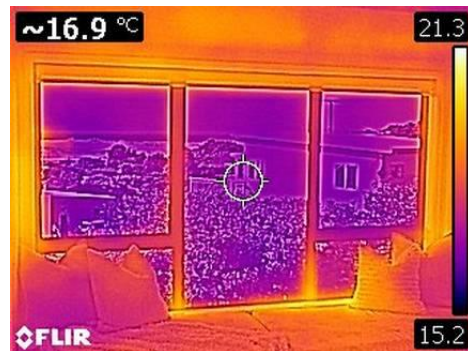
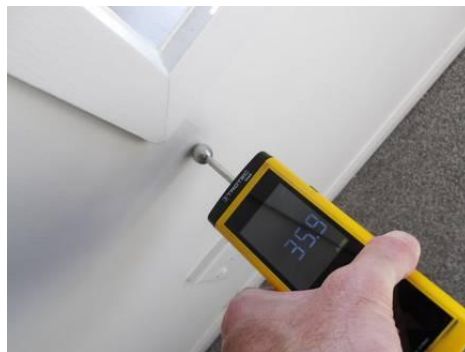
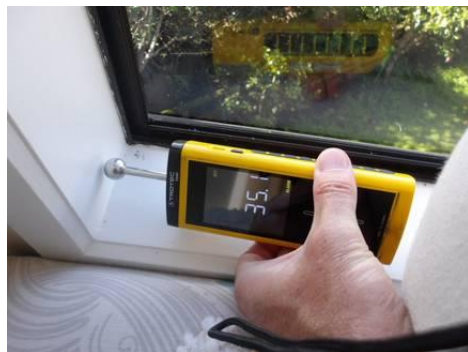
### ***Dining: Acceptable***

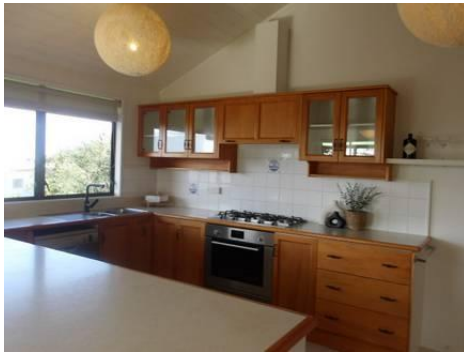
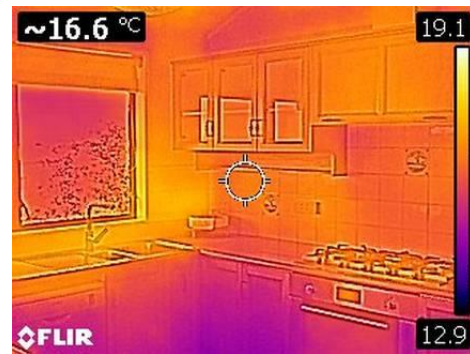
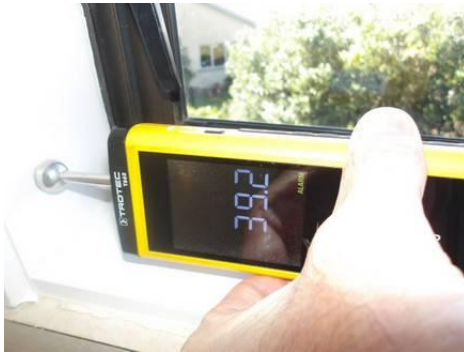
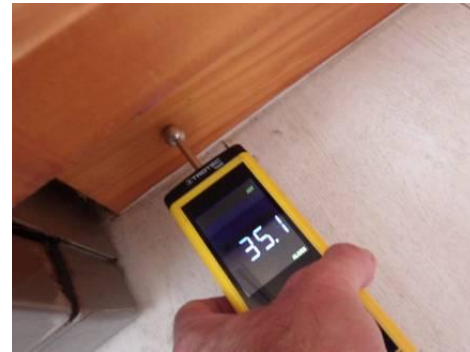
### ***Kitchen: Acceptable***

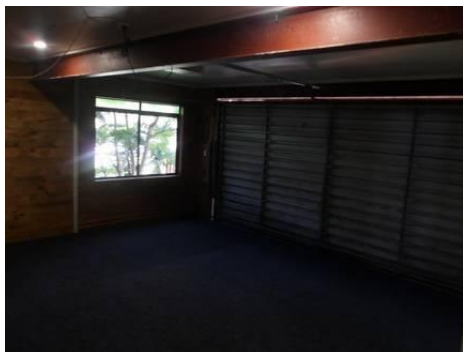
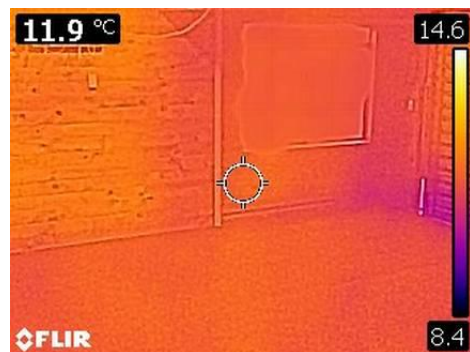
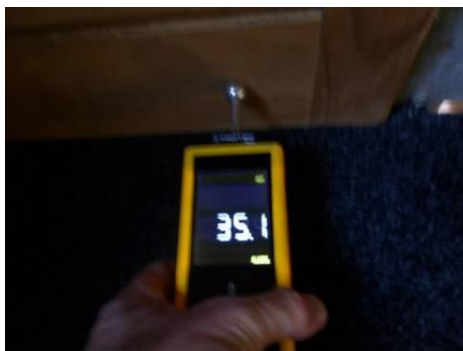
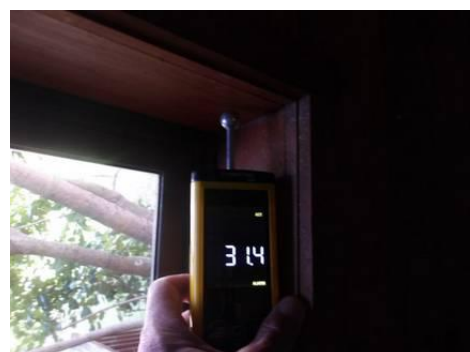
### ***Garage: Acceptable***

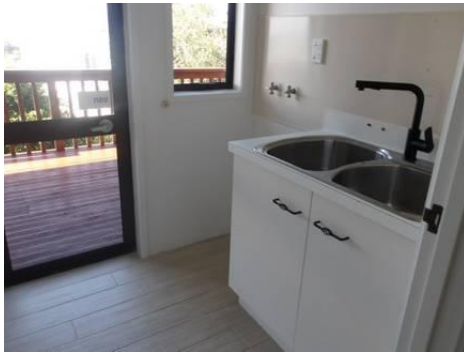
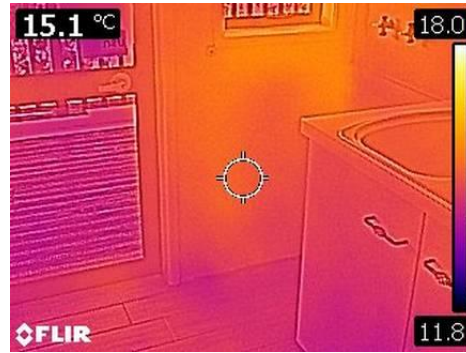
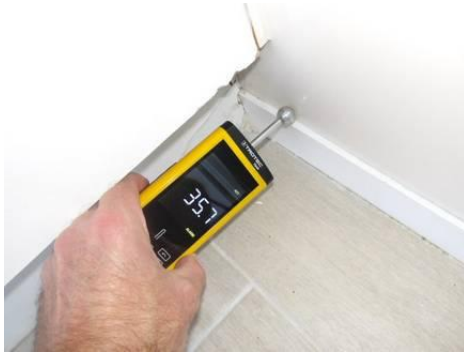
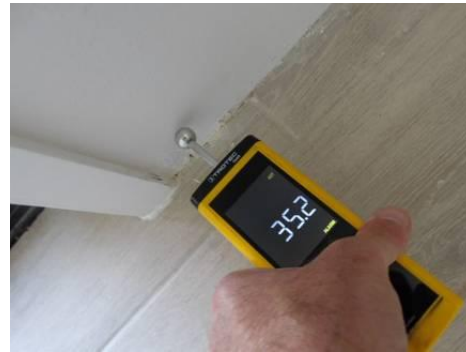
### ***Laundry: Acceptable***

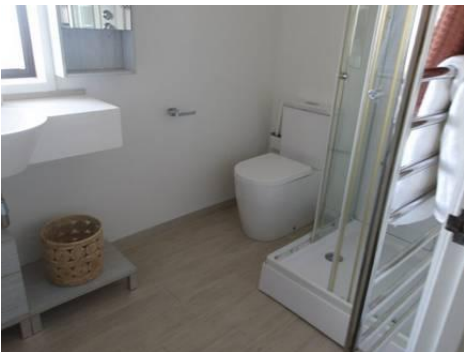
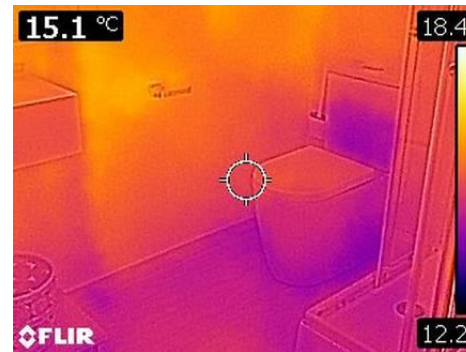
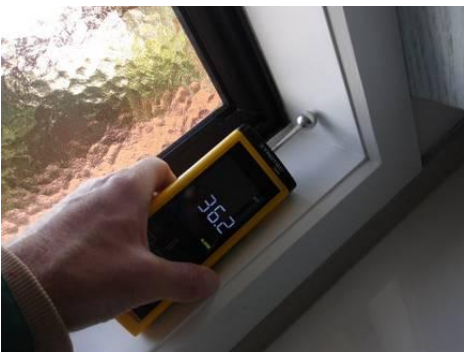
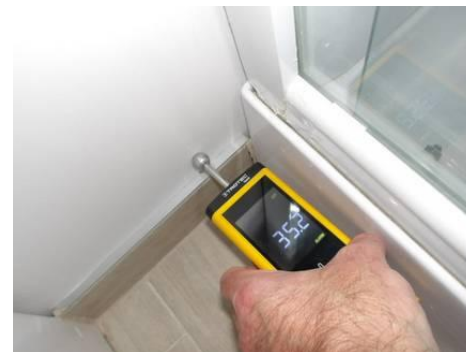
### ***Family Bathroom: Acceptable***

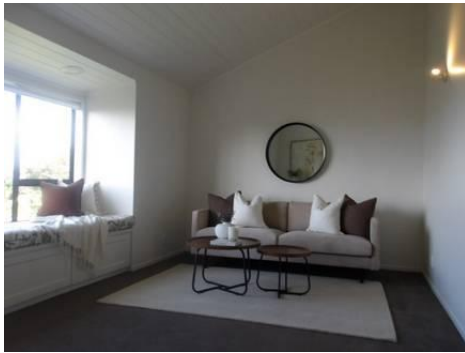
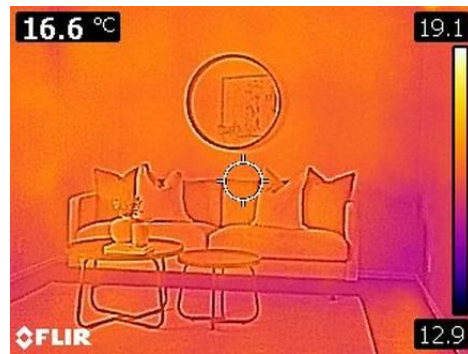
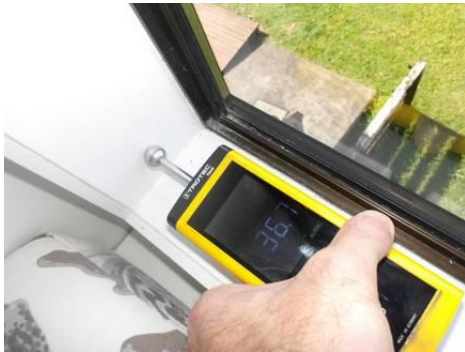
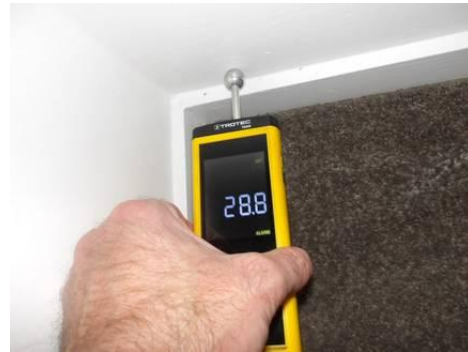
***Family Room: Acceptable***

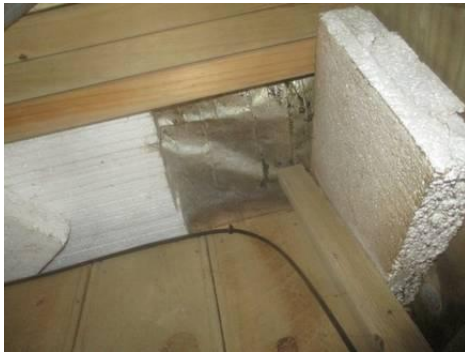
**Only insulation to storage areas**

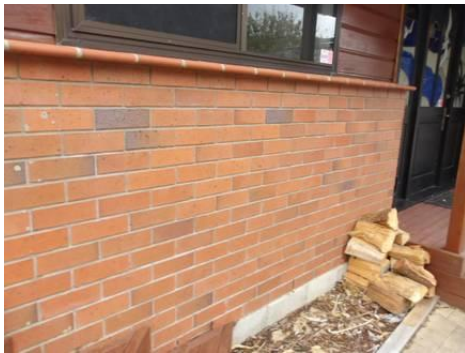
A small portion of the exterior cladding to the dwelling is of brick veneer, installed over a timber frame, with a 45-70mm cavity.

**Cavity system**

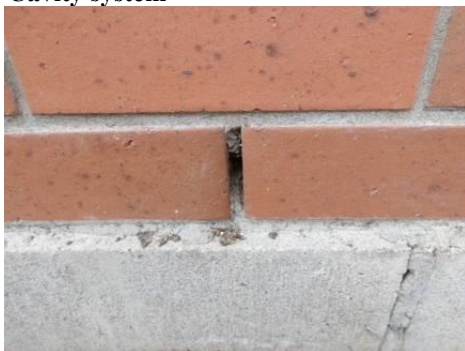
Note: There is no air gap between the bottom of the timber cladding and the brick cladding (this is consistent with methods used at the time of construction); therefore, there is potential for moisture to be drawn in via capillary action.

**No air gap**

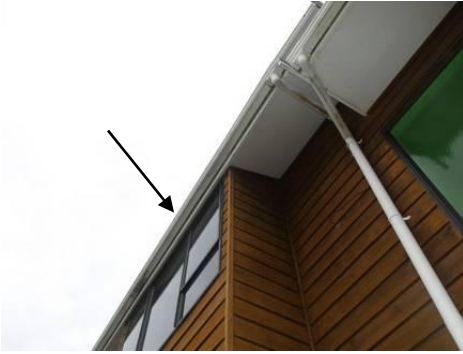
Roof flashings appear to be well installed, suitably fixed and sealed appropriately in accordance with good trade practice. NOTE: Kick-out flashings have not been installed – this was not a requirement at the time of construction. Please ensure roof-to-wall junctions remain well sealed as this is a critical junction.

**No kick-out flashings - Keep roof-to-wall junctions well sealed**

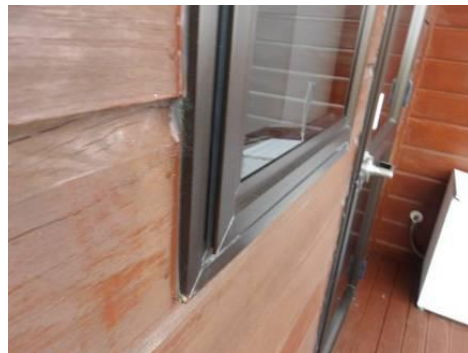
Note: There is a door off the lower bedroom on the southern elevation which opens from a height – this must be kept permanently and securely closed.

**Door from a height**

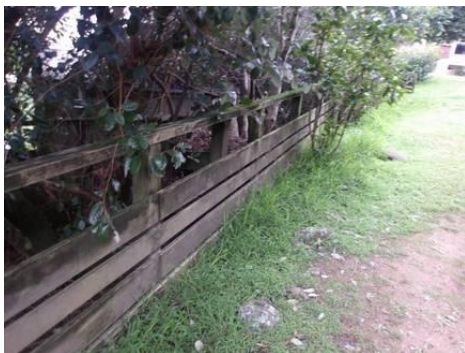
Note: There has been a repair to the retaining wall by the front of the dwelling – the works appear to have completed to a satisfactory standard.

**Repair**

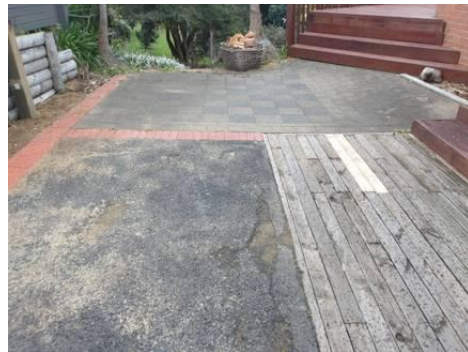
Areas to Note: The drainage is currently blocked, and the outlet is expelling directly onto the ground.

**Expelling onto the ground**

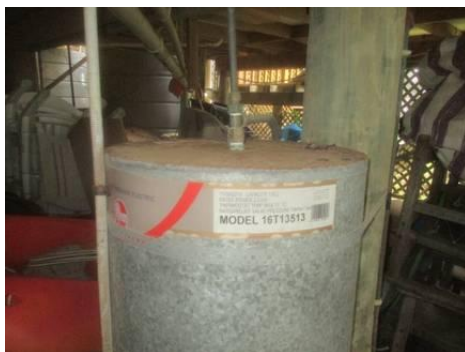
Area to Note: The smaller, Low pressure unit has rust developing – please monitor.

**Rust**

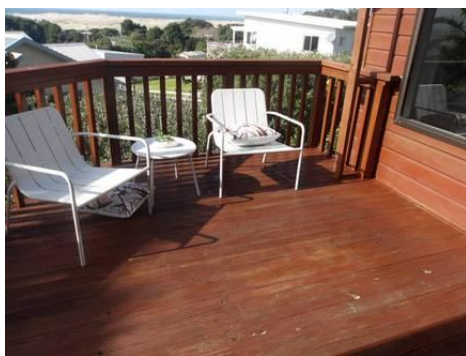
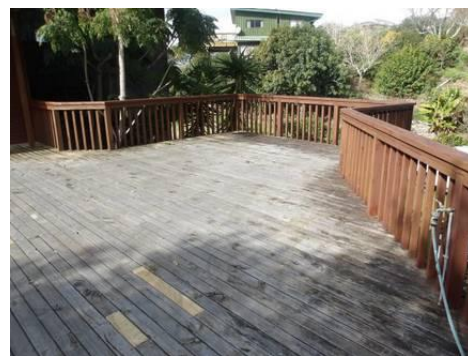
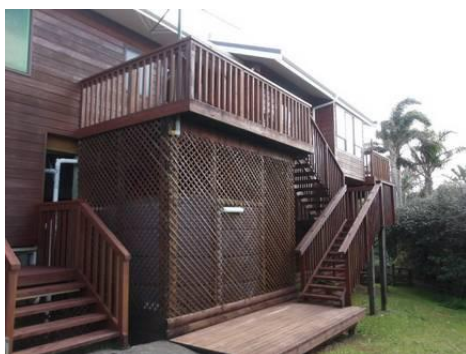
NOTE: The decking has been built up against the cladding with no moisture break – this is consistent with methods used at the time of construction – current building code requires a 12mm gap to ensure moisture cannot become trapped.

NOTE: The height of the handrails are less than 1m, but would have been acceptable at the time of construction. However, as the building code has changed since the construction, should the handrails be altered or replaced as part of general maintenance, then the handrail would be required to meet the current building code, particularly; - the top rail needs to be a minimum of 1m from the deck, with vertical balusters and spacings no greater than 100mm. (this also applies to the internal stairs balustrade).

**No capillary break**

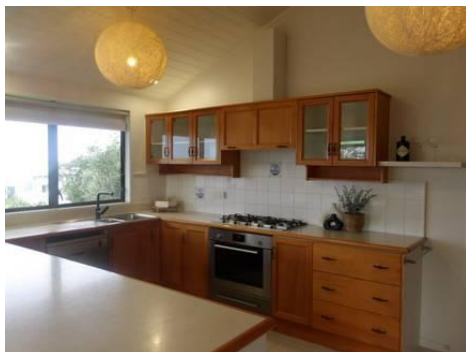
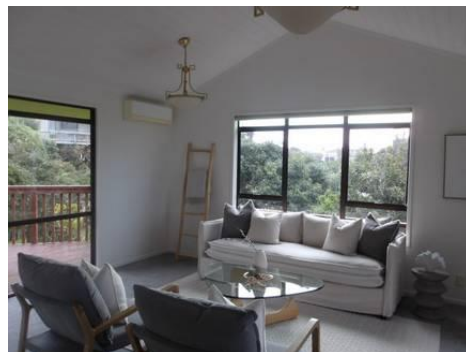
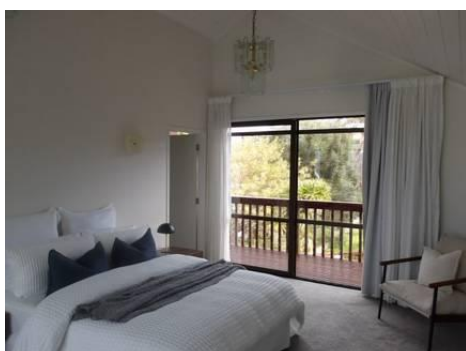
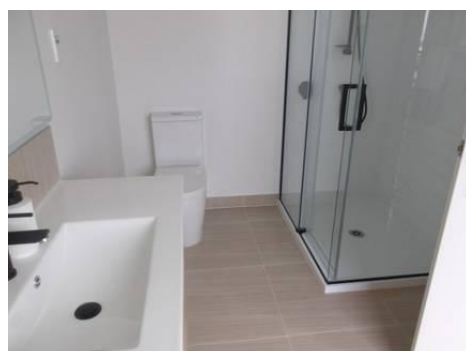
The interior to the dwelling is in very good condition throughout, having been well maintained to date.

The master ensuite is in excellent condition. Lower bathrooms are in very good condition. The kitchen benchtops and units are in average condition.

Light fittings, both surface mounted and recessed, are in good condition and functioning well.

Flooring consists of timber laminate, vinyl, tiles and carpet. Flooring is generally in excellent/ good condition.
