## PROPERTY CHECK EXPRESS REPORT

| <b>Job Number</b> | 54378 |
| <b>Property Inspected</b> | 6/28 Beveridge Street, Christchurch |
| <b>Inspection Date</b> | 10 April 2026 |

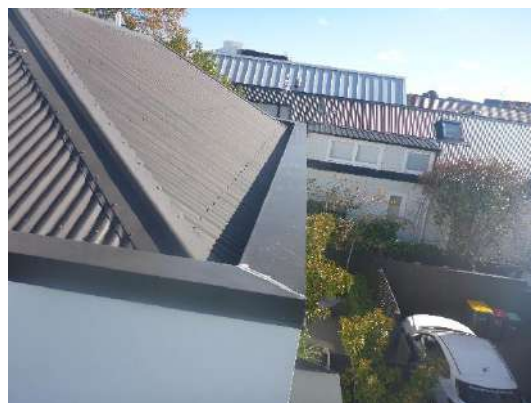
We identified what appears to be a patch to the metal gutter on the south elevation with the remote camera on the pole. We could not determine if this could be prone to leaking or not as that would require a close physical inspection using access equipment. However, there were no clear signs of issues with the patch and such repairs are common in butyl rubber.

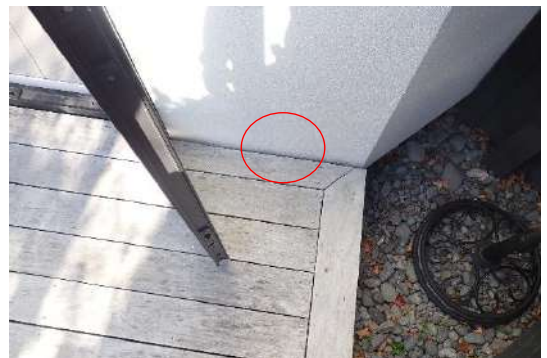
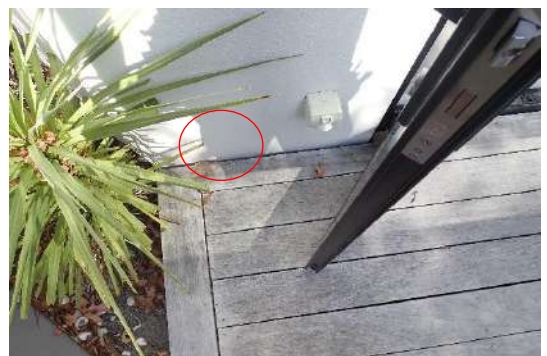
There are no doorstops installed to the double doors off the kitchen area. It is recommended they are installed to prevent damage to this area.

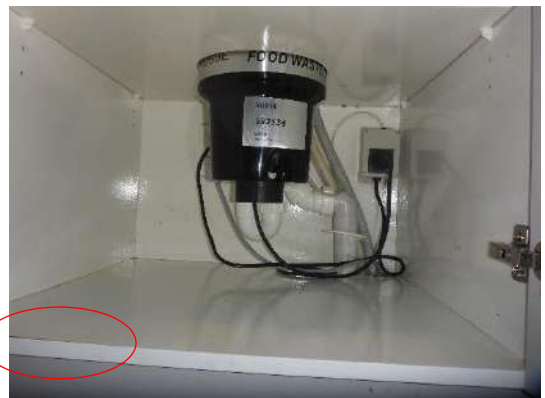
There is minor damage to the units below the kitchen sink from previous leaks and repairs to the damaged joinery may be considered.

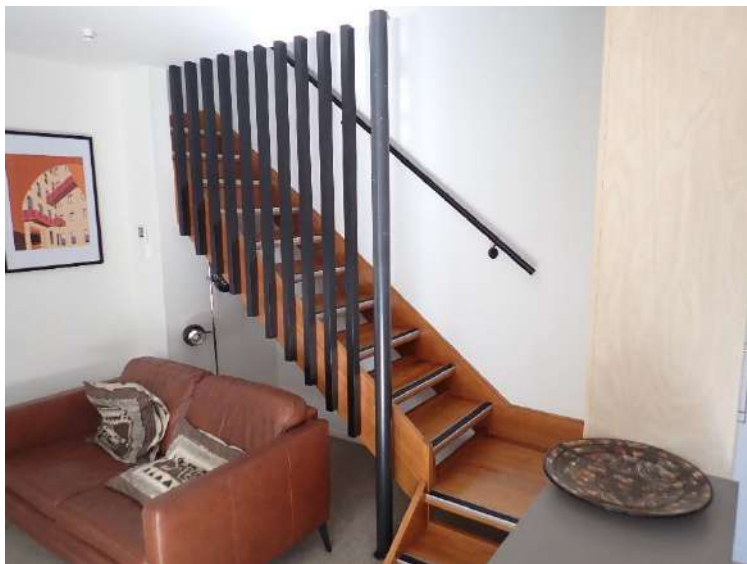
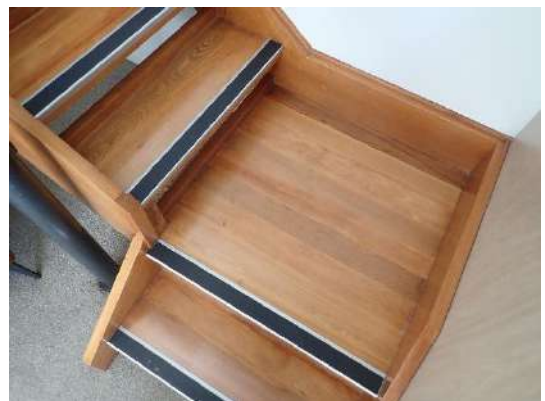
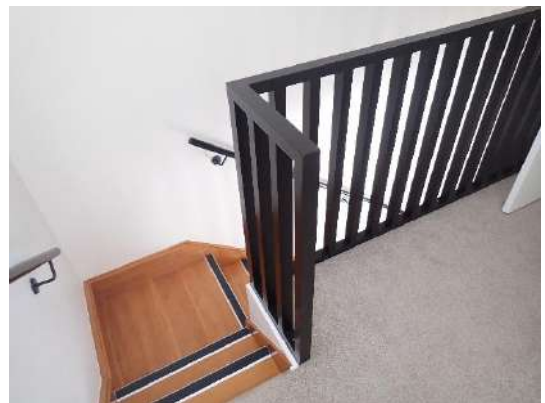
## STAIRS

No significant defects identified.

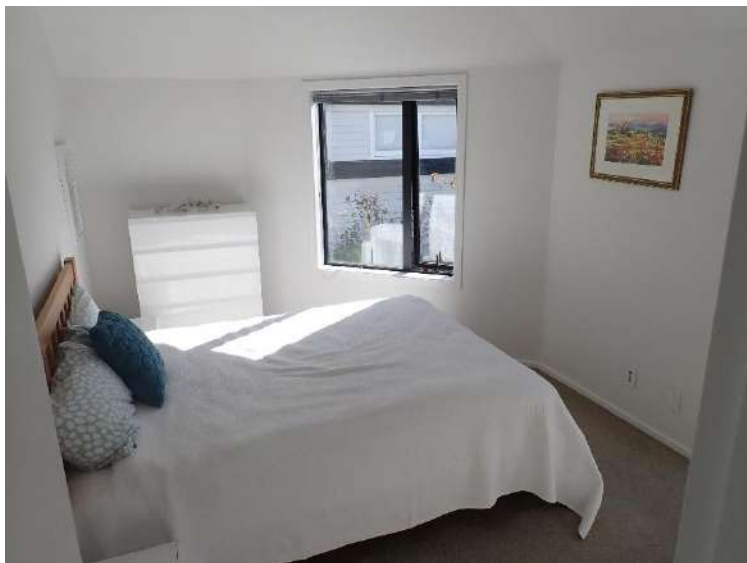
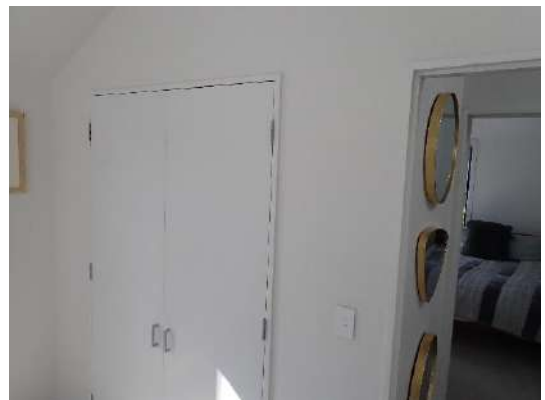
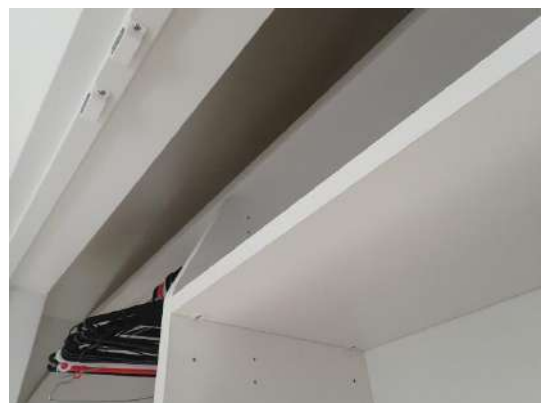
## BEDROOM 1

No significant defects identified.

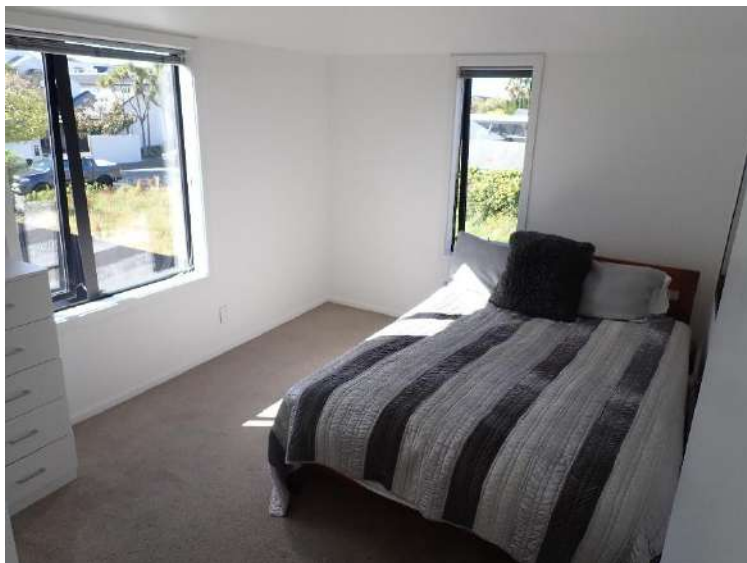
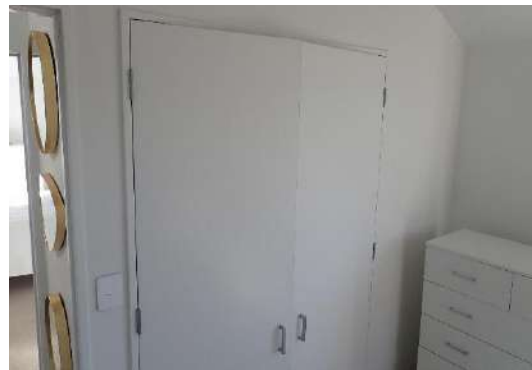
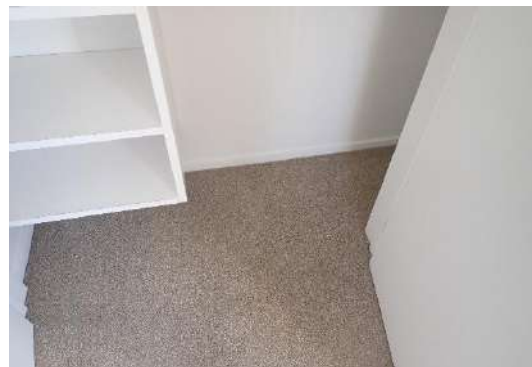
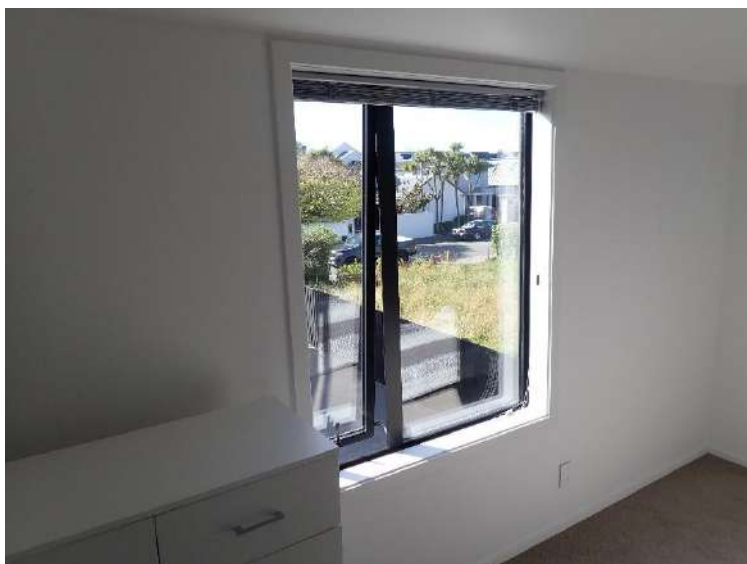
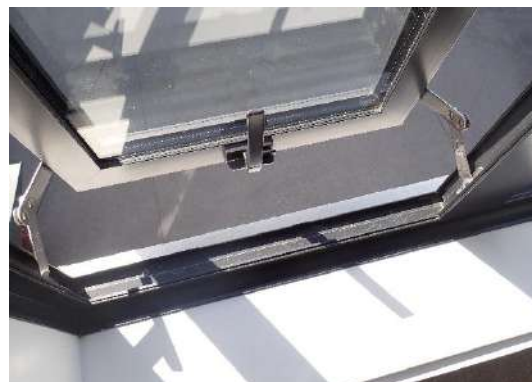
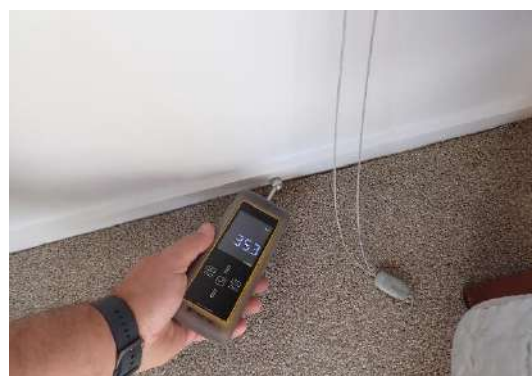
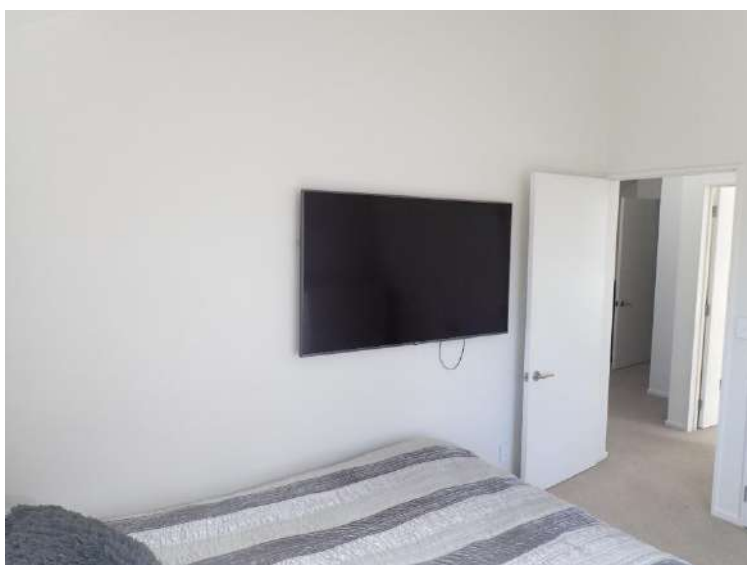
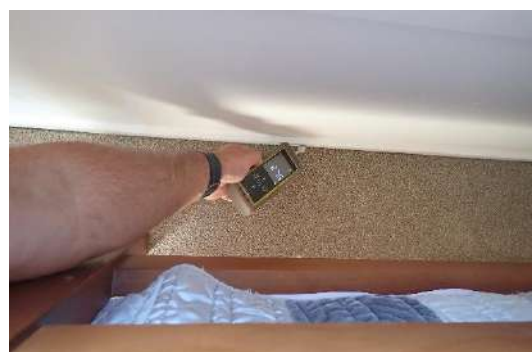
## BEDROOM 2

No significant defects identified.

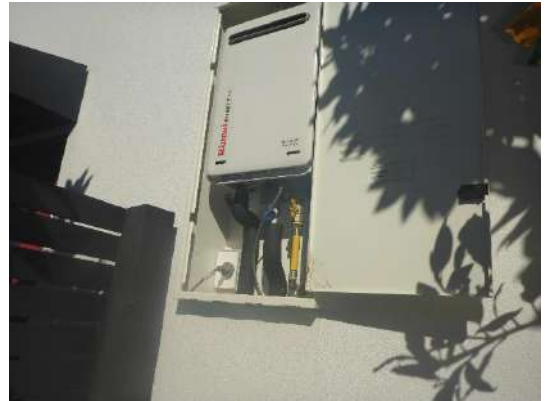
**HOT WATER SUPPLY****Gas water heater - North elevation**

No significant defects identified.

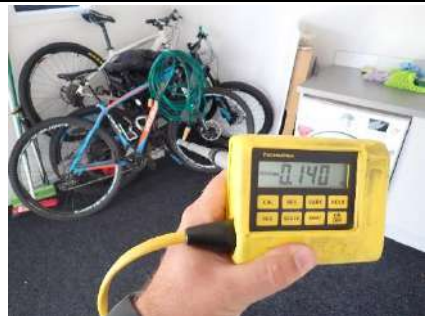
| Description | Locations | Photographs |
|---|---|---|
| Overall Variation Across Floor<br><br>(note: some displayed readings may not match the readings provided due to the adjustments made for differing floor covering thicknesses and steps in floor levels) | Lowest reading:<br>Garage (-26mm) | |

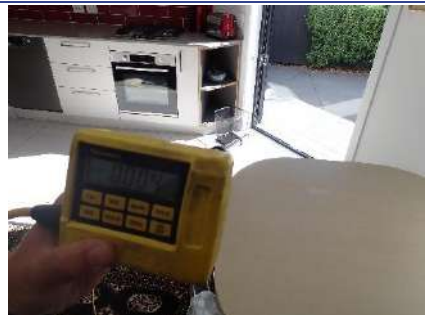
| Description | Locations | Photographs |
|---|---|---|
| | Highest reading:<br>Kitchen (+4mm) | |

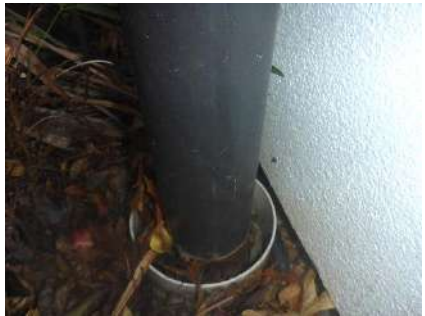
| | Comments | Photographs |
|---|---|---|
| Stormwater System | There are no visual signs of stormwater blockages at the time of inspection. | |

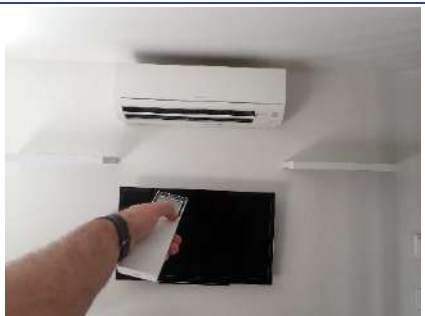
| | Comments | Photographs |
|---|---|---|
| Heating | Heat pump located in the dining area. No significant faults identified. | |

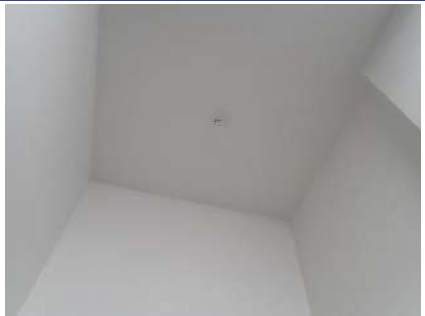
| | Comments | Photographs |
|---|---|---|
| Smoke Detectors | Smoke detectors were located in the compliant locations. | |
