## PROPERTY CHECK WEATHERTIGHTNESS REPORT

| <b>Property Inspected</b> | 6-28 Beveridge Street, Christchurch |
| <b>Inspection Date</b> | 4 June 2026 |

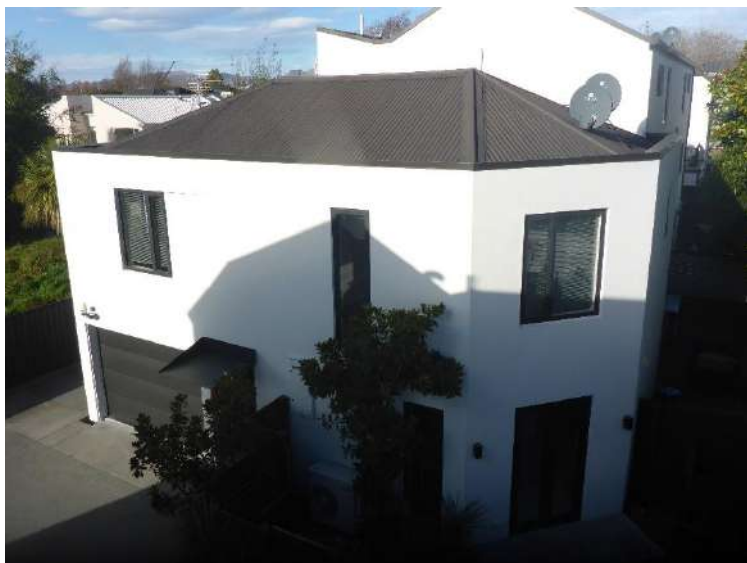
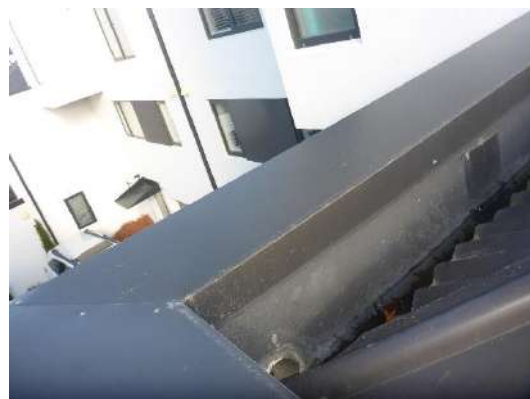
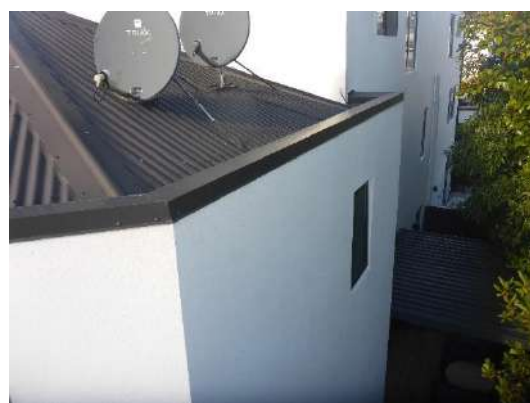
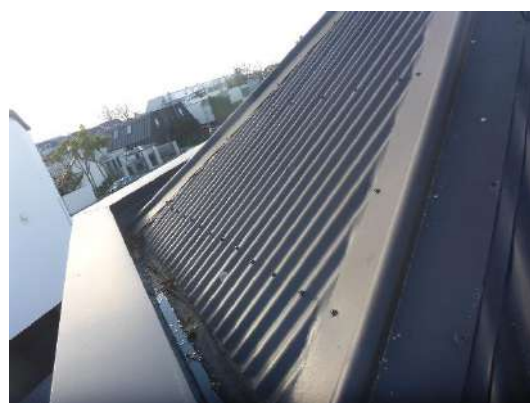
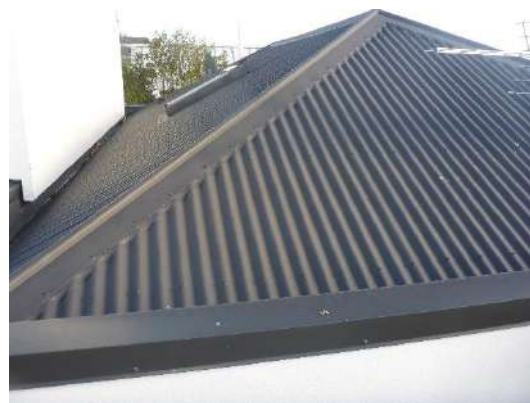
#### Pre-painted profiled metal

The inspection was carried out via a remote camera mounted on a pole and operated from the ground. There are limitations with this method that restrict the inspection to what could be seen via the camera video footage.

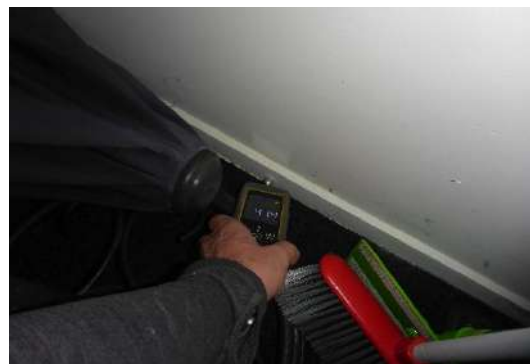
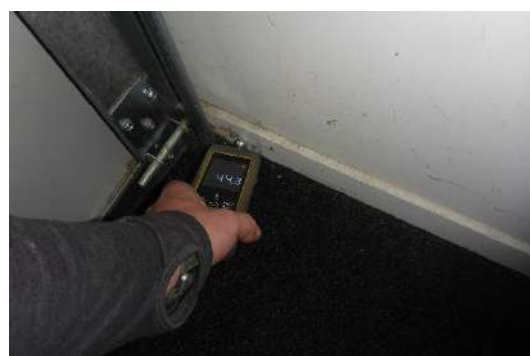
### Moisture test results

Normal readings returned from moisture scanner.
