# PRE-SALE BUILDING INSPECTION REPORT

for: Hamish Nimmo C/ Estate of L.Tod

15 Pratt Street  
Waikouaiti, Otago  
9510 New Zealand

Inspected by: Nathan Farrell | Inspection Date: 15 Jun 2026 | Ph: 027 4556106

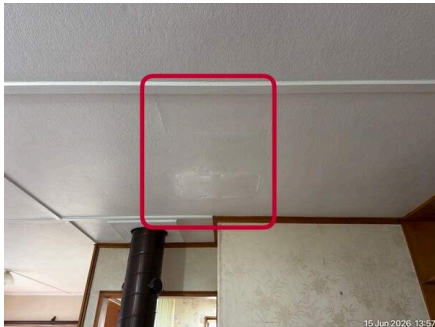
#16: Patching in the living room.

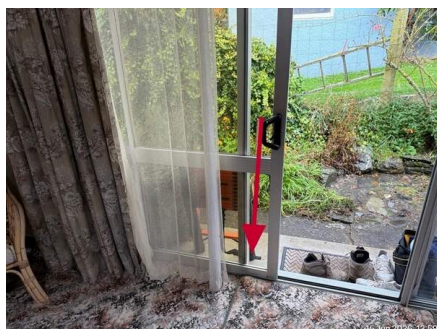
#29: Rollers require maintenance.

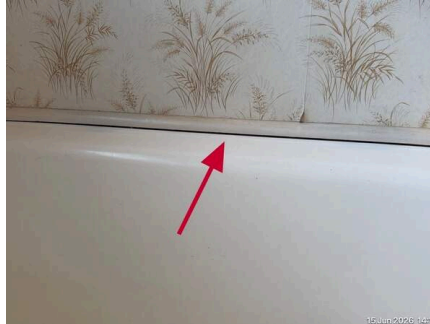
| <b>Details:</b> | - The bath to wall junction is not sealed, the installation of a sealant would help reduce potential moisture damage to the wall linings around the bath and the flooring below the bath. |

#50: Gaps to the bath trim junction.

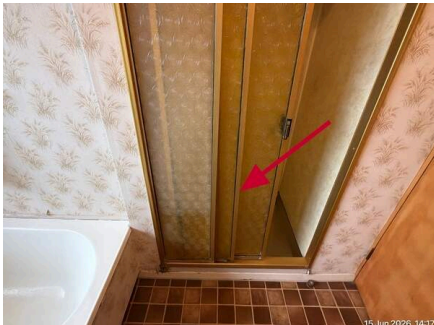
#52: Shower doors are broken.

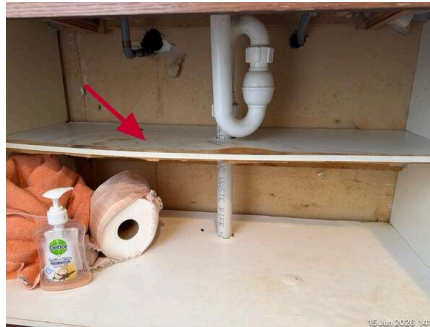
#56

- A leak was detected to the waste pipe below the basin. Engage a licensed plumber for repairs.  
Action Required

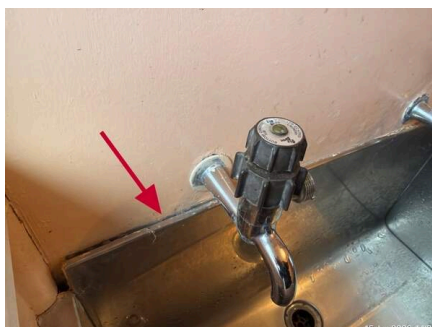
**Details:** - The tub is not sealed at the wall junction, the installation of sealant would help prevent the potential deterioration of the cabinetry and wall lining behind.  
**Rating:** Minor Maintenance

#63: Tub is not sealed to the wall.

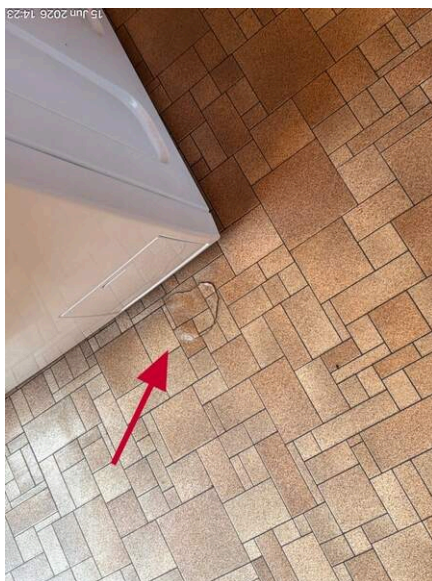
#65: Tear to the flooring.

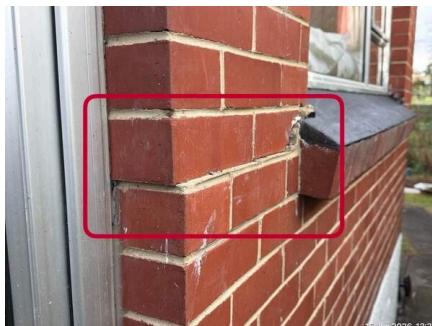
- A large number of cracks were sighted in the brick cladding. This is a sign of movement and could lead to further cracking. An engineer is required to assess and determine the cause and the best repair solution.

#80: Extensive movement visible to the western face.

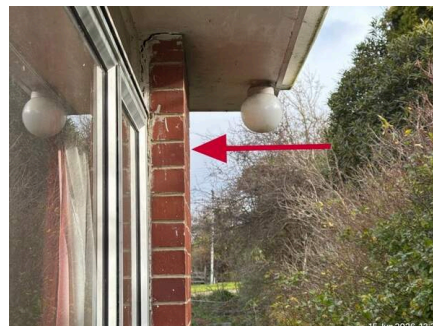
#81: Vertical movement to the brickwork visible at the SW corner.

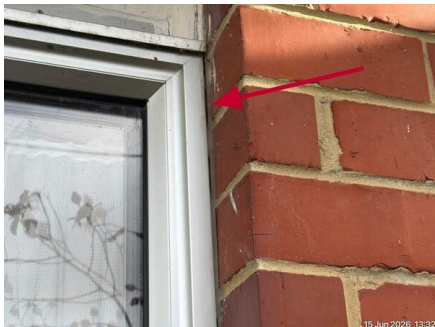
#93: Gaps in the sealant around the windows.

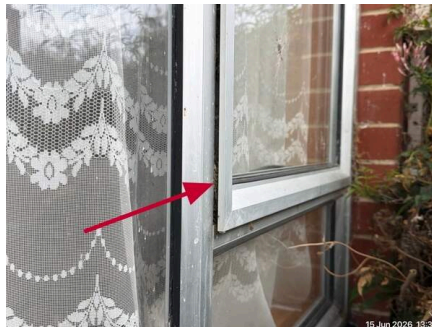
#94: Gaps around the sashes.

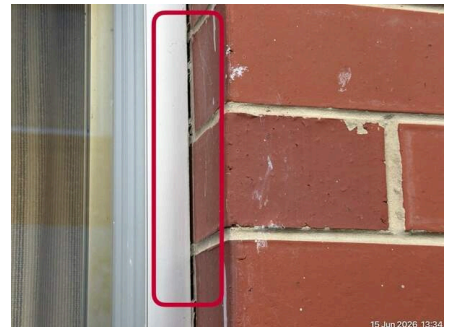
#95: Gaps at the joinery to cladding junction.

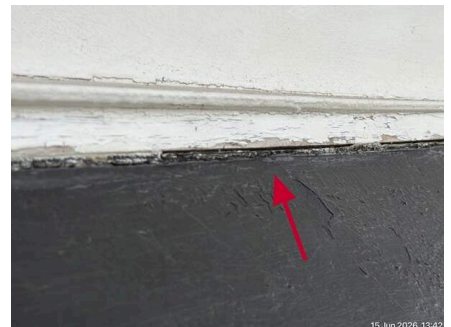
#98: Gaps to the sill south face.

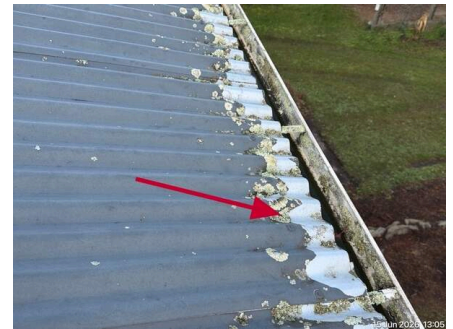
#111: Coating delamination due to moss and lichen.

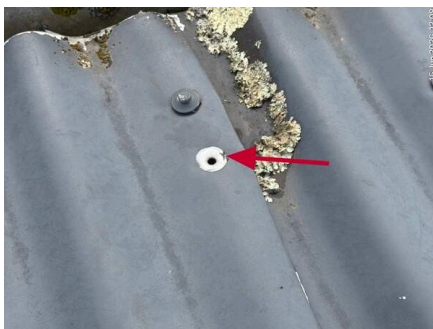
#112: Unsealed fixing penetrations in various locations.

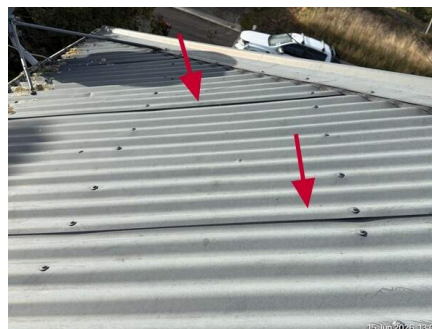
#113: Sheet edge lifting visible.

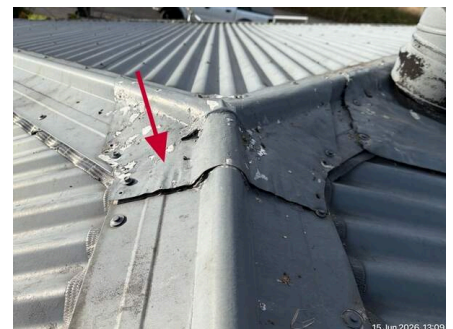
#114: Older hip cap with multiple old penetration holes visible.

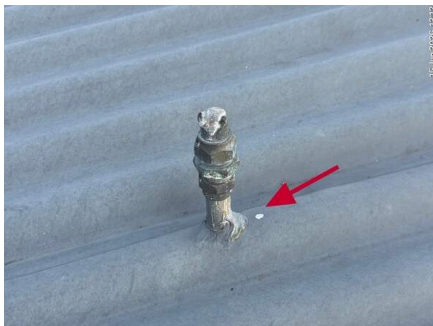
- The pipe penetration located below has no flashing detail in place. While this was sealed at the roof junction this is a risk area that could break down which could cause water ingress in the roof cavity. A licensed roofer is required to assess and determine the best repair solution.

#122: Poorly sealed penetration.

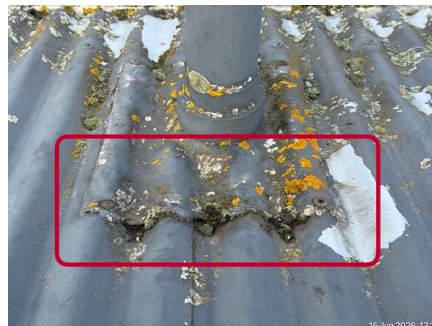
- Pipe penetration details:**
- Older-style roof penetration flashings were in place. These are getting of age and replacement needs to take place in the near future.

#123: Corrosion and gaps at the flashing junction.

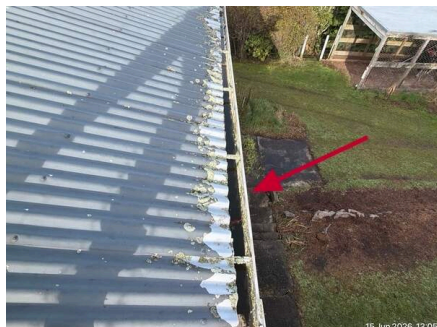
- The guttering located below is holding water as the gutter is falling away from the downpipe. This could cause the guttering to overflow under rain. Re-pitching the guttering to ensure it is pitched towards the downpipes would help prevent this. A licensed roofer/plumber should assess and complete.
- Vegetation build-up was sighted in some guttering. This could cause the guttering to block and potentially overflow under rain. The gutters should be clear to ensure water can flow to the downpipe and drain. An exterior cleaning specialist could complete this.

#124: South facing gutter is holding water.

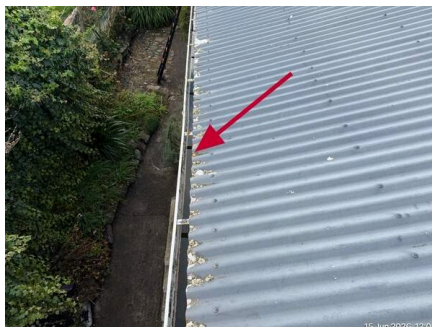
#125: West facing gutter is holding water.

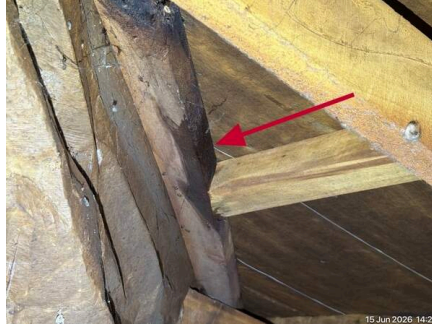
- Moisture staining was evident to the roof framing. As detailed in the roofing section of the report, external roof work will need to take place to prevent water ingress and deterioration of the timber framing. Refer to the roofing section for further details.

#139: Moisture staining to the framing visible.

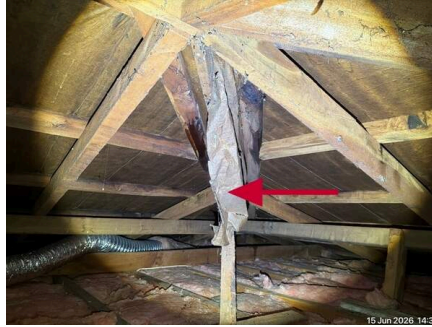
**Details:** - Tears and holes were sighted in the roofing paper, repairs to the roofing paper can take place from inside the roof cavity to ensure it would perform if required.  
**Rating:** Minor Maintenance

#146: Sagging paper and gaps visible.

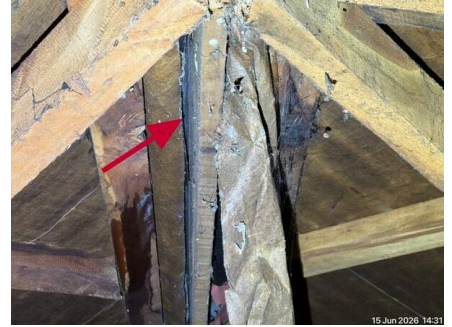
#147: Sagging paper and gaps visible.

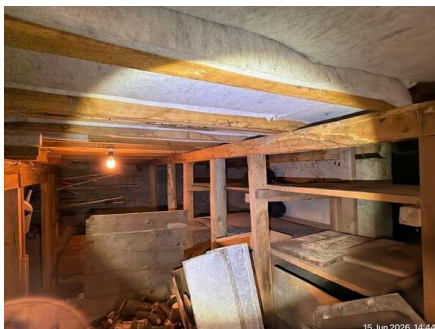
- Pile Foundation Details:** - Some of the piles sighted are leaning slightly, advice from a specialist piling company should be sought to determine if any remedial works are required.

#162: Leaning piles visible.

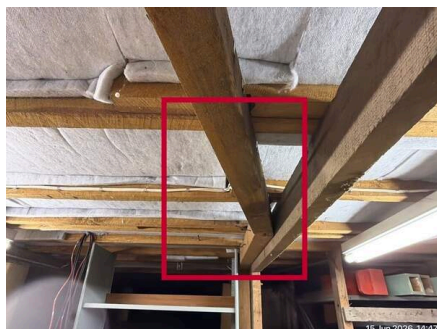
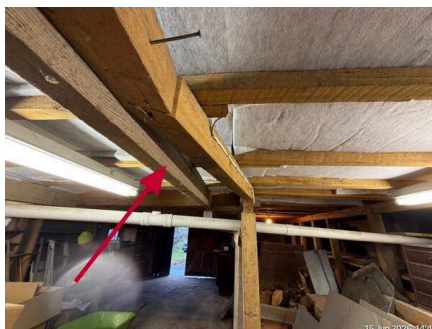
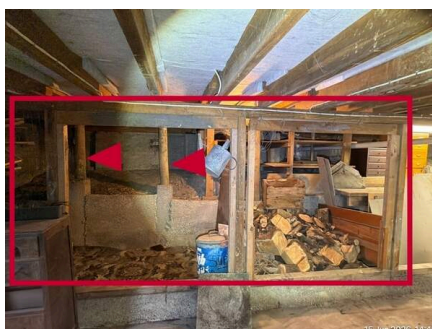
#167: Modifications and poorly supported bearers.

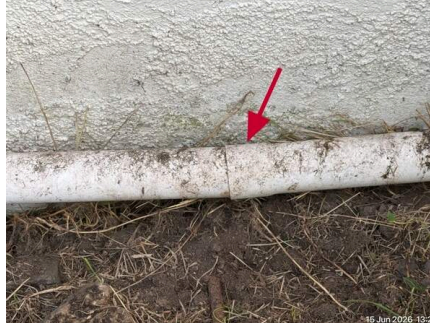
- The downpipe joint is unglued and loose. Engage a licensed plumber to secure the connection with the appropriate adhesive and install downpipe clips to secure the pipe to the dwelling exterior.

Minor Maintenance

#207: Loose downpipe join.

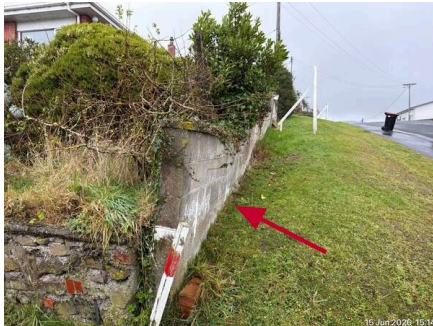
#239: Front masonry fence is on a lean.

- Movement was detected to the fencing. A builder should be engaged to assess and repair it to help prevent further movement.

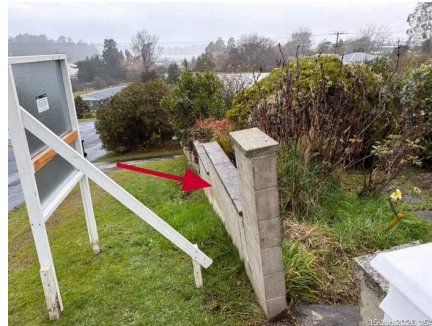
#240: Front masonry fence is on a lean.

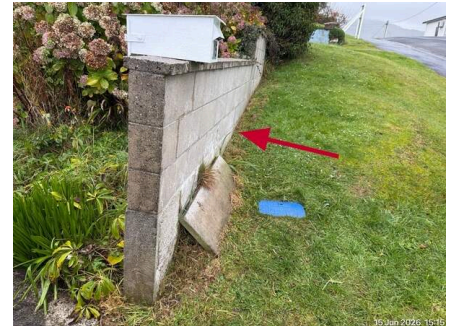
#241: Front masonry fence is on a lean.
