## RESIDENTIAL HOUSE INSPECTION COPY

18 Downing St  
Christchurch, Canterbury Region 8025

11/06/2026

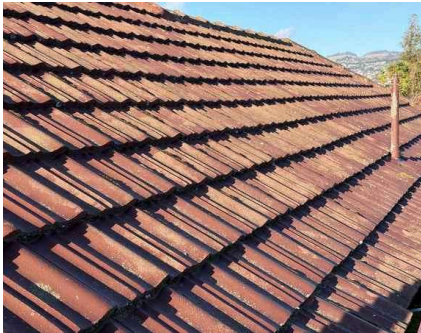
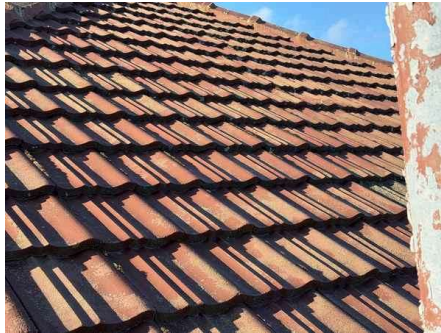
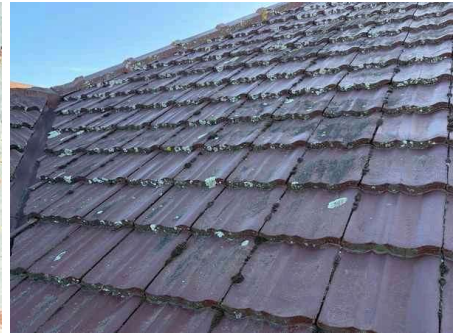
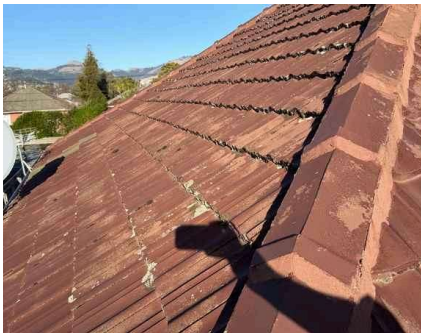
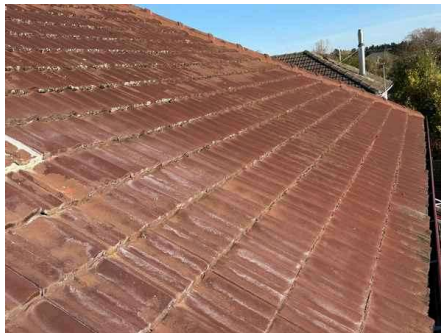
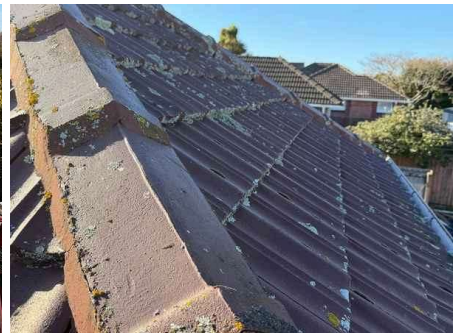
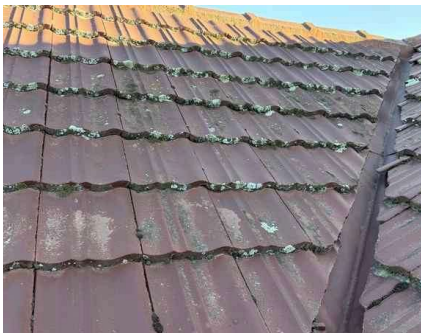
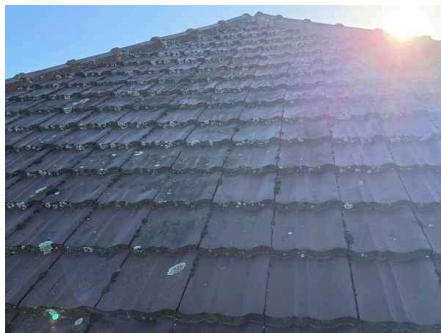
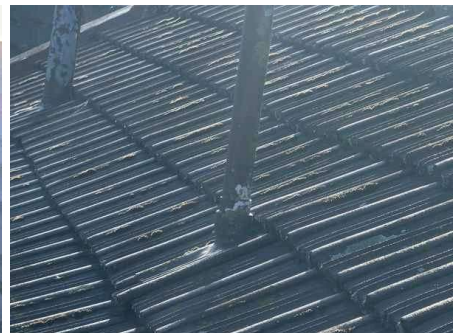
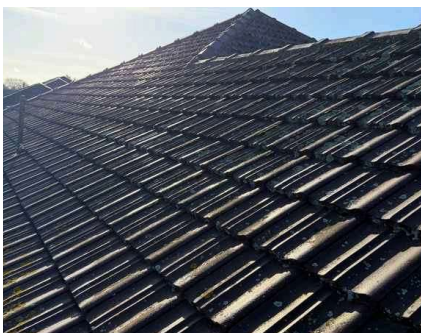
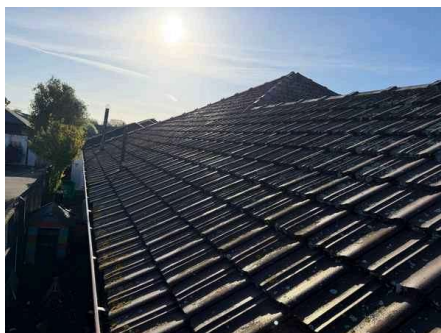
#### Roof System Images: Images Of The Roof System:

previous repairs noted to vent.

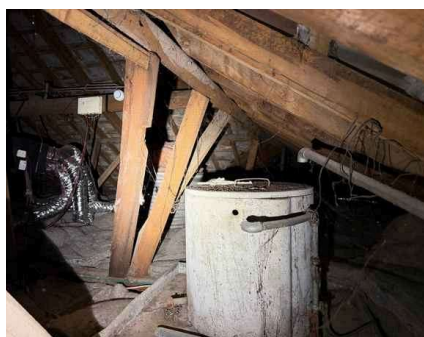
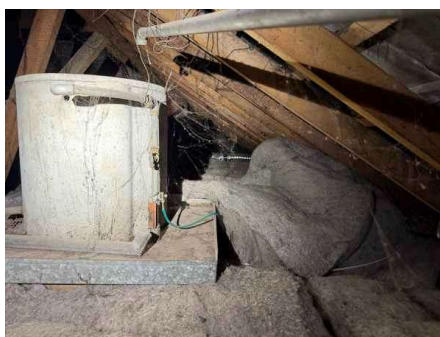
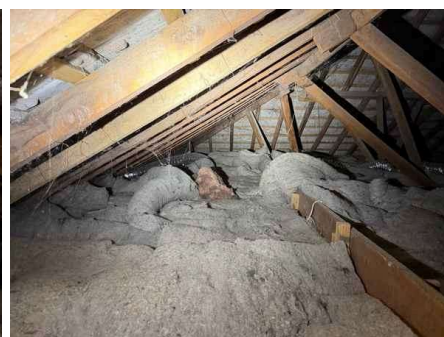
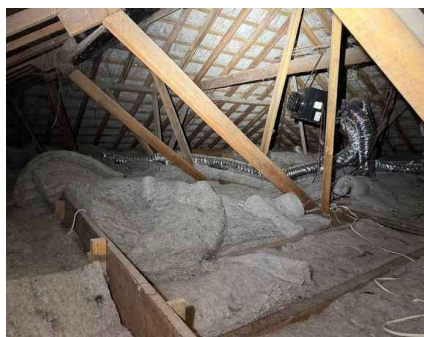
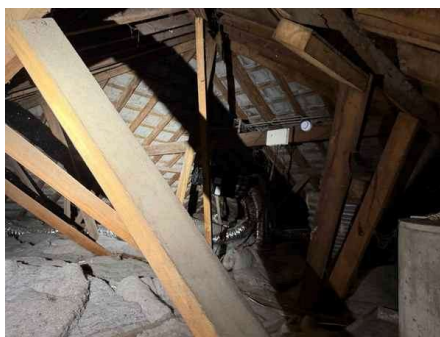
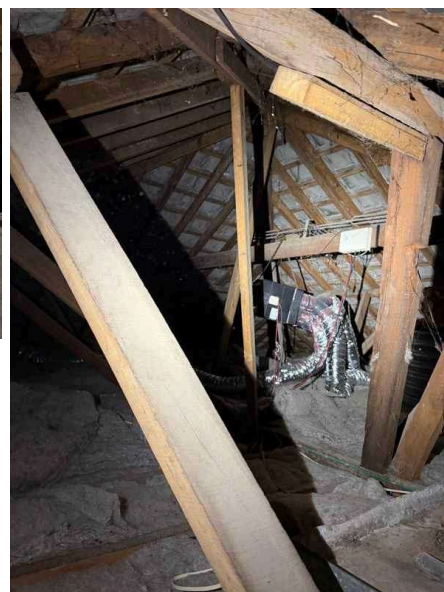
**Roof Space Images:: Images**

Roof underlay is a self supporting bitumen paper

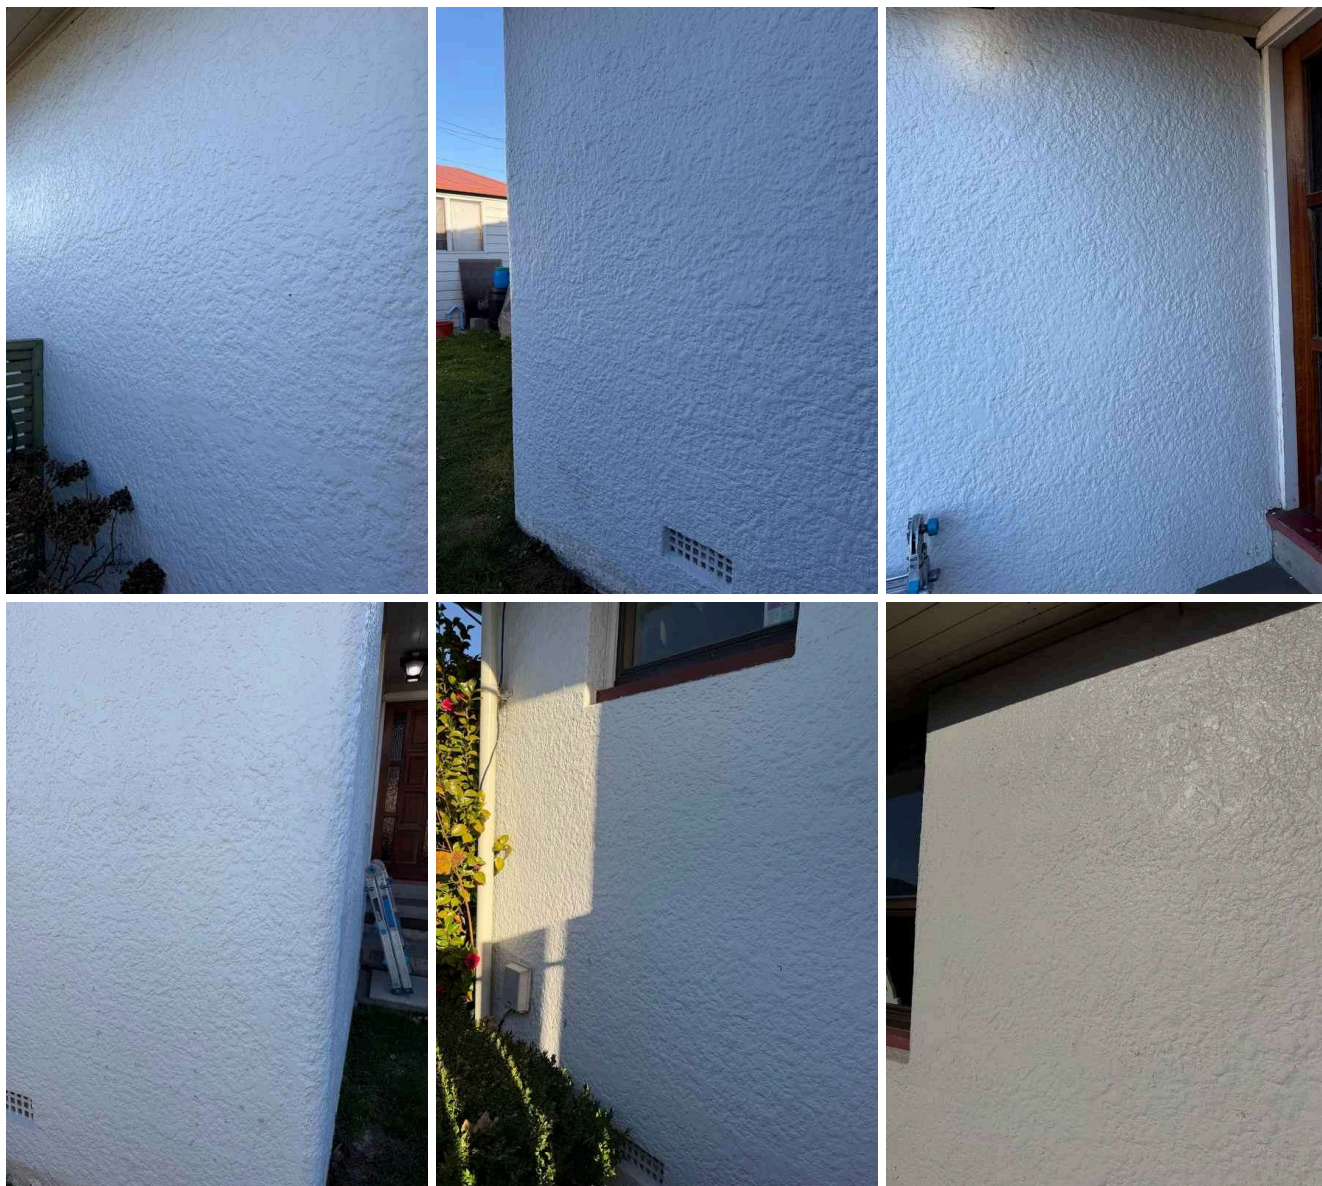
#### Exterior Cladding Images: Images

A plaster system has been applied over a presumed brick veneer, the cladding system is of an acceptable standard with no significant issues when inspected.

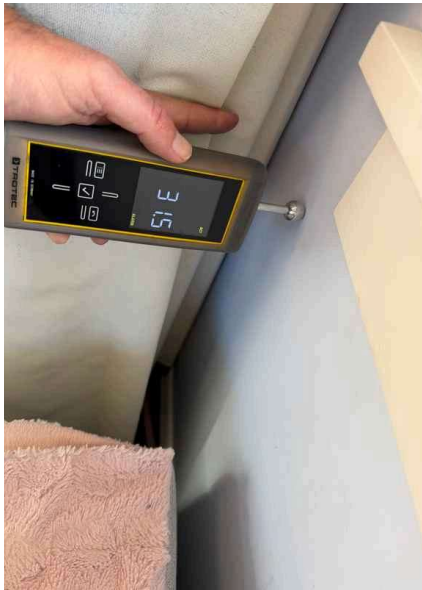
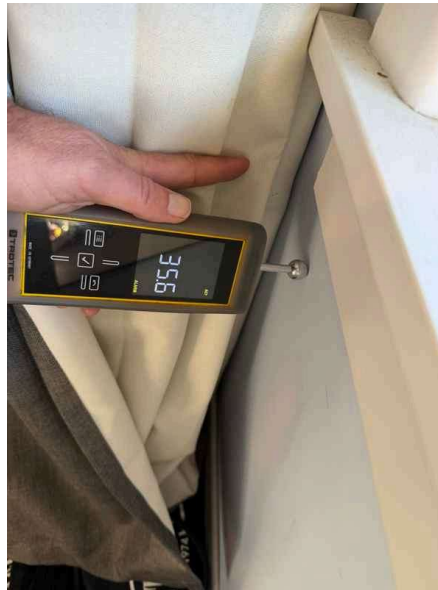
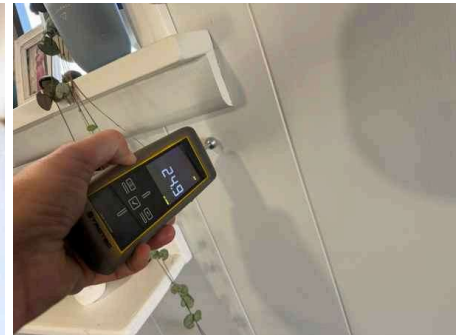
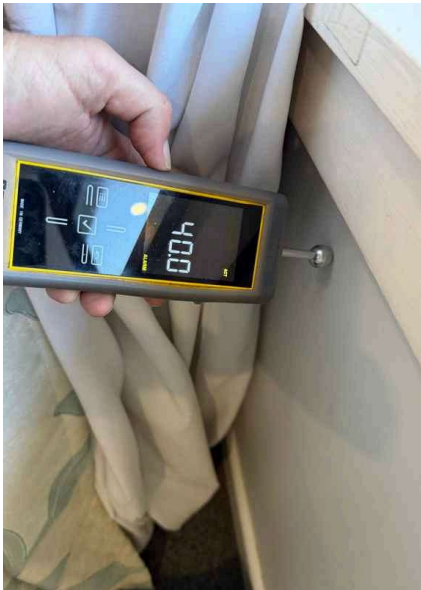
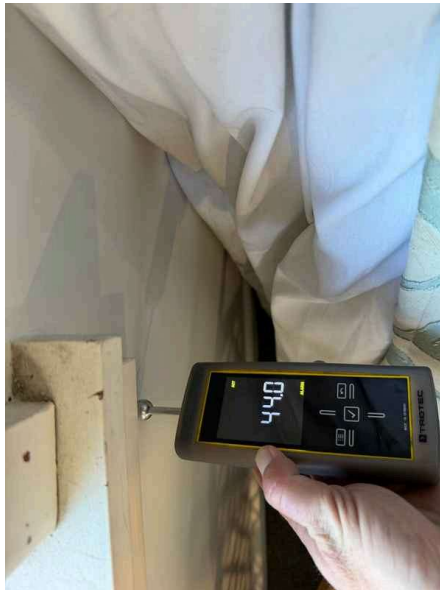
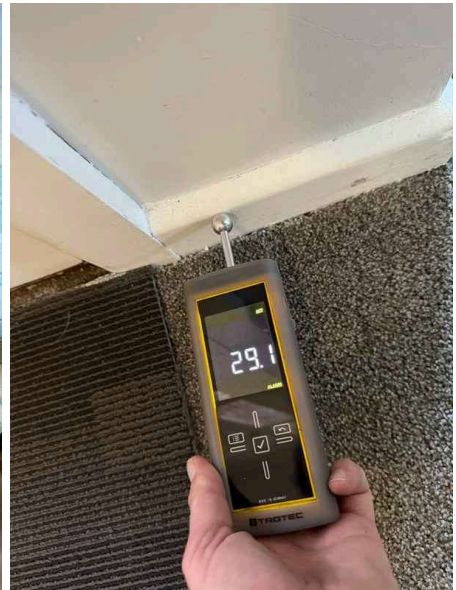
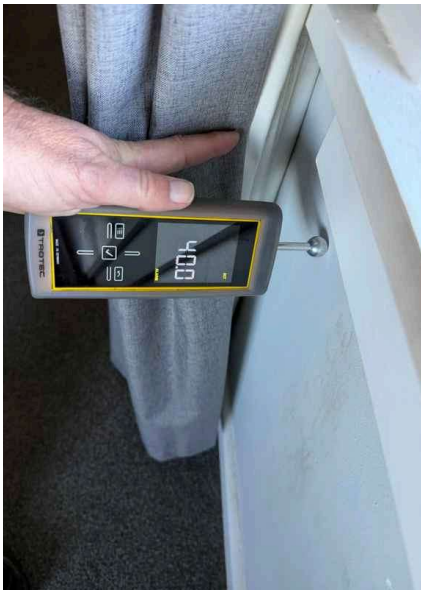
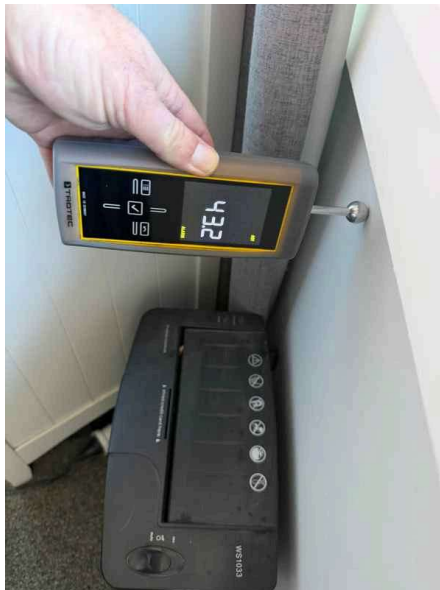
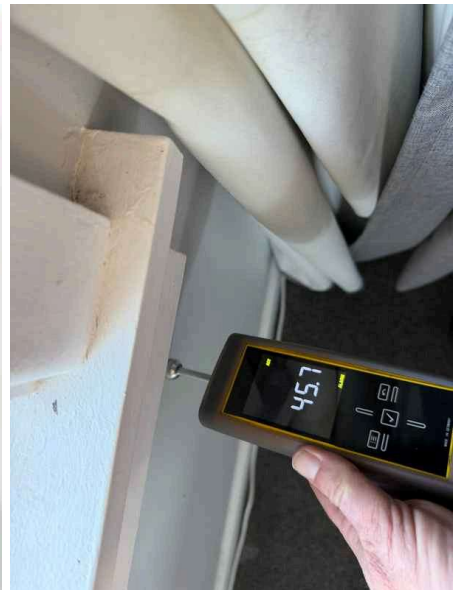
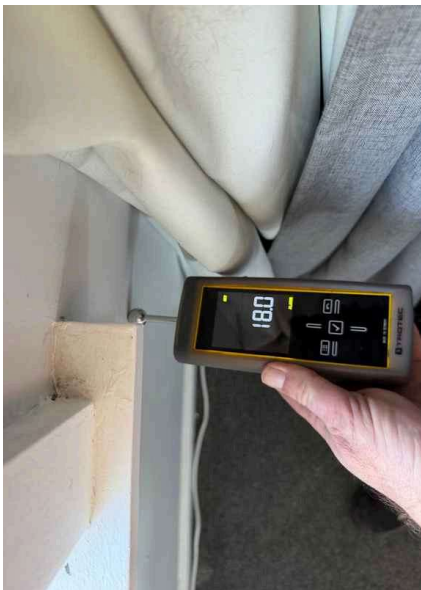
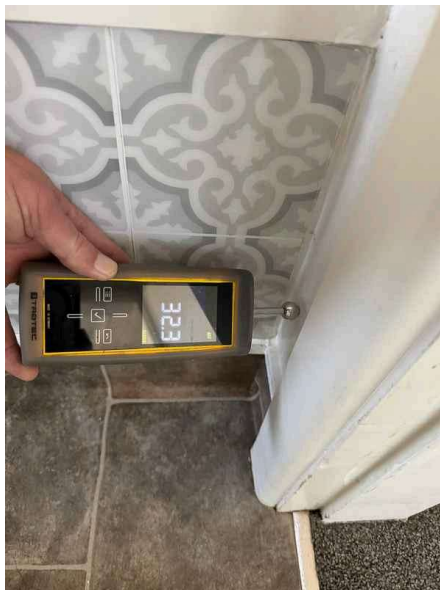
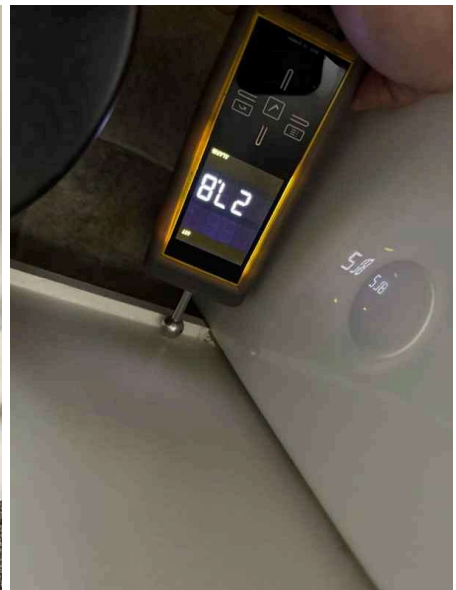
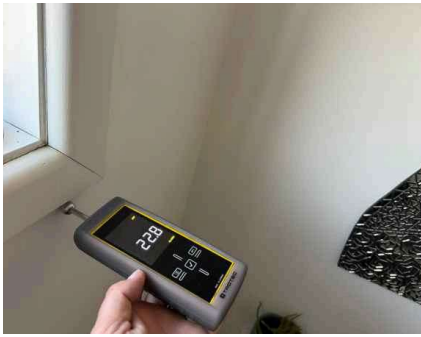
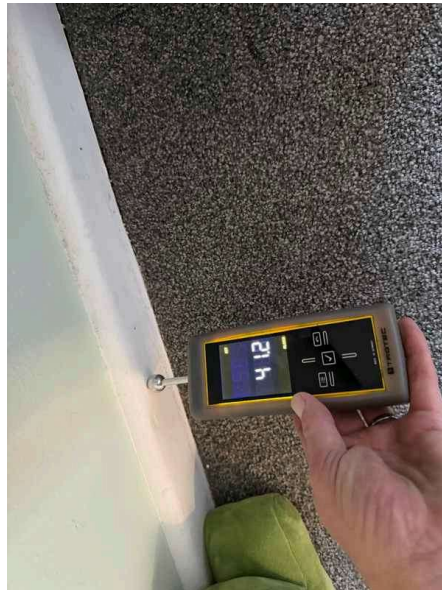
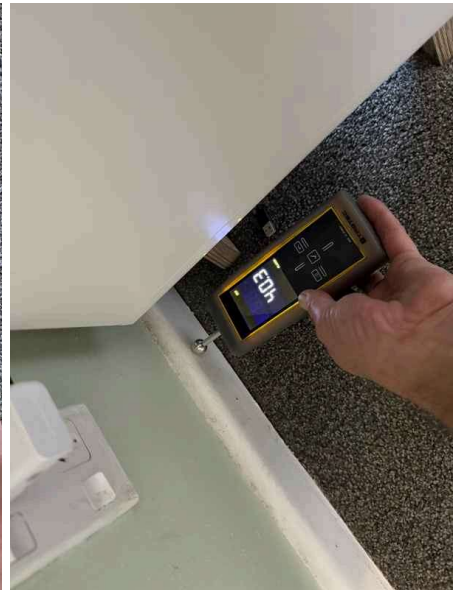
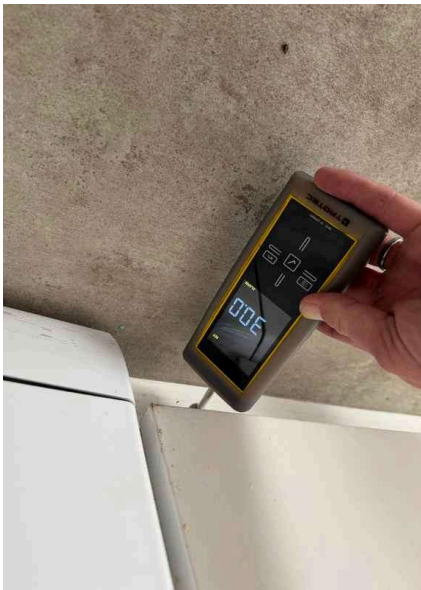
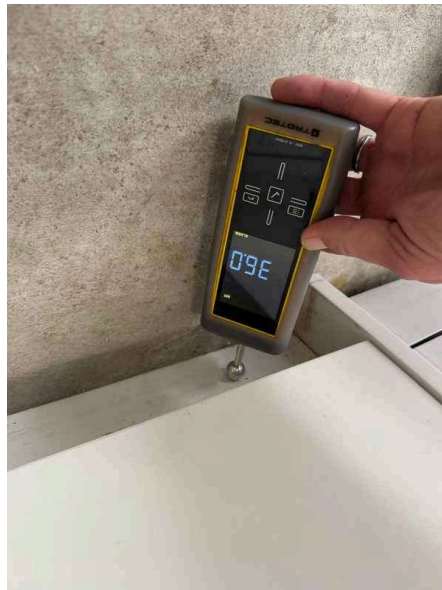
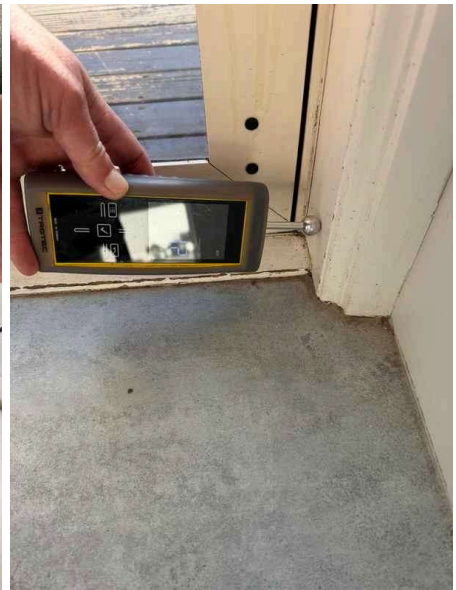
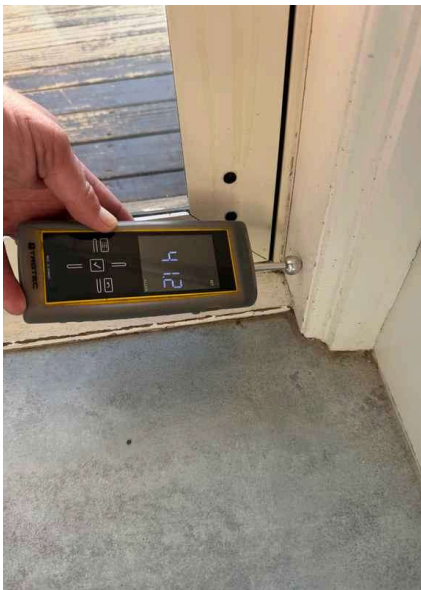
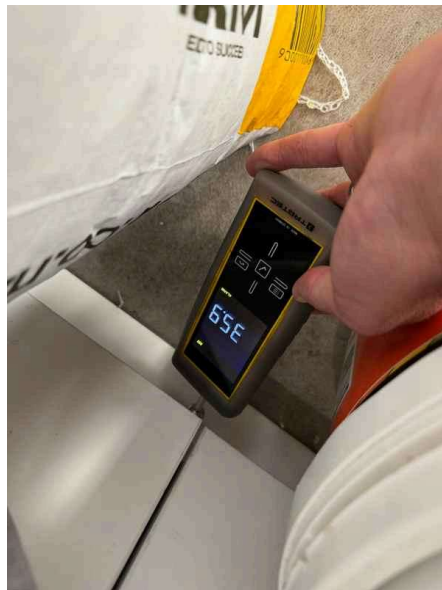
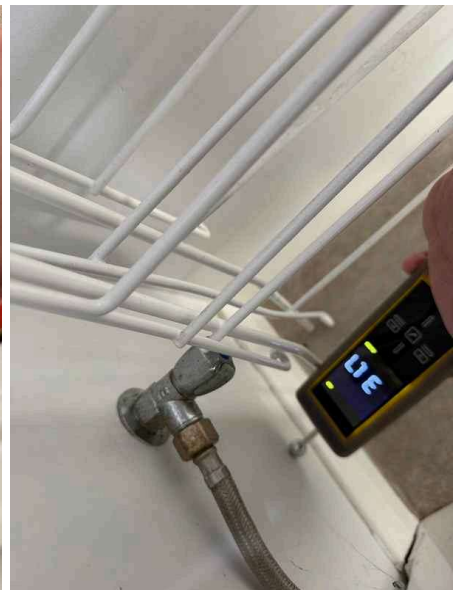
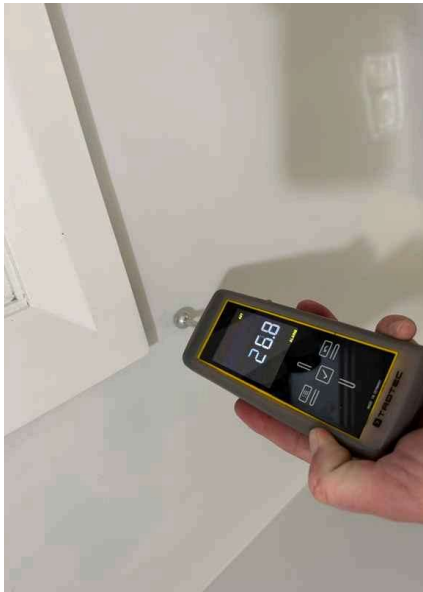
#### Moisture : Sample Of Readings

**Moisture : No elevated moisture levels were noted at the time of inspection.**

Photos are samples of readings taking around the dwelling. Instrument may be tilted to allow image to be taken.

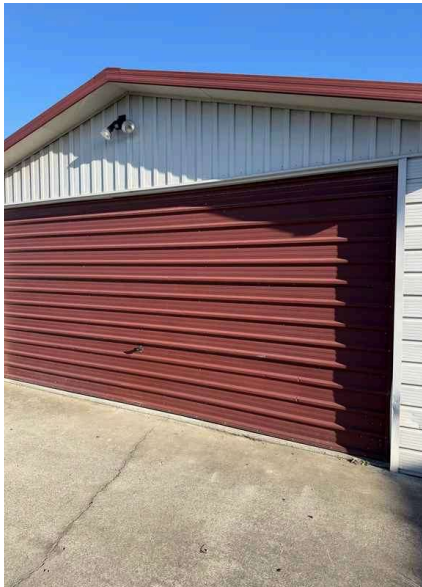
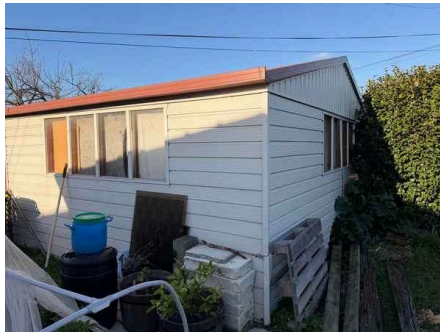
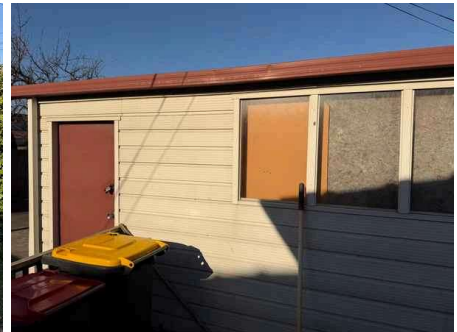
#### **Additional Structure Images: Images**

Consistent with its age and intended use with no significant issues noted at the time of inspection.

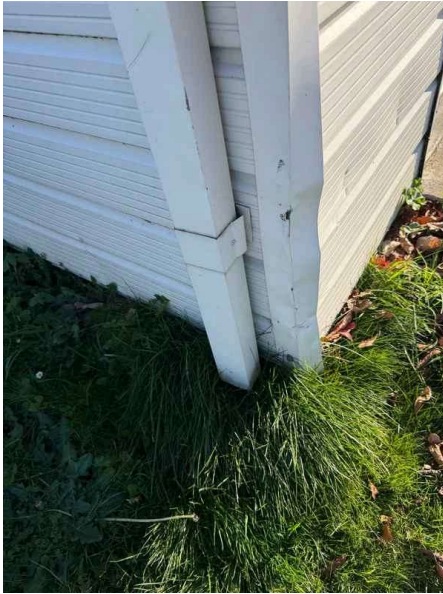
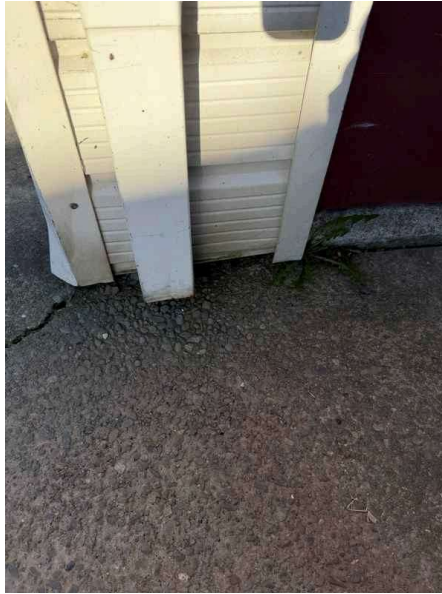
## 25.4.1 Defects Wall System

**IMPACT DAMAGE TO CLADDING NOTED**
