PRE-SALE BUILDING INSPECTION REPORT

for Gaylene Leadley

10 Rowanwood Close
Halswell, Christchurch
8025 New Zealand

Inspected by: Jordyn Ellis | Inspection Date: 15 Jan 2026 | Ph: 0210534077

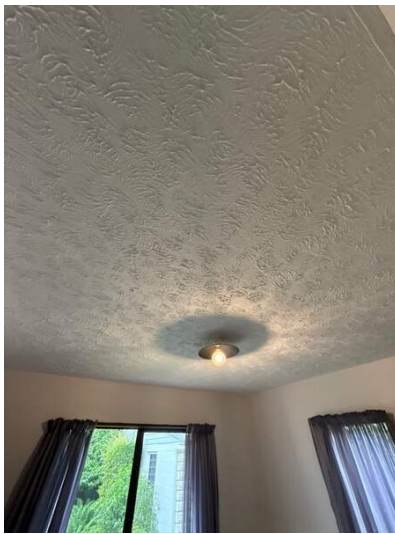
#15

- Textured ceiling linings were in place in the (location). Due to the age of the dwelling, there is a chance the textured coating could contain asbestos; this is unknown without lab testing. It is recommended the ceilings are kept well-maintained and sealed. Testing should take place prior to any remedial works that may disturb the coating. Caution is advised if these are to be disturbed.

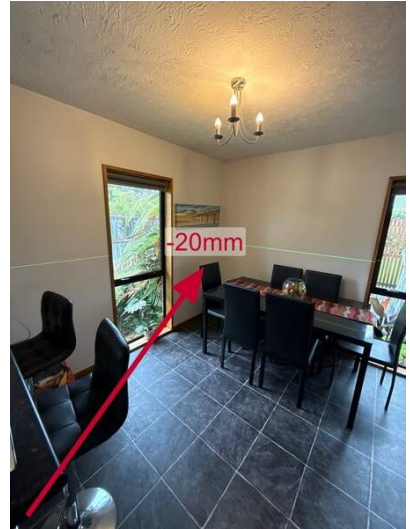
#20: -20mm - Southeastern corner

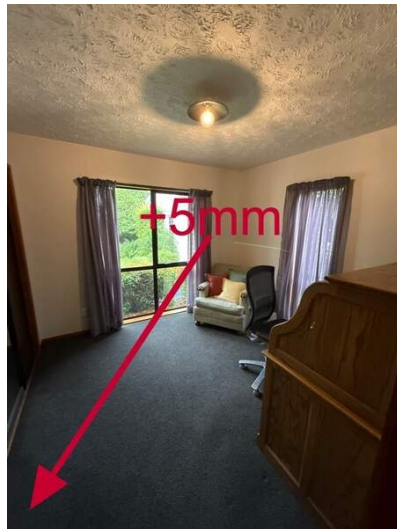
#22: +5mm - Northwestern corner

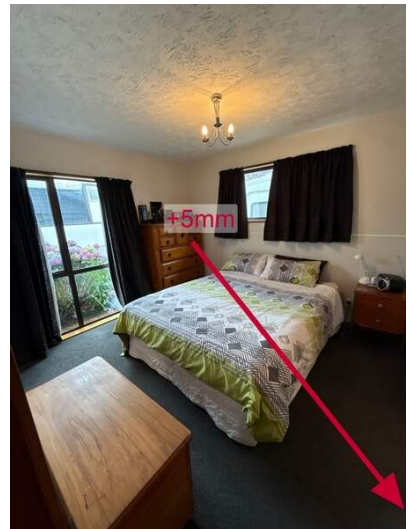
#23: +5mm - Northeastern corner

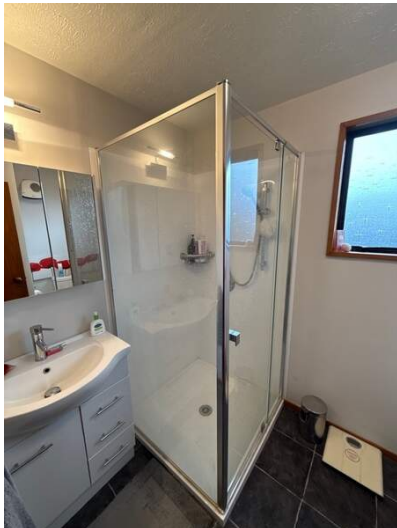
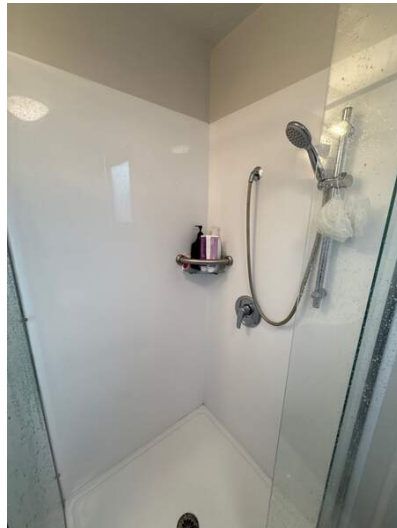
- First-floor shower - When the shower was spray tested, leaking was detected in the bottom right-hand corner of the unit. A tradesman shower installer is required to assess and repair the leak.

- When the shower was spray tested, leaking was detected in the bottom right-hand corner of the unit. A tradesman shower installer is required to assess and repair the leak.

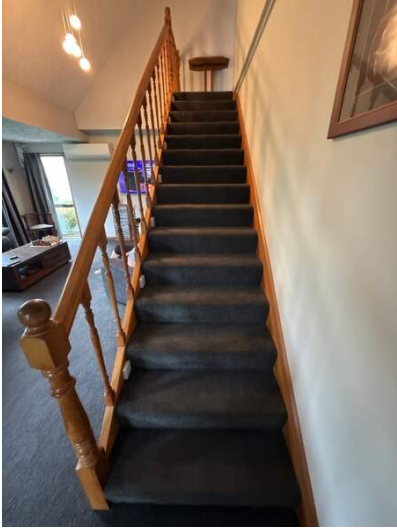
#55

The stairs were sufficiently rigid.

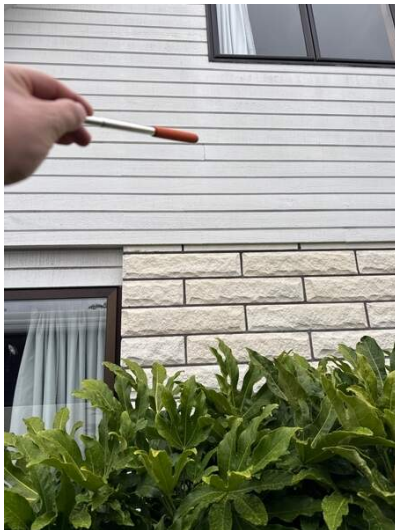
- Some weatherboard joints have opened; this can be very common. Sealing and painting the joints would help reduce the chance of moisture deterioration. Alternatively, the installation of soaker flashings would be a good long-term solution. This is an easy repair for a licensed builder.

#69: Weatherboard joints opening up - Northern elevation

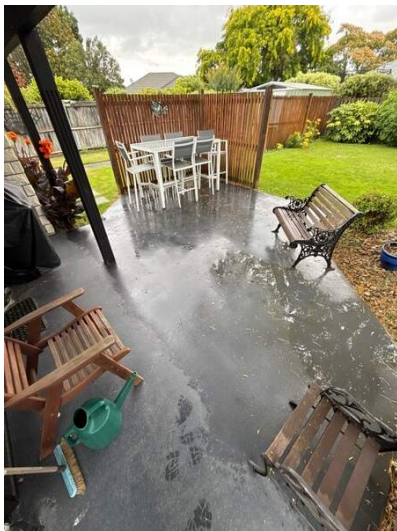
#80

- Cracks were sighted to the concrete patio from general settlement and movement. These appear superficial and can be filled as a repair strategy if required.

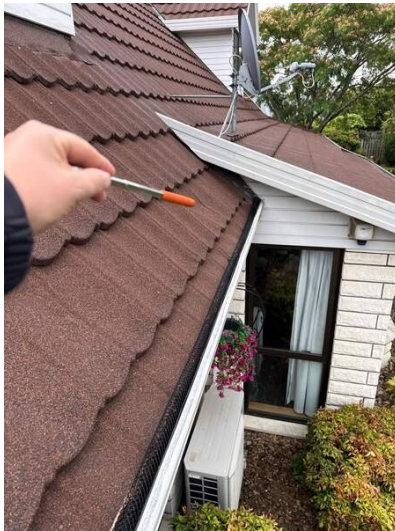
- Dented tiles were sighted, which can allow water to sit in the tiles and lead to rust deterioration and potential holes in the tiles. Monitor these for performance going forward.

#93: Tile dents - Western elevation

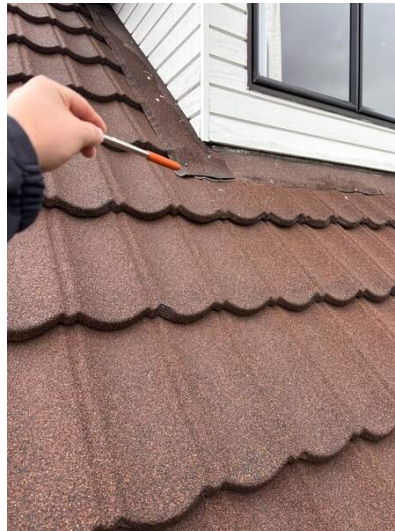
- Popped roofing nails were sighted in areas of the roof. I recommend the affected nails are replaced with a roofing screw and washers. This work can be carried out by a licensed roofing contractor.

#94: Popped nail - Western elevation

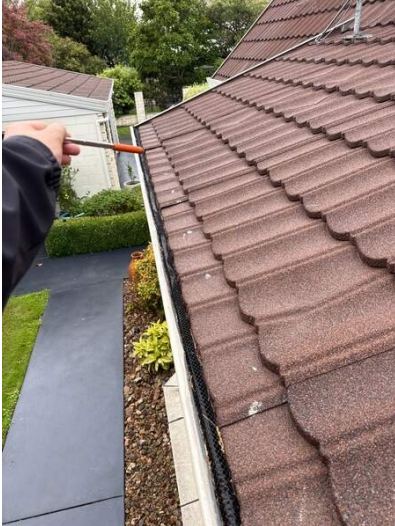
#96: Popped nails - Western elevation

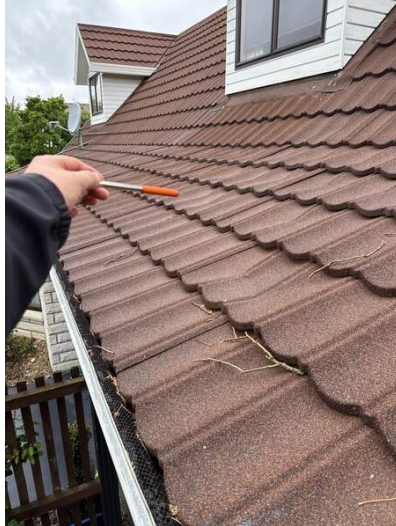
#97: Tile dents - Western elevation

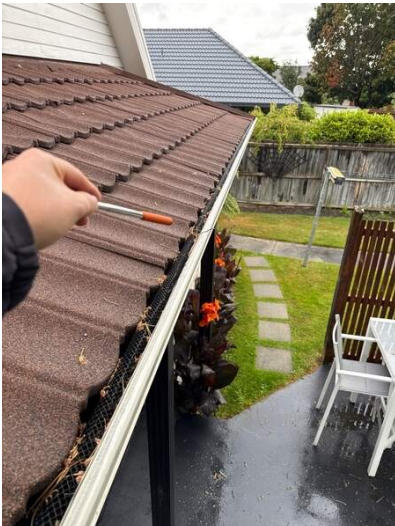
#99: Popped nails - Southern elevation

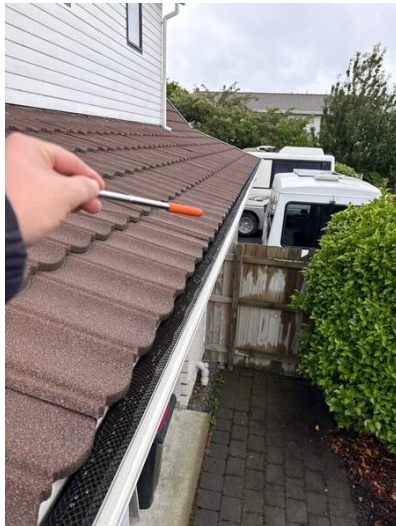
#100: Popped nails - Eastern elevation

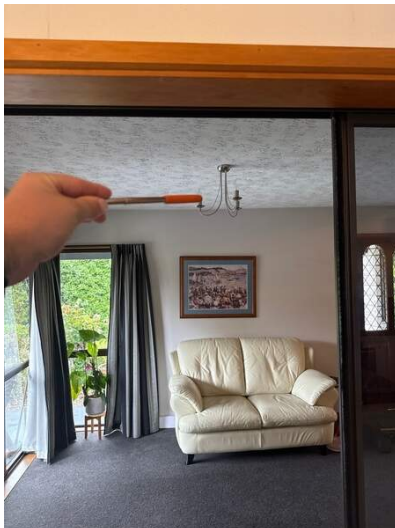
#131: Living room

The majority of the accessible lights were tested and working: the light located below was not operating or had a missing bulb. A licensed electrician is required to assess.

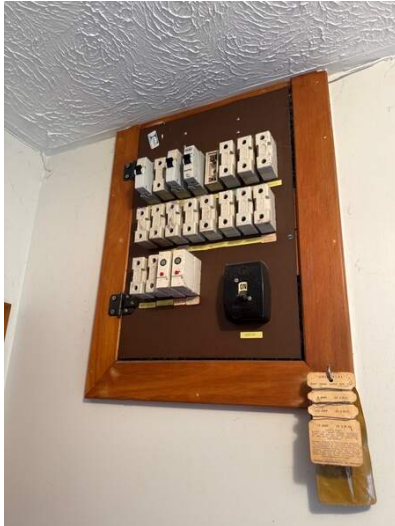
#135

- A licensed electrician is required to inspect the fuse board to determine what fuses are in use and if upgrades are recommended.

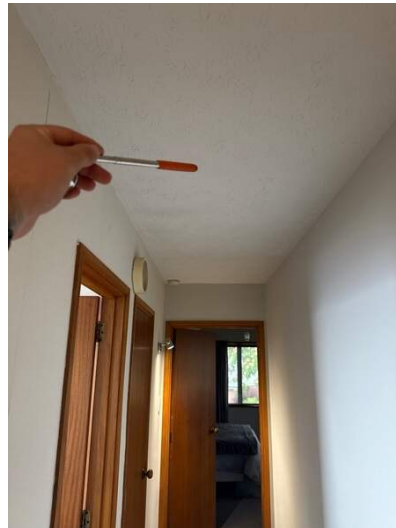
There was an inadequate number of smoke alarms. Refer to the details below.

#137: Smoke alarm required -
First-floor hallway

I recommend installing more smoke alarms as this can be a safety risk without them. There must be at least one working smoke alarm within 3 metres of each bedroom door or every room where a person sleeps, in multi-storey or multi-level homes (including split levels) there must be at least one smoke alarm on each level or storey.

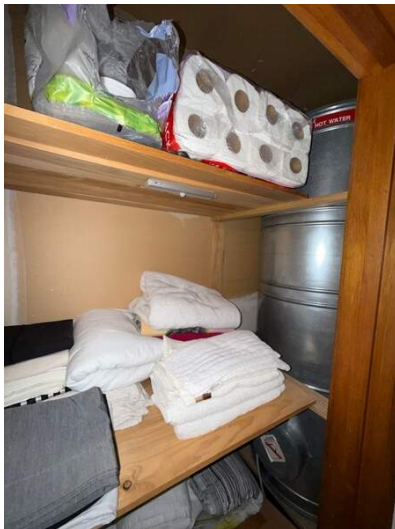
#139

Age:	Unable to sight
Seismic straps:	It is recommended a seismic strap is installed.
Over flow drain:	No overflow tray was in place, it is recommended an overflow tray be installed.

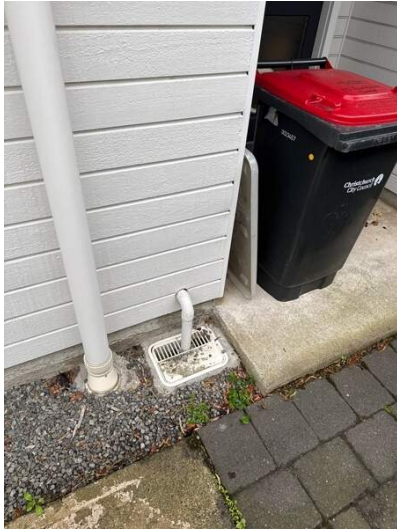
#141

The gully traps were free of movement/cracking and no blockages were sighted.
