KIWI HOUSE INSPECTIONS

Weathertightness & Building Inspection Report on 267B Glenfield Road, Glenfield

Address of Property: 267B Glenfield Road
Glenfield
Auckland

INDEPENDENT BUILDING INSPECTION
267B Glenfield Road

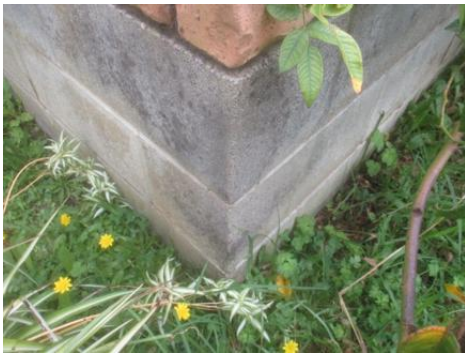
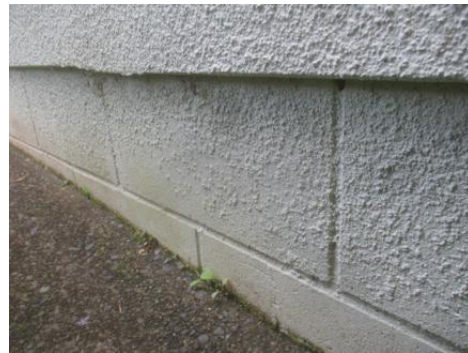
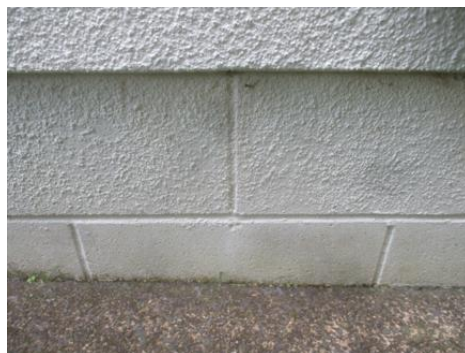
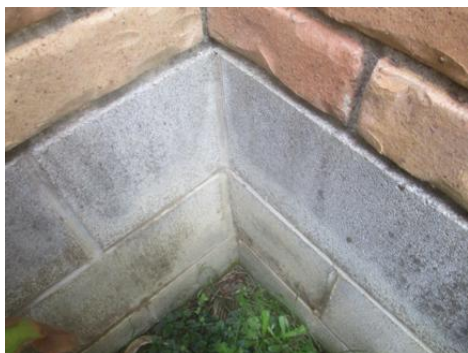
The dwelling is built on a series of reinforced concrete slabs to the lower level, encased within solid poured masonry blockwork, founded on concrete strip footings to the entire dwelling.

The foundations appear to have been well constructed, there were no visible signs of stress movement either vertically or horizontally, or any deterioration at the time of inspection.

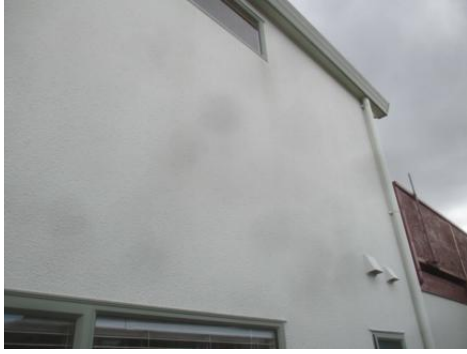
The cladding on this dwelling has been fixed directly to the framing without a cavity, and should any moisture penetrate through the cladding system or at the location of any junctions, penetrations or flashings then there is potential that damage may occur to other building elements.

No cavity

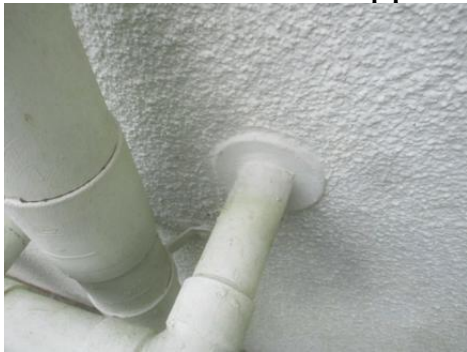
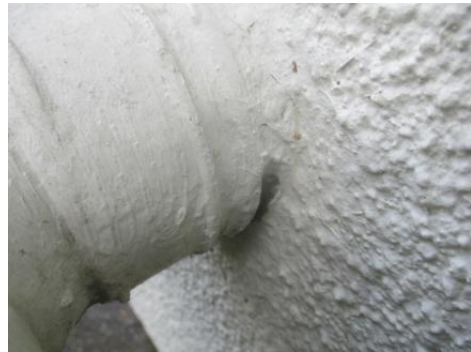
Keep penetrations well sealed

Also, it is imperative that all penetrations through the cladding are kept well sealed as these are potential areas for moisture ingress to occur over time – these penetrations include wastepipes, vents and ventilation grills, overflow pipes, electrical meter board, exterior joinery, etc.

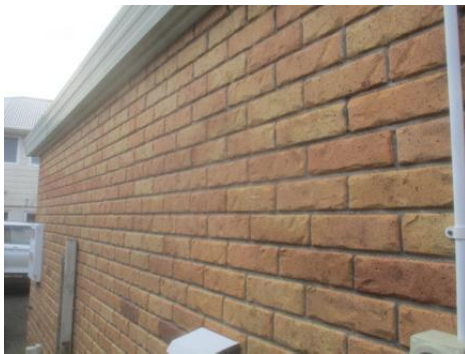
Cavity system

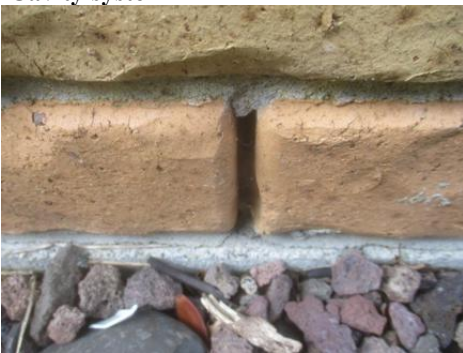
Keep junctions well sealed

NOTE: Please ensure junctions between the cladding types are kept well sealed.

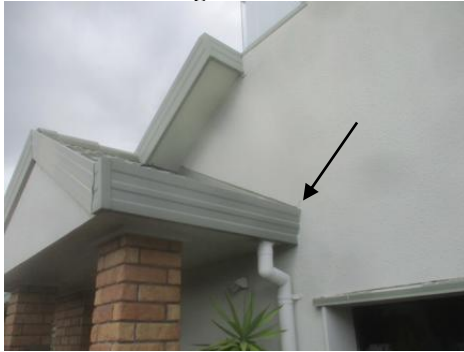
Keep roof-to-wall-junctions well sealed

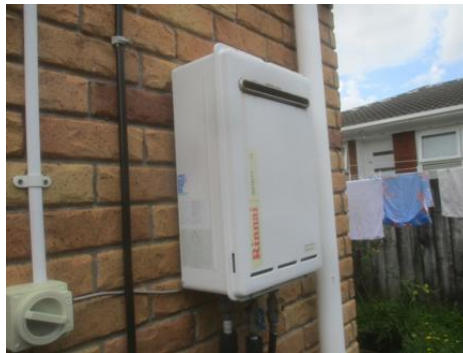
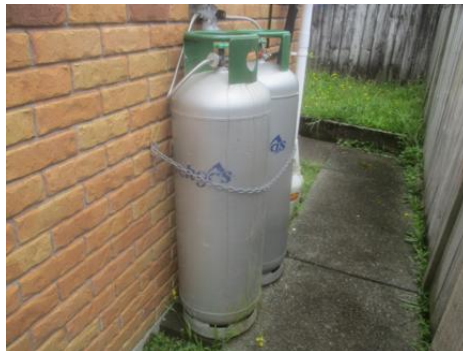
A wall mounted, bottle-fed gas Rinnai 26ltr infinity type system has been installed to the exterior wall on the western elevation.

The unit appears to have been professionally installed and is currently in good working condition.

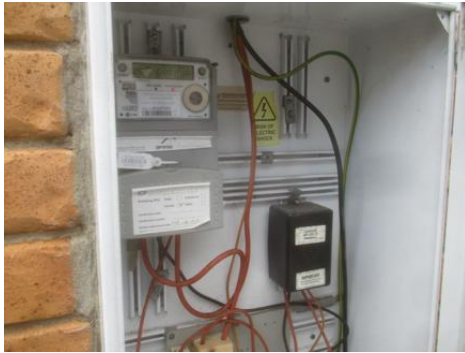
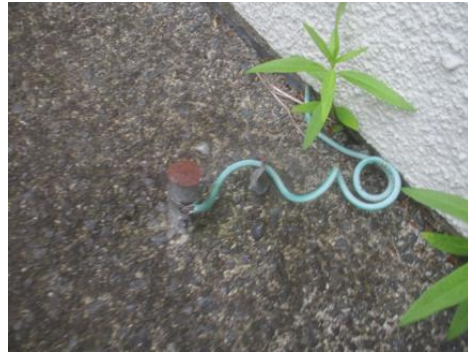
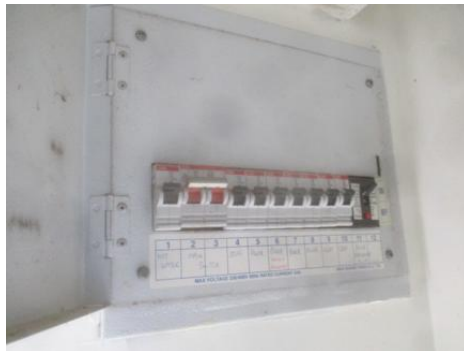
A standard meter box has been professionally installed to the exterior of the dwelling.

A standard distribution board has been professionally installed to the interior of the garage.

There were no signs of excess heat buildup, at either the boards or power points.

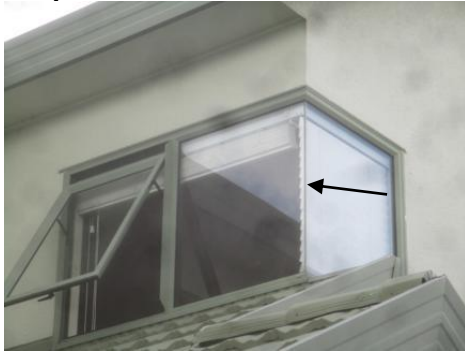
NOTE: Although head flashings have been installed, there is no adequate jamb flashing to the sill or side of the windows, and there is no air gap between the flashing and cladding; therefore, silicone sealant is relied on to form the weather seal. Cracks may appear between the joinery and cladding, due to variation in thermal expansion rates between the aluminium and plaster. Re-sealing the joinery to the cladding should be undertaken as part of the maintenance plan. Mitered corner junction also must be kept well sealed.

Keep well sealed

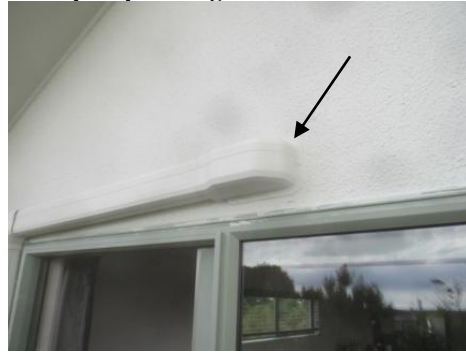
Areas to Note: The heat pump appears to have been installed through the lintel – this is a structural member.

Heat pump through lintel

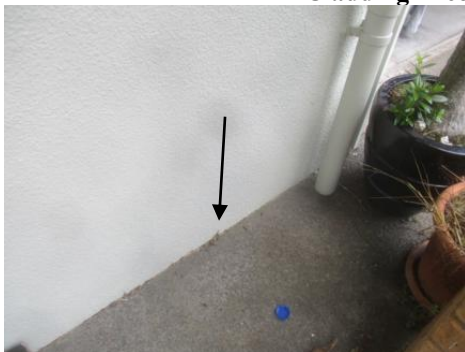
NOTE: The cladding system has been taken down to the ground in some locations. It is now generally accepted that the bottom edges of plaster systems of this type should be kept clear of finished exterior ground levels to ensure that surface water is not absorbed into the back edges of the plaster and transferred into the internal framing by means of capillary action. Installing a channel drain along here is an acceptable solution. Moisture readings were within acceptable limits at the time of inspection.

Cladding in contact with grounds

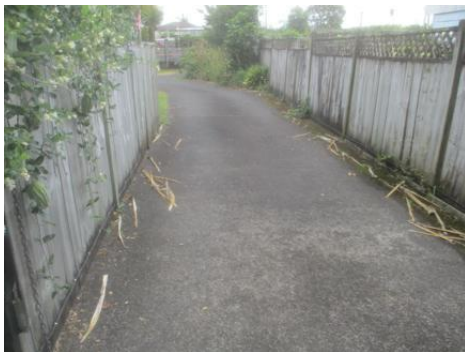
Area to Note: There is movement and cracking at the end of the driveway.

Cracking

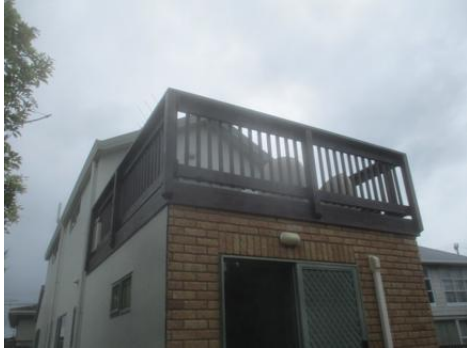
There is not adequate clearance between the bottom edges of the cladding and the deck; therefore, there is potential for moisture ingress to occur via capillary action up through the cladding and be transferred into the internal timber framing.

Inadequate clearances

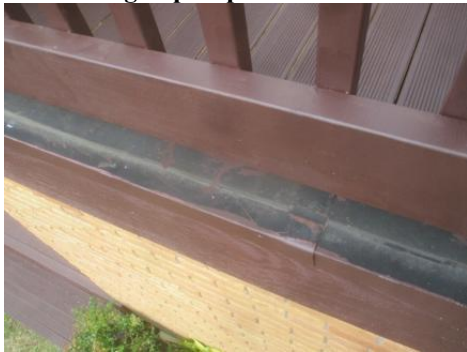
Areas to Note: Butynol generally has a maximum lifespan of 25 years; therefore, it is due for replacement. The position the heat pump unit is located is not compliant as it can be climbed.

Butynol beyond intended lifespan

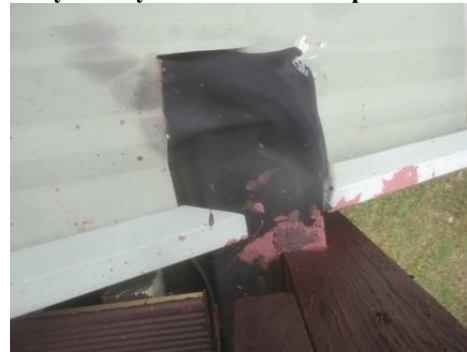
The deck has been waterproofed with a Butynol membrane. NOTE: We are unable to comment on the condition of the membrane or outlets as they are concealed. The falls are less than the current acceptable limits. There are no drip edges. The downpipe runs inside the building envelope; therefore, if leakage occurs it will enter the dwelling.

Internally routed outlet

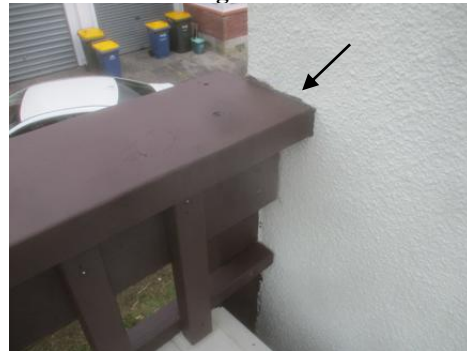
Non-compliant location

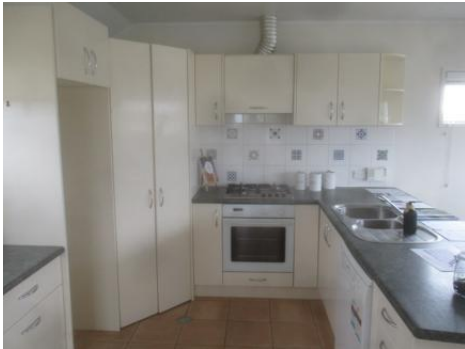
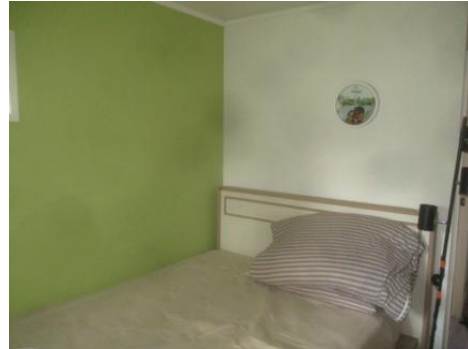
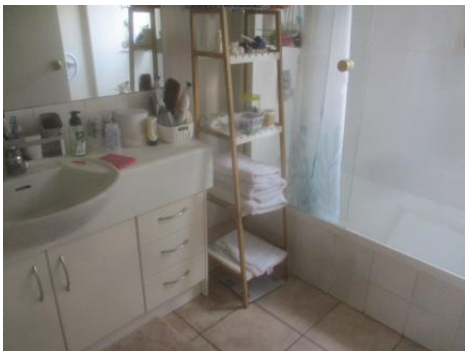
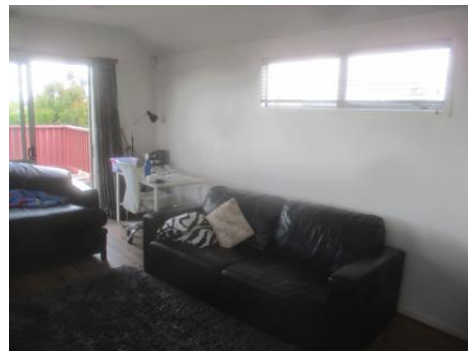
The bathrooms, kitchen units and bench tops are in good/ average condition, with some swelling of cabinetry.

Flooring consists of vinyl, ceramic tiles and carpet. Flooring is in good condition, with some marking. Some older tiles have cracks.
