# Lot 15, 220 Withy Road, Awakaponga

## Geotechnical report

Project 50721 - Rev.0 - 28/03/2023

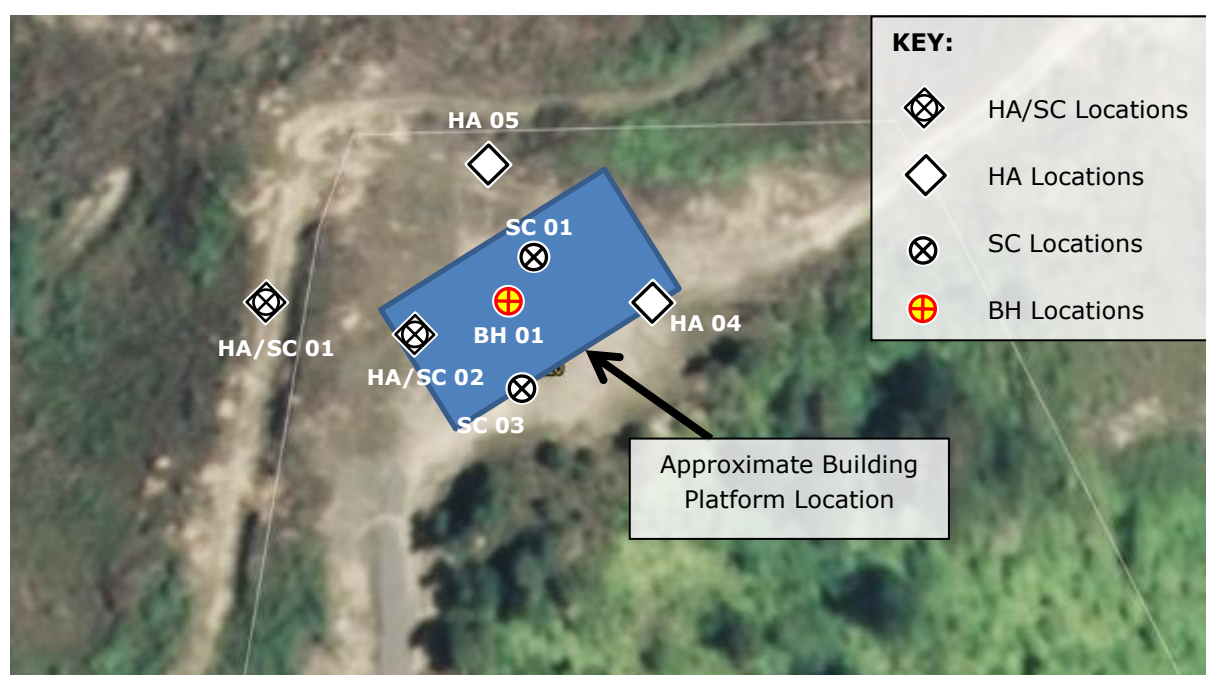
Figure 12: Intrusive Investigation Approximate Locations

EDC visited the site on 13/07/22 to undertake a shallow geotechnical investigation in order to determine the subsoil conditions.

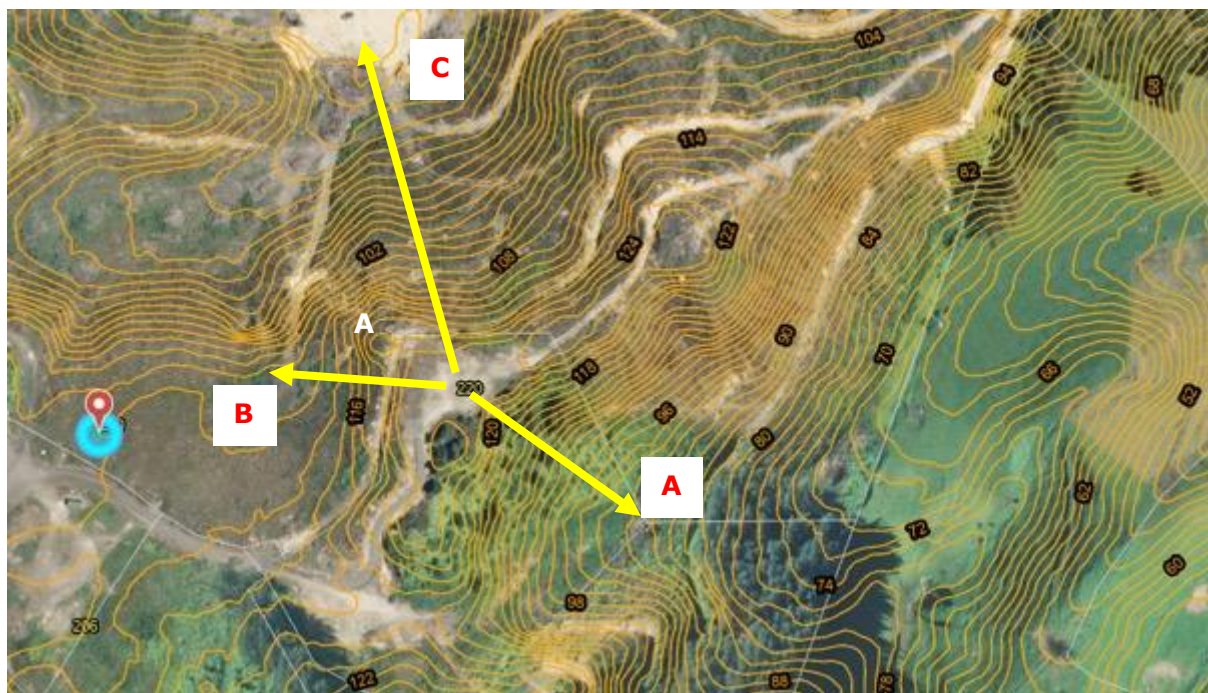
Figure 13: Slope Stability Analysis Cross-Section

In the absence of a topographical survey, EDC's site measurement and the contours available on the BOPRC GIS have been used to construct a cross-section through the site. The cross-section location is shown on Figure 12 and was selected at the inferred worst-case location for instability risk; based on gradient and slope height.

| Slope | Analysis Condition | Target FoS | Minimum Calculated FoS | Comments |
|---|---|---|---|---|
| | Transient | 1.3 | 0.5 | Potential deep failure extends to the building platform (FOS-1.2) |
| | Seismic | 1.0 | 0.7 | Potential deep failure extends to the building platform |
| | Transient w/ support | 1.3 | 0.5/1.3 | Potential shallow failure to the edge of the support (FOS-0.5), the ground above the barrier pile wall is stable (FOS-1.3) |

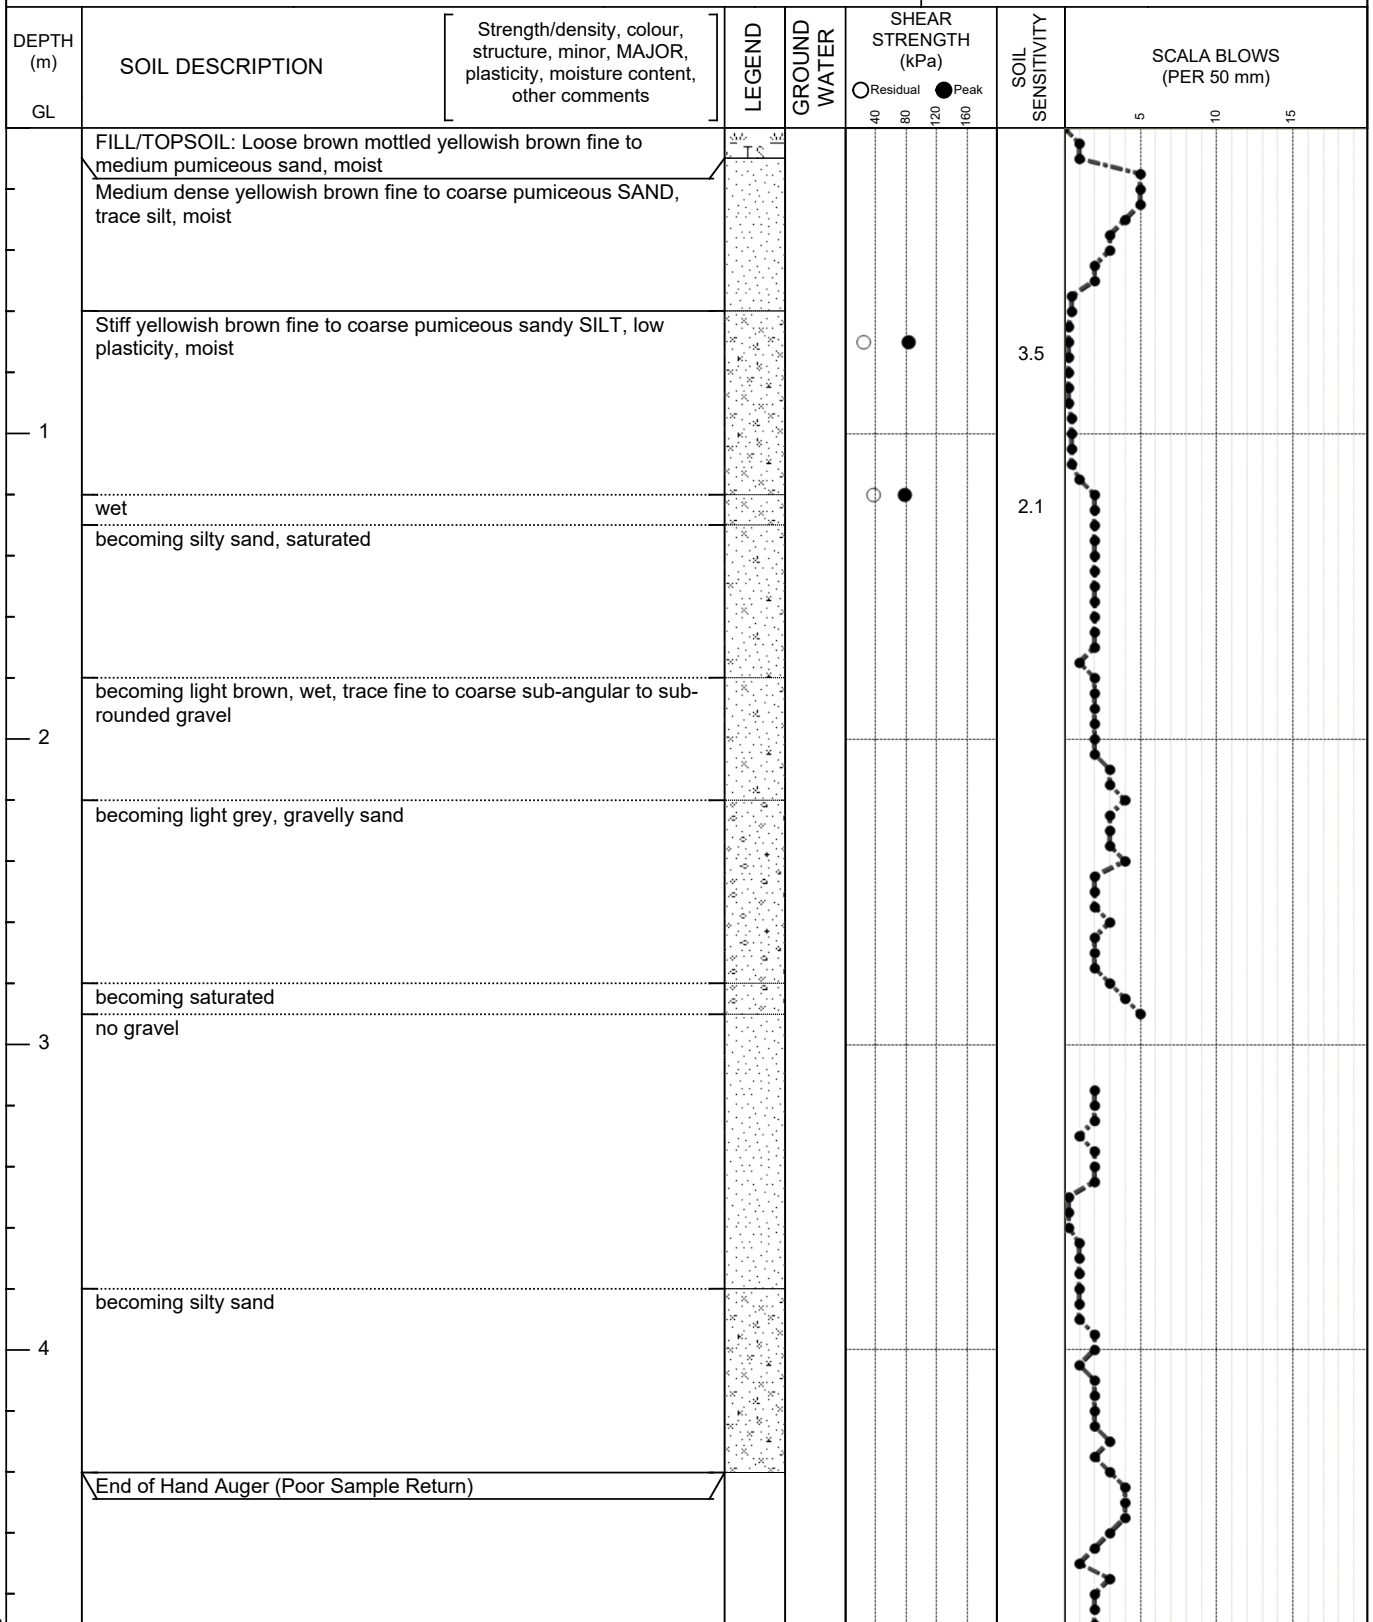
While groundwater was not encountered during hand auger drilling, the soil was wet from 1.2m and saturated from 1.3m.
