Healthy Home Assessment

**19 Lithgow Place East
Glengarry
Invercargill 9810**

Job Number
#42902

Location
19 Lithgow Place East, Glengarry, Invercargill,
Southland

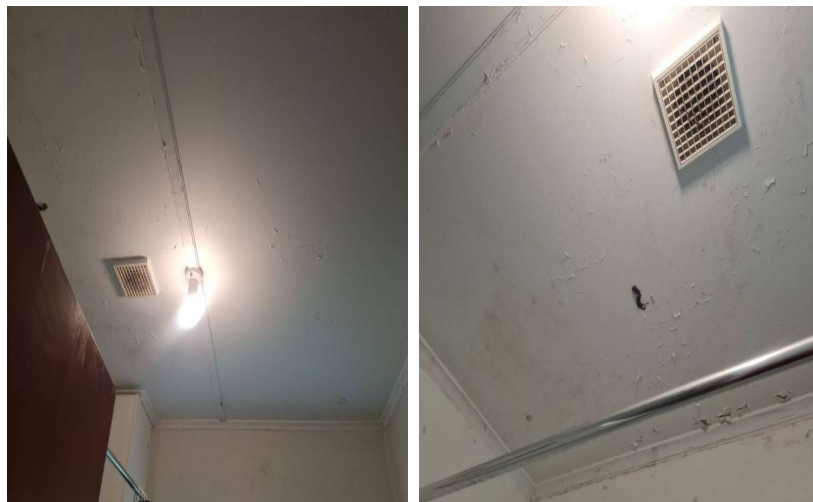
Evidence provided

This evidence has been provided by Nik. As this evidence was not provided by Healthy Homes NZ we cannot confirm the information complies with the Healthy Home Standards and therefore Healthy Homes NZ does not accept any liability around the accuracy of the information provided.
