Healthy Homes Evaluation

1/315 Southampton Street East
Akina Hastings 4122

2/315 Southampton Street East
Akina Hastings 4122

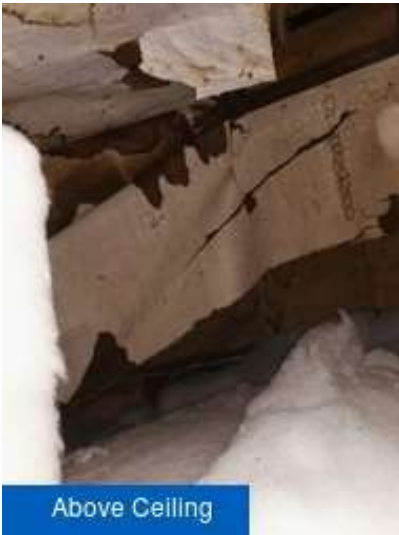
Above Ceiling

The ceiling hatch only gives access to about 10% of the roof space. Although there is compliant insulation in this space any other part of the roof space cannot be seen. The owner may provide access or documentation to show installation to the remaining area.

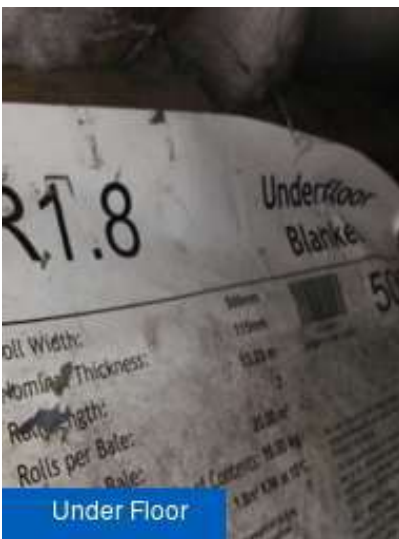
Location	Result	Statement
Under Floor	Compliant	Compliant due to each domestic living space in the premises being fully covered where possible by qualifying insulation blanket

Under Floor: R1.8

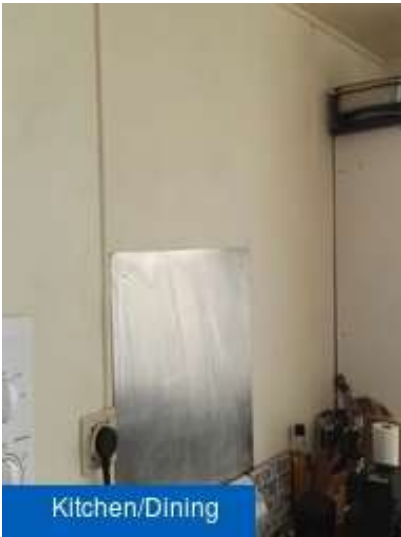
Location	Result	Statement
Kitchen/Dining	Non-Compliant	Non-compliant due to not having an extractor fan that vents to the outside (bathrooms require at least 120mm in diameter ducting or 25 litres per second and kitchens require at least 150mm in diameter ducting or 50 litres per second).
	Additional Comment	Exterior wall mounting may be possible, or roof mounting. Exterior wall is timber weather board, the roof is steel. Switch board is 5m.

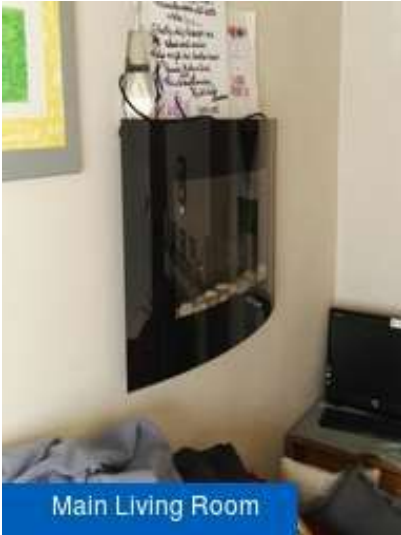
Location	Result	Statement
Main Living Room	Non-Compliant	Non-compliant due to not being able to determine the kW rating of the fixed heating device due to a lack of labelling. Evidence required to determine compliance and other - see comments.
	Additional Comment	The wall fire is not hardwired so cannot be considered, it also has no labels identifying any heating output.

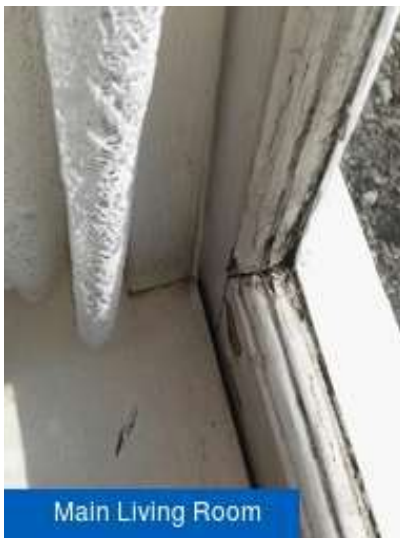
Main Living Room	Non-Compliant	Non-compliant due to the window perimeter not being sealed adequately.
-------------------------	----------------------	--

Additional Comment	Fitting of draft stop to the windows will resolve this issue.
---------------------------	---

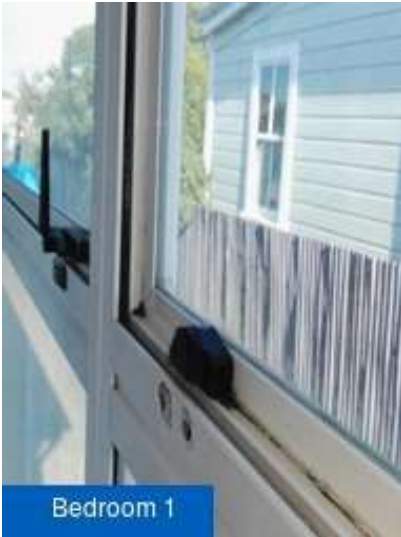
Location	Result	Statement
Bedroom 1	Non-Compliant	Non-compliant due to absent window latch.
	Additional Comment	Replacing the window latch will resolve this issue.

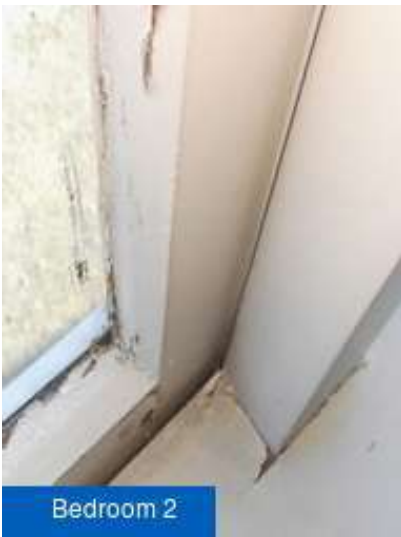
Location	Result	Statement
Bedroom 2	Non-Compliant	Non-compliant due to the window perimeter not being sealed adequately.
Additional Comment		Fitting of draft stop to the windows will resolve this issue.

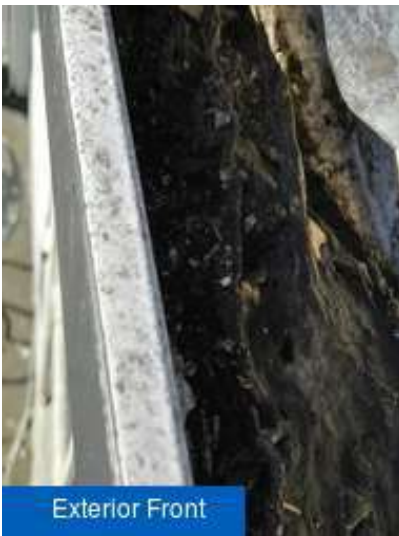
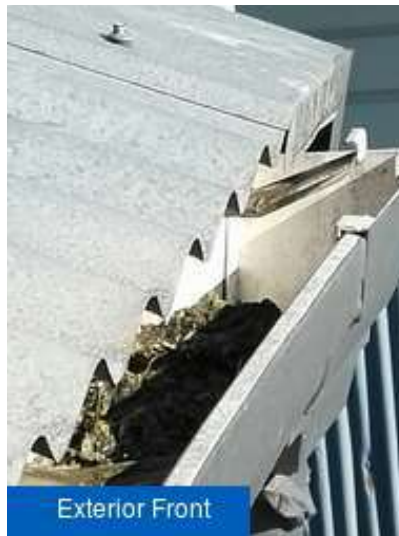
Non-compliant due to gutters blocked, gutters damaged and surface ground water not directed away from the property adequately.

Reclipping of one gutter clip and clearing of 5m of the lower gutter. In addition, fitting of a gutter and downpipe connected to the surface water drain for the small roof over the window will resolve this issue.

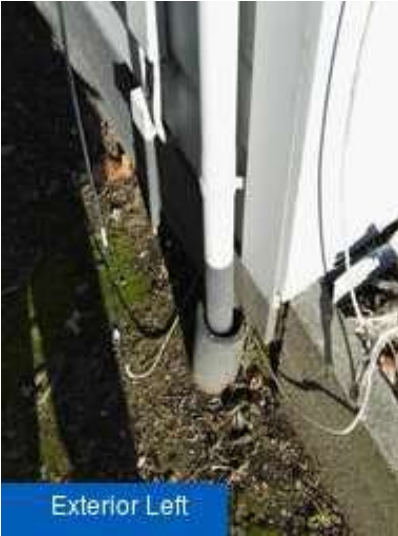
Exterior Left	Non-Compliant	Non-compliant due to drain blocked.
------------------	----------------------	-------------------------------------

Additional Comment	Clearing of the front left drain will resolve this issue.	
---------------------------	---	--

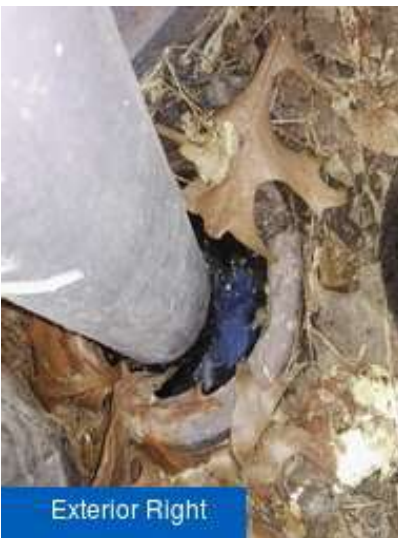
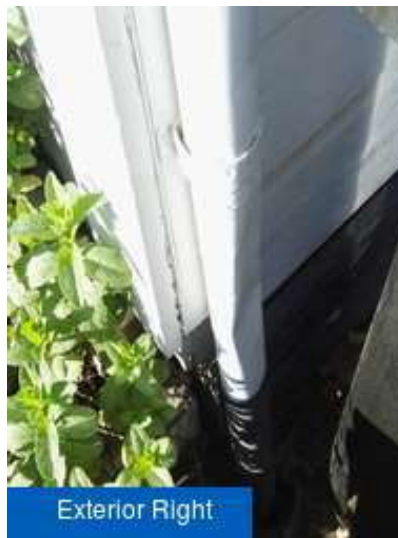
Exterior Right	Non-Compliant	Non-compliant due to drain blocked.
-------------------	----------------------	-------------------------------------

Additional Comment	Clearing of the front right drain will resolve this issue.	
---------------------------	--	--

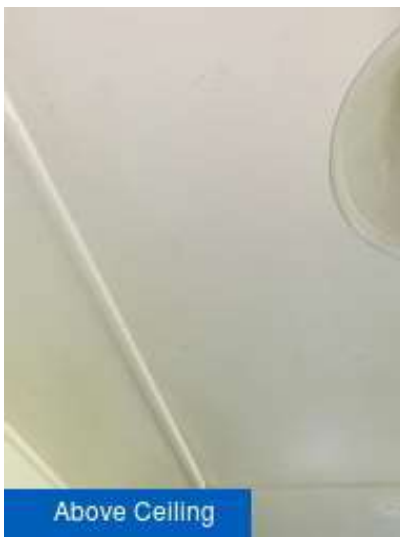
Non-compliant due to there appears to be an above ceiling void although no visible access to inspect. Owner to supply access for inspection or evidence/statement of compliance.

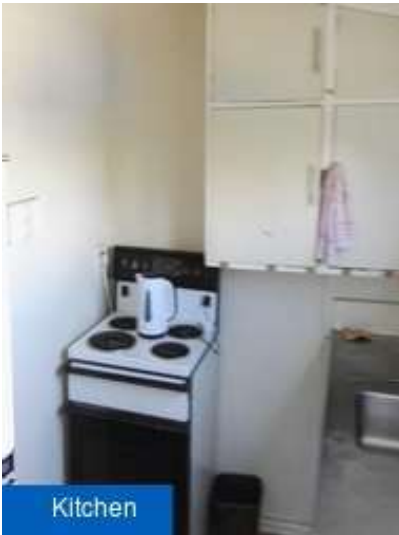
Location	Result	Statement
Kitchen	Non-Compliant	Non-compliant due to not having an extractor fan that vents to the outside (bathrooms require at least 120mm in diameter ducting or 25 litres per second and kitchens require at least 150mm in diameter ducting or 50 litres per second).
	Additional Comment	Exterior wall or roof mounting may be possible. Exterior wall is timber weather board, roof is steel. Switch board is 15m.

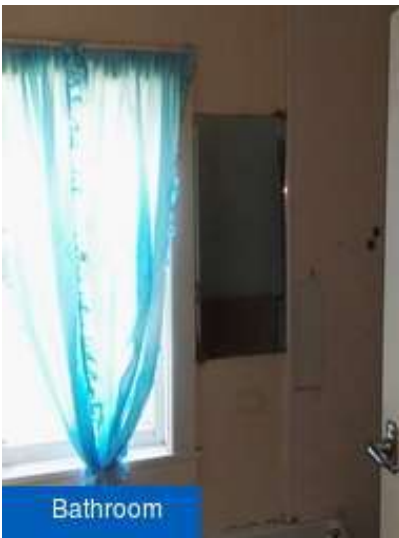
Location	Result	Statement
Bathroom	Non-Compliant	Non-compliant due to not having an extractor fan that vents to the outside (bathrooms require at least 120mm in diameter ducting or 25 litres per second and kitchens require at least 150mm in diameter ducting or 50 litres per second).
	Additional Comment	Exterior wall mounting may be possible. Exterior wall is timber weather board. Switch board is 10m. Suspected asbestos material in the cladding to the walls.

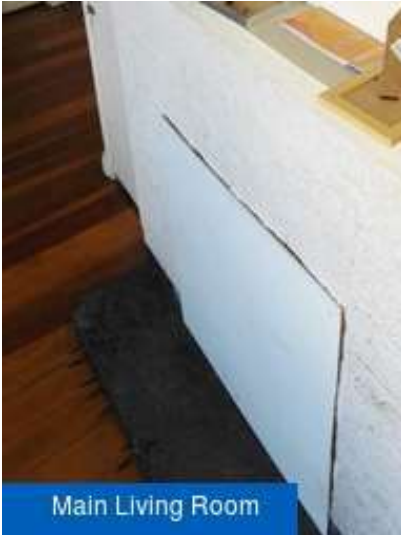
Location	Result	Statement
Main Living Room	Non-Compliant	Non-compliant due to the main living room not having a qualifying heater with the required kW capacity to achieve the minimum temperature of 18° for the floor area estimation and climate zone.

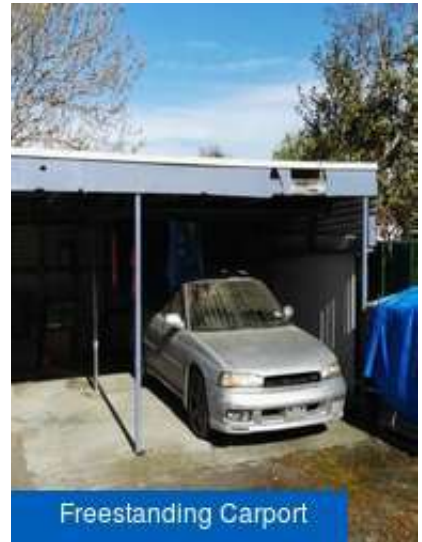
Location	Result	Statement
Freestanding Carport	Non-Compliant	Non-compliant due to gutters blocked, gutters damaged, drain blocked and surface ground water not directed away from the property adequately.
	Additional Comment	Repair or replace the gutter, clearing of the drain and make sure that the drain, if any, is connecting to a surface water drain will resolve this issue.
