# LONG TERM MAINTENANCE PLAN

Body Corporate 534969 – Avenue Apartments,  
Mangere Auckland

## **LONG TERM MAINTENANCE PLAN - AVENUE APARTMENTS – BODY CORPORATE 534969 - 69 HALL AVENUE, MANGERE**

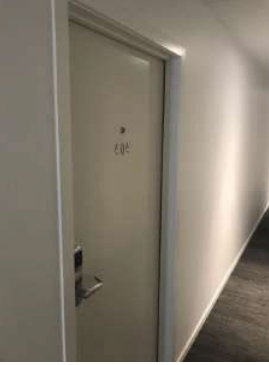
Location: Block 1

| Block 1<br>Internal/External | <div>Doors</div> <div>Personnel Electronic Door Entry System<br/>General Repair Allowance Door Entry Systems</div> <div>General Repair Allowance Door Entry Systems</div> | Very Good - As New | | No | 1 | \$1,500 | \$1,500 | \$1,576 | |

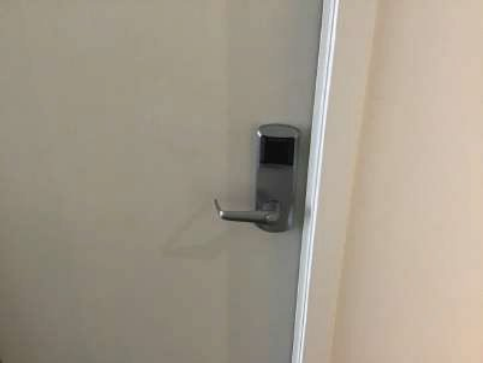
Location: Block 2

| Block 2<br>Internal<br>General Internal | <div>Doors</div> <div>Personnel Electronic Door Entry System<br/>General Repair Allowance Door Entry Systems</div> <div>General Repair Allowance Door Entry Systems</div> | Very Good - As New | | No | 1 | \$1,500 | \$1,500 | \$1,576 | |

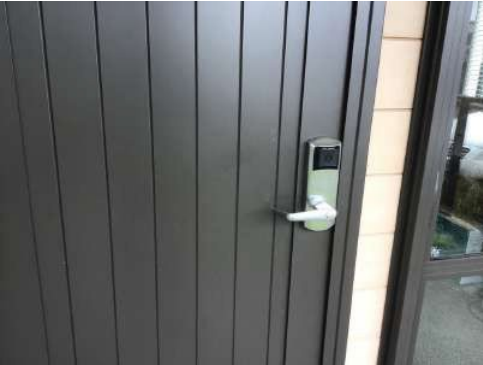
Location: Block 3

| Block 3<br>Internal/External | <div>Doors</div> <div>Personnel Electronic Door Entry System<br/>General Repair Allowance Door Entry Systems</div> <div>General Repair Allowance Door Entry Systems</div> | Very Good - As New | | No | 1 | \$1,500 | \$1,500 | \$1,576 | |

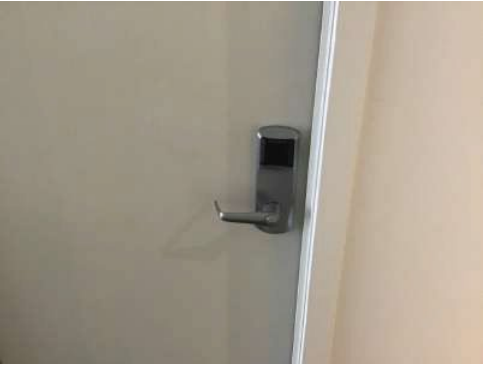
Location: Block 4

The door entry system to Block 4 was noted to be damaged and should be repaired immediately. The internal push button exit button was noted to be badly cracked impeding its use.

| Block 4<br>Internal<br>General Internal | Doors<br><br>Personnel<br>Electronic Door Entry<br>System<br>General Repair Allowance<br>Door Entry Systems<br><br>General Repair Allowance<br>Door Entry Systems | Very Good - As<br>New | | No | 1 | \$1,500 | \$1,500 | \$1,576 | |

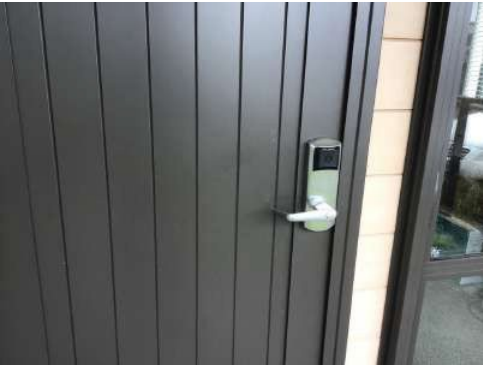
Location: Block 5

| Block 5<br>Internal/External | Doors<br><br>Personnel<br>Electronic Door Entry<br>System<br>General Repair Allowance<br>Door Entry Systems<br><br>General Repair Allowance<br>Door Entry Systems | Very Good - As<br>New | | No | 1 | \$1,500 | \$1,500 | \$1,576 | |

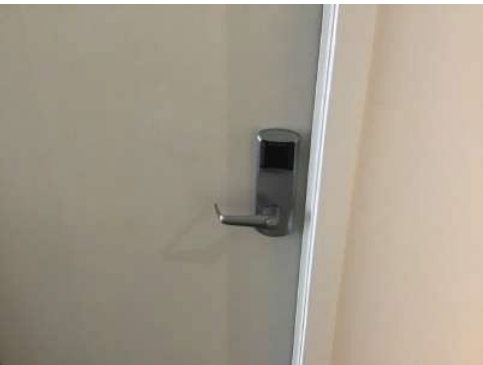
Location: Block 6

| Block 6<br>Internal<br>General Internal | Doors<br><br>Personnel<br>Electronic Door Entry<br>System<br>General Repair Allowance<br>Door Entry Systems<br><br>General Repair Allowance<br>Door Entry Systems | Very Good - As<br>New | | No | 1 | \$1,500 | \$1,500 | \$1,576 | |

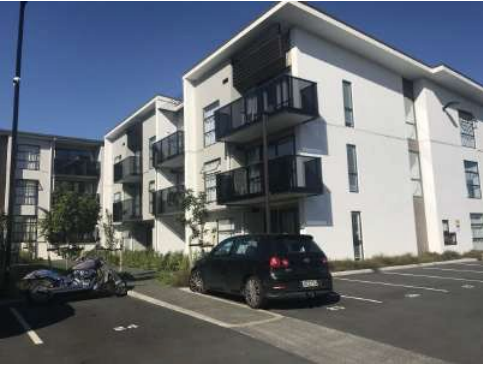
| Block 1<br>Internal<br>General Internal | <div>Electrical Services</div> <div>Electrical Reticulation<br/>Lighting Installations<br/>General Electrical<br/>Allowance</div> <div>General Allowance<br/>Electrical Reticulation</div> | Very Good - As<br>New | | No | 1 | \$3,000 | \$3,000 | \$3,311 | |

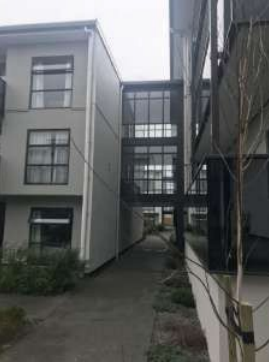
| Block 2<br>Internal<br>General Internal | <div>Electrical Services</div> <div>Electrical Reticulation<br/>Lighting Installations<br/>General Electrical<br/>Allowance</div> <div>General Allowance<br/>Electrical Reticulation</div> | Very Good - As<br>New | | No | 1 | \$3,000 | \$3,000 | \$3,311 | |

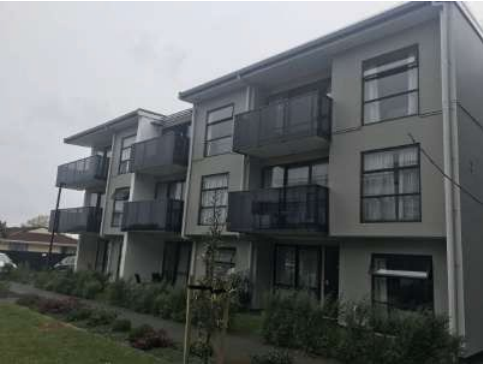
| Block 3<br>Internal<br>General Internal | <div>Electrical Services</div> <div>Electrical Reticulation<br/>Lighting Installations<br/>General Electrical<br/>Allowance</div> <div>General Allowance<br/>Electrical Reticulation</div> | Very Good - As<br>New | | No | 1 | \$3,000 | \$3,000 | \$3,311 | |

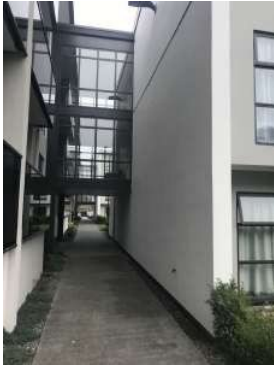
| Block 4<br>Internal<br>General Internal | <div>Electrical Services</div> <div>Electrical Reticulation<br/>Lighting Installations<br/>General Electrical<br/>Allowance</div> <div>General Allowance<br/>Electrical Reticulation</div> | Very Good - As<br>New | | No | 1 | \$3,000 | \$3,000 | \$3,311 | |

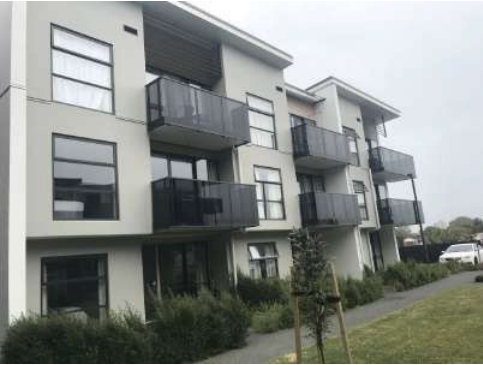
| Block 5<br>Internal<br>General Internal | <div>Electrical Services</div> <div>Electrical Reticulation<br/>Lighting Installations<br/>General Electrical<br/>Allowance</div> <div>General Allowance<br/>Electrical Reticulation</div> | Very Good - As<br>New | | No | 1 | \$3,000 | \$3,000 | \$3,311 | |

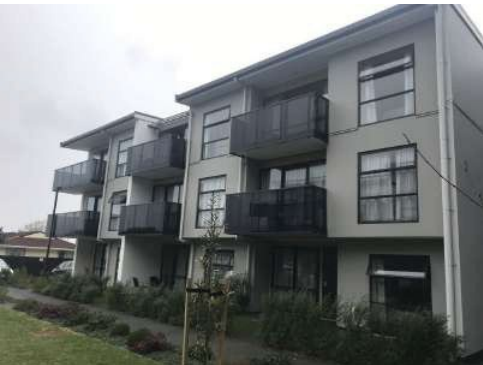
| External common areas<br>External | <div>Electrical Services</div> <div>Electrical Reticulation<br/>Underground Electrical<br/>Cabling - multi unit<br/>General Allowance<br/>Electrical</div> <div>General Electrical<br/>Allowance</div> | Very Good - As<br>New | | No | 1 | \$3,000 | \$3,000 | \$3,311 | |

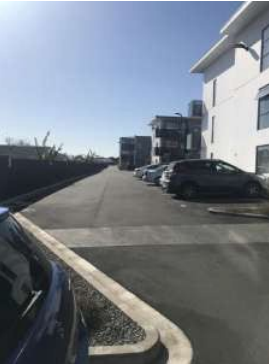
| External common areas<br>External | <div>External Works</div> <div>Boundary Structures<br/>Fencing, Timber, Paling<br/>General Fencing Repairs</div> <div>General Allowance Fencing<br/>Repairs</div> | Very Good - As<br>New | | No | 1 | \$1,500 | \$1,500 | \$1,656 | |

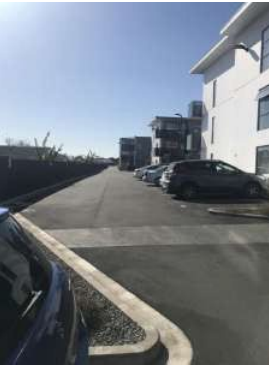
| External common areas<br>External | <div>External Works</div> <div>Hard Landscaping<br/>Hot Mix / Asphalt Patch<br/>Repairs<br/>Site Wide Asphalt Repairs</div> <div>General Asphalt Repairs</div> | Very Good - As<br>New | | m2 | 10 | \$80 | \$801 | \$884 | |

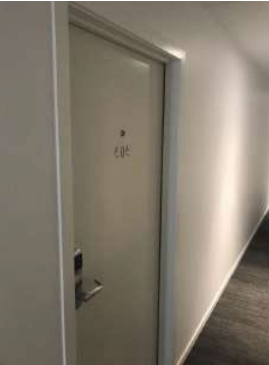
Location: Block 1

| Block 1<br>Internal/External | Doors<br><br>Personnel<br>Electronic Door Entry<br>System<br>General Repair Allowance<br>Door Entry Systems<br><br>General Repair Allowance<br>Door Entry Systems | Very Good - As<br>New | | No | 1 | \$1,500 | \$1,500 | \$1,697 | |

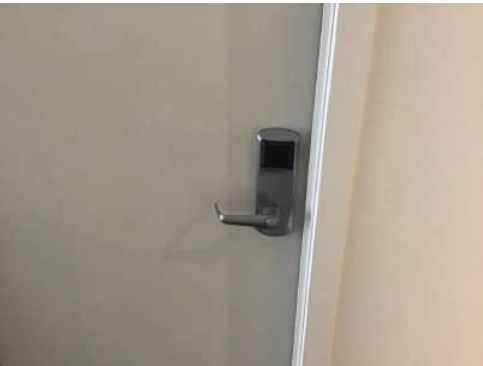
Location: Block 2

| Block 2<br>Internal<br>General Internal | Doors<br><br>Personnel<br>Electronic Door Entry<br>System<br>General Repair Allowance<br>Door Entry Systems<br><br>General Repair Allowance<br>Door Entry Systems | Very Good - As<br>New | | No | 1 | \$1,500 | \$1,500 | \$1,697 | |

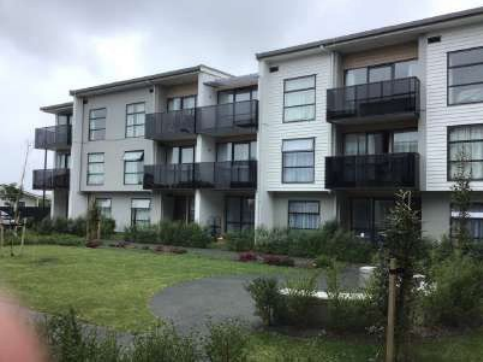
Location: Block 1

| Block 1<br>External<br>Building External | <div>Decoration</div> <div>External<br/>Paint - Walls, Soffits,<br/>Timber, Generally, Acrylic,<br/>Scaffolding</div> <div>Repaint External Walls And<br/>Soffits</div> | Very Good - As<br>New | External decoration presents in very good<br>condition | m2 | 575 | \$65 | \$37,375 | \$43,344 | |

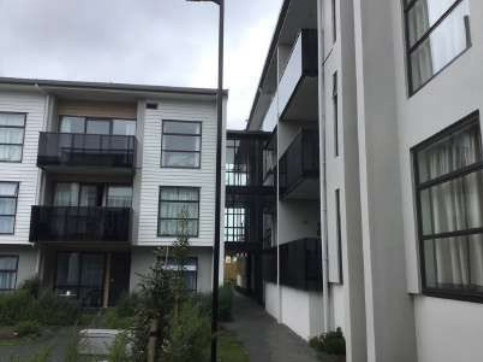
Location: Block 2

| Block 2<br>External<br>Building External | <div>Decoration</div> <div>External<br/>Paint - Walls, Soffits,<br/>Timber, Generally, Acrylic,<br/>Scaffolding</div> <div>Repaint External Walls And<br/>Soffits</div> | Very Good - As<br>New | External decoration presents in very good<br>condition | m2 | 520 | \$65 | \$33,800 | \$39,198 | |

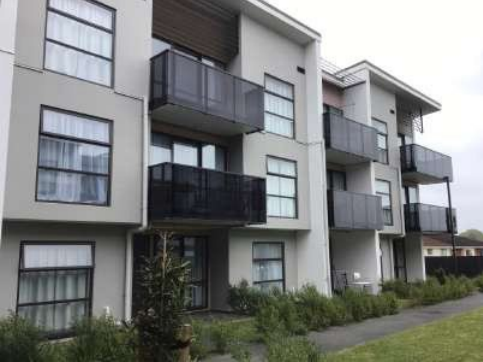
Location: Block 3

| Block 3<br>External<br>Building External | <div>Decoration</div> <div>External<br/>Paint - Walls, Soffits,<br/>Timber, Generally, Acrylic,<br/>Scaffolding</div> <div>Repaint External Walls And<br/>Soffits</div> | Very Good - As<br>New | External decoration presents in very good<br>condition | m2 | 540 | \$65 | \$35,100 | \$40,705 | |

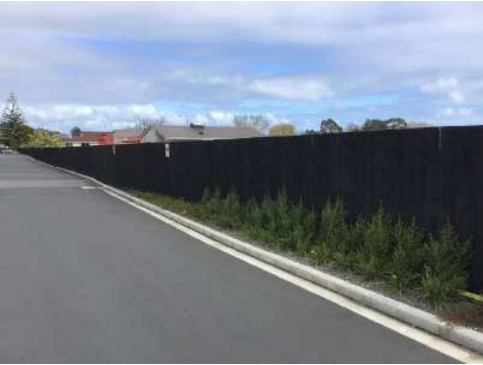
| Location | Building Element | Condition | Comments | Unit | Quantity | Unit Cost | Current cost | Future Cost | Photographs |
|---|---|---|---|---|---|---|---|---|---|
| External common areas<br>External | Decoration<br><br>External Staining<br>Staining To Fencing<br><br>Re Stain Fencing | Very Good - As New | External decoration presents in very good condition | m2 | 382 | \$19 | \$7,258 | \$8,417 | |

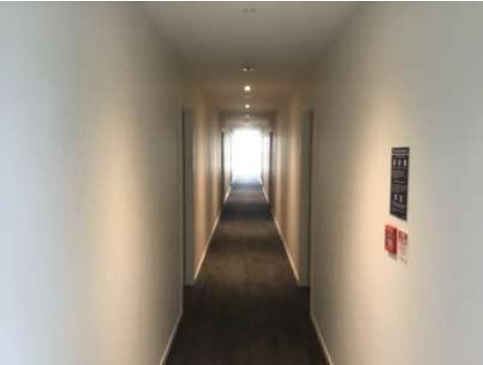
| Block 1<br>Internal<br>Level 2 | <b>Decoration</b><br><br>Internal<br>Paint - Enamel,<br>plasterboard walls and<br>ceilings<br><br>Prepare And Repaint | Very Good - As<br>New | Internal decoration presents in very good<br>condition | m2 | 111 | \$24 | \$2,644 | \$3,143 | |

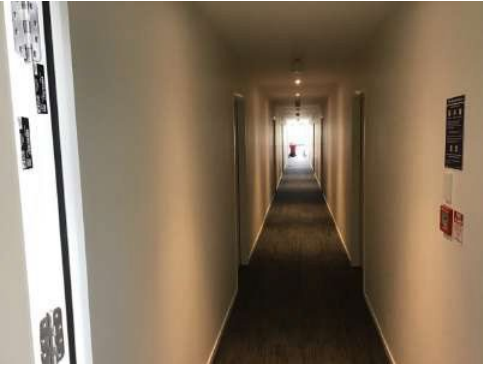
| Block 1<br>Internal<br>Level 1 | <b>Decoration</b><br><br>Internal<br>Paint - Enamel,<br>plasterboard walls and<br>ceilings<br><br>Prepare And Repaint | Very Good - As<br>New | Internal decoration presents in very good<br>condition | m2 | 111 | \$24 | \$2,644 | \$3,143 | |

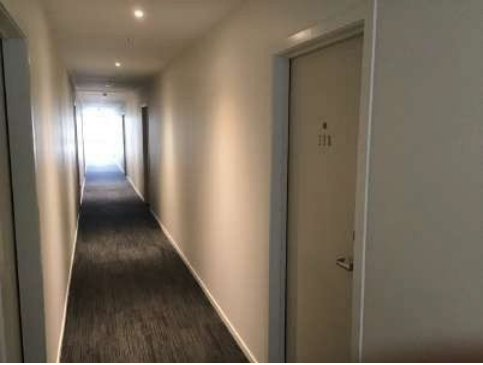
| Block 1<br>Internal<br>Level 2 | <b>Decoration</b><br><br>Internal<br>Paint to door and frame<br><br>Repaint Door And Frame<br>(One Side Only) | Very Good - As<br>New | Internal decoration presents in very good<br>condition | m | 6 | \$105 | \$630 | \$749 | |

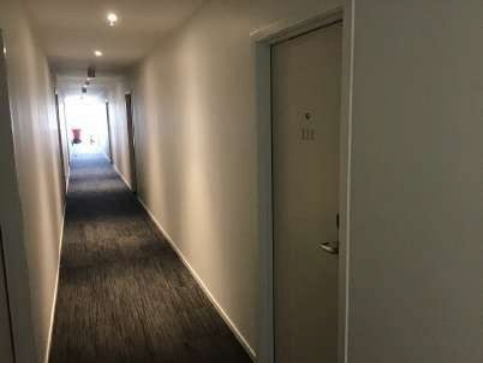
| Block 1<br>Internal<br>Level 1 | <b>Decoration</b><br><br>Internal<br>Paint to door and frame<br><br>Repaint Door And Frame<br>(One Side Only) | Very Good - As<br>New | Internal decoration presents in very good<br>condition | m | 6 | \$105 | \$630 | \$749 | |

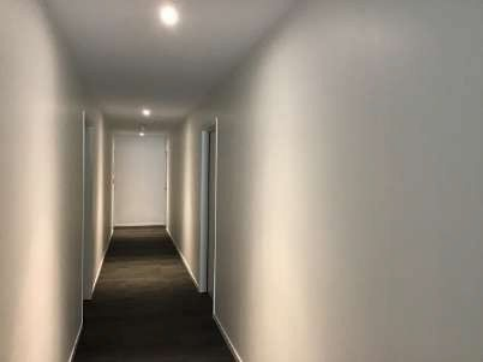
| Location | Building Element | Condition | Comments | Unit | Quantity | Unit Cost | Current cost | Future Cost | Photographs |
|---|---|---|---|---|---|---|---|---|---|
| Block 2<br>Internal<br>Level 1 | <b>Decoration</b><br><br>Internal<br>Paint - Enamel,<br>plasterboard walls and<br>ceilings<br><br>Prepare And Repaint | Very Good - As<br>New | Internal decoration presents in very good<br>condition | m2 | 131 | \$24 | \$3,120 | \$3,709 | |

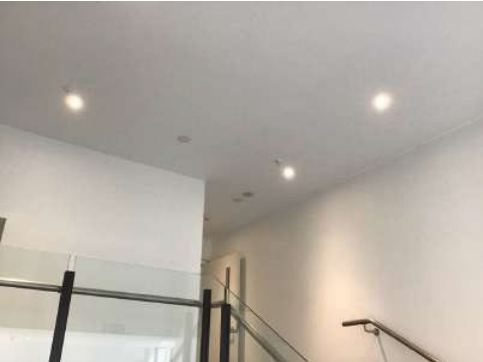
| Location | Building Element | Condition | Comments | Unit | Quantity | Unit Cost | Current cost | Future Cost | Photographs |
|---|---|---|---|---|---|---|---|---|---|
| Block 2<br>Internal<br>Stairway and<br>Landings | <b>Decoration</b><br><br>Internal<br>Paint - Enamel,<br>plasterboard walls and<br>ceilings<br><br>Prepare And Repaint | Very Good - As<br>New | Internal decoration presents in very good<br>condition | m2 | 260 | \$24 | \$6,193 | \$7,361 | |

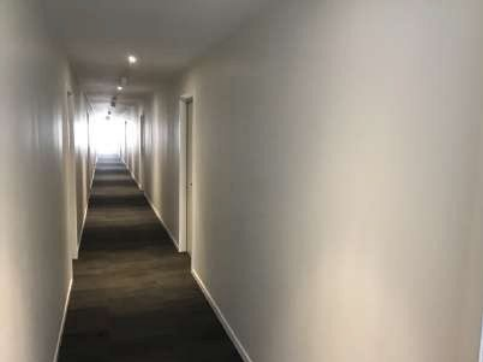
| Location | Building Element | Condition | Comments | Unit | Quantity | Unit Cost | Current cost | Future Cost | Photographs |
|---|---|---|---|---|---|---|---|---|---|
| Block 2<br>Internal<br>Level 2 | <b>Decoration</b><br><br>Internal<br>Paint - Enamel,<br>plasterboard walls and<br>ceilings<br><br>Prepare And Repaint | Very Good - As<br>New | Internal decoration presents in very good<br>condition | m2 | 131 | \$24 | \$3,120 | \$3,709 | |

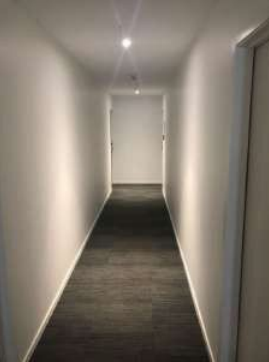
| Location | Building Element | Condition | Comments | Unit | Quantity | Unit Cost | Current cost | Future Cost | Photographs |
|---|---|---|---|---|---|---|---|---|---|
| Block 2<br>Internal<br>Ground Floor | <b>Decoration</b><br><br>Internal<br>Paint - Enamel,<br>plasterboard walls and<br>ceilings<br><br>Prepare And Repaint | Very Good - As<br>New | Internal decoration presents in very good<br>condition | m2 | 131 | \$24 | \$3,120 | \$3,709 | |

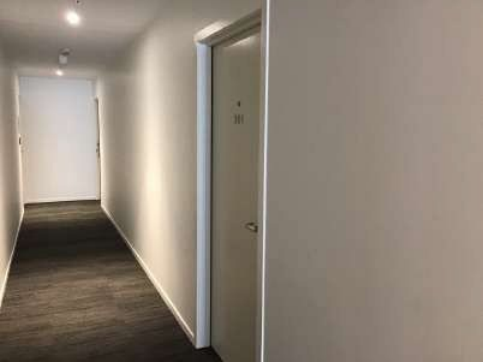
| Location | Building Element | Condition | Comments | Unit | Quantity | Unit Cost | Current cost | Future Cost | Photographs |
|---|---|---|---|---|---|---|---|---|---|
| Block 2<br>Internal<br>Level 1 | <b>Decoration</b><br><br>Internal<br>Paint to door and frame<br><br>Repaint Door And Frame<br>(One Side Only) | Good - Minor<br>Defects | Internal decoration presents in very good<br>condition | m | 9 | \$105 | \$945 | \$1,123 | |

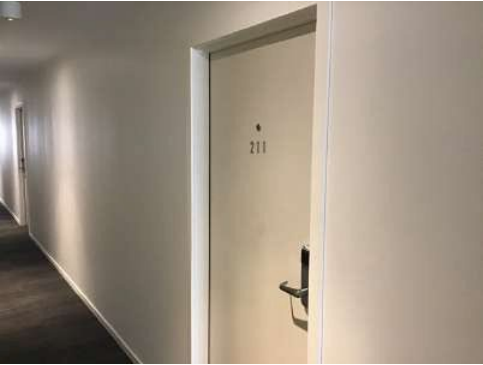
| Location | Building Element | Condition | Comments | Unit | Quantity | Unit Cost | Current cost | Future Cost | Photographs |
|---|---|---|---|---|---|---|---|---|---|
| Block 2<br>Internal<br>Level 2 | <b>Decoration</b><br><br>Internal<br>Paint to door and frame<br><br>Repaint Door And Frame<br>(One Side Only) | Very Good - As<br>New | Internal decoration presents in very good<br>condition | m | 9 | \$105 | \$945 | \$1,123 | |

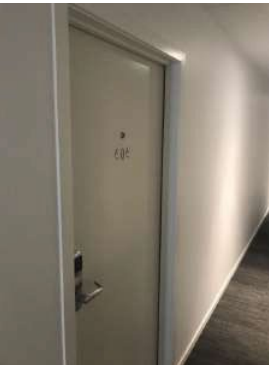
| Location | Building Element | Condition | Comments | Unit | Quantity | Unit Cost | Current cost | Future Cost | Photographs |
|---|---|---|---|---|---|---|---|---|---|
| Block 2<br>Internal<br>Ground Floor | <b>Decoration</b><br><br>Internal<br>Paint to door and frame<br><br>Repaint Door And Frame<br>(One Side Only) | Good - Minor<br>Defects | Internal decoration presents in very good<br>condition | m | 9 | \$105 | \$945 | \$1,123 | |

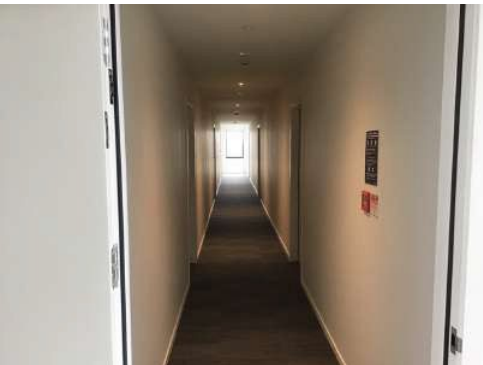
| Location | Building Element | Condition | Comments | Unit | Quantity | Unit Cost | Current cost | Future Cost | Photographs |
|---|---|---|---|---|---|---|---|---|---|
| Block 3<br>Internal<br>Level 2 | <b>Decoration</b><br><br>Internal<br>Paint - Enamel,<br>plasterboard walls and<br>ceilings<br><br>Prepare And Repaint | Very Good - As<br>New | Internal decoration presents in very good<br>condition | m2 | 111 | \$24 | \$2,644 | \$3,143 | |

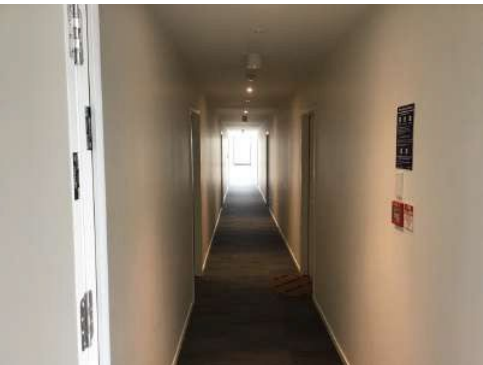
| Location | Building Element | Condition | Comments | Unit | Quantity | Unit Cost | Current cost | Future Cost | Photographs |
|---|---|---|---|---|---|---|---|---|---|
| Block 3<br>Internal<br>Level 1 | <b>Decoration</b><br><br>Internal<br>Paint - Enamel,<br>plasterboard walls and<br>ceilings<br><br>Prepare And Repaint | Very Good - As<br>New | Internal decoration presents in very good<br>condition | m2 | 111 | \$24 | \$2,644 | \$3,143 | |

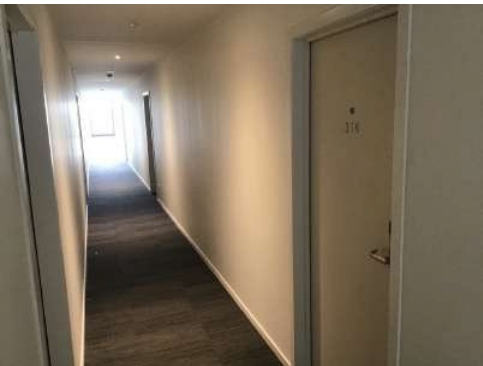
| Location | Building Element | Condition | Comments | Unit | Quantity | Unit Cost | Current cost | Future Cost | Photographs |
|---|---|---|---|---|---|---|---|---|---|
| Block 3<br>Internal<br>Level 2 | <b>Decoration</b><br><br>Internal<br>Paint to door and frame<br><br>Repaint Door And Frame<br>(One Side Only) | Very Good - As<br>New | Internal decoration presents in very good<br>condition | m | 6 | \$105 | \$630 | \$749 | |

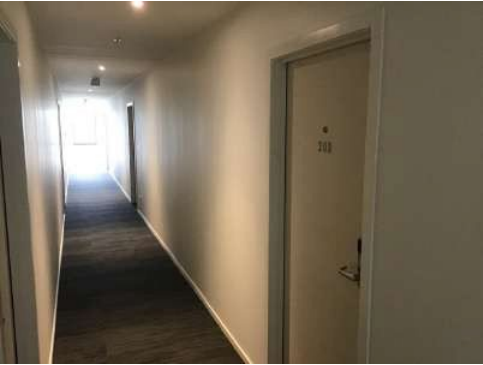
| Location | Building Element | Condition | Comments | Unit | Quantity | Unit Cost | Current cost | Future Cost | Photographs |
|---|---|---|---|---|---|---|---|---|---|
| Block 3<br>Internal<br>Level 1 | <b>Decoration</b><br><br>Internal<br>Paint to door and frame<br><br>Repaint Door And Frame<br>(One Side Only) | Very Good - As<br>New | Internal decoration presents in very good<br>condition | m | 6 | \$105 | \$630 | \$749 | |

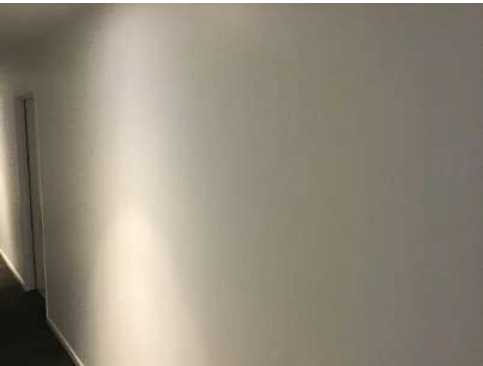
| Block 4<br>Internal<br>Ground floor | <b>Decoration</b><br><br>Internal<br>Paint - Enamel,<br>plasterboard walls and<br>ceilings<br><br>Prepare And Repaint | Very Good - As<br>New | Internal decoration presents in very good<br>condition | m2 | 131 | \$24 | \$3,120 | \$3,709 | |

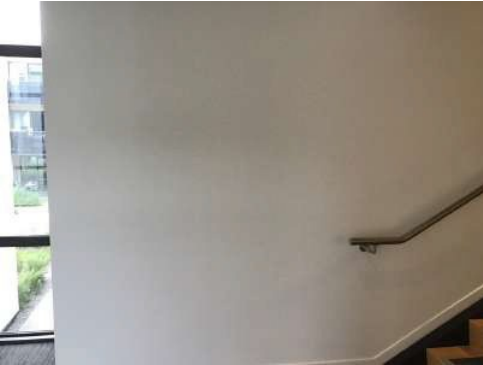
| Block 4<br>Internal<br>Stairway and<br>Landings | <b>Decoration</b><br><br>Internal<br>Paint - Enamel,<br>plasterboard walls and<br>ceilings<br><br>Prepare And Repaint | Very Good - As<br>New | Internal decoration presents in very good<br>condition | m2 | 260 | \$24 | \$6,193 | \$7,362 | |

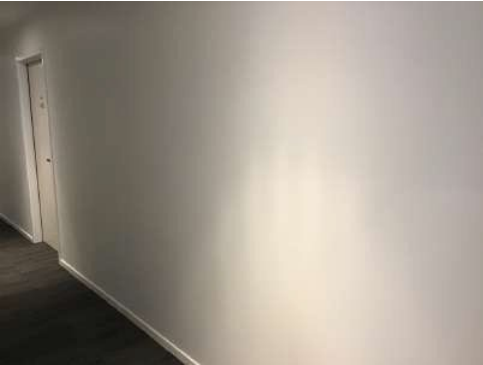
| Block 4<br>Internal<br>Level 1 | <b>Decoration</b><br><br>Internal<br>Paint - Enamel,<br>plasterboard walls and<br>ceilings<br><br>Prepare And Repaint | Very Good - As<br>New | Internal decoration presents in very good<br>condition | m2 | 131 | \$24 | \$3,120 | \$3,709 | |

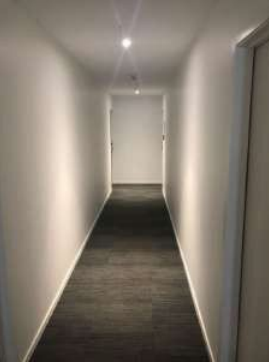
| Block 4<br>Internal<br>Level 2 | <b>Decoration</b><br><br>Internal<br>Paint - Enamel,<br>plasterboard walls and<br>ceilings<br><br>Prepare And Repaint | Very Good - As<br>New | Internal decoration presents in very good<br>condition | m2 | 131 | \$24 | \$3,120 | \$3,709 | |

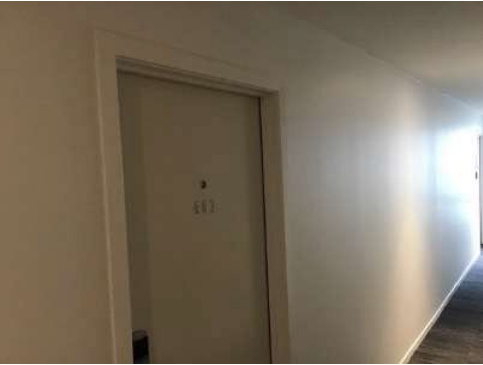
| Location | Building Element | Condition | Comments | Unit | Quantity | Unit Cost | Current cost | Future Cost | Photographs |
|---|---|---|---|---|---|---|---|---|---|
| Block 4<br>Internal<br>Ground floor | <b>Decoration</b><br><br>Internal<br>Paint to door and frame<br><br>Repaint Door And Frame<br>(One Side Only) | Good - Minor<br>Defects | Internal decoration presents in very good<br>condition | m | 9 | \$105 | \$945 | \$1,123 | |

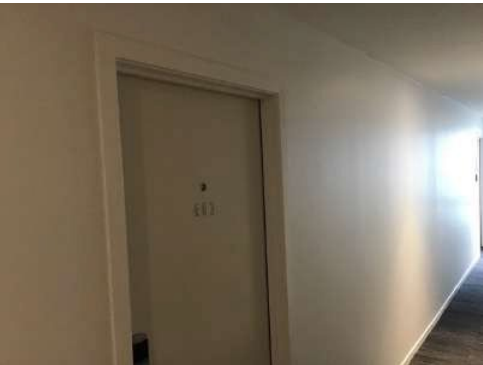
| Location | Building Element | Condition | Comments | Unit | Quantity | Unit Cost | Current cost | Future Cost | Photographs |
|---|---|---|---|---|---|---|---|---|---|
| Block 4<br>Internal<br>Level 1 | <b>Decoration</b><br><br>Internal<br>Paint to door and frame<br><br>Repaint Door And Frame<br>(One Side Only) | Very Good - As<br>New | Internal decoration presents in very good<br>condition | m | 9 | \$105 | \$945 | \$1,123 | |

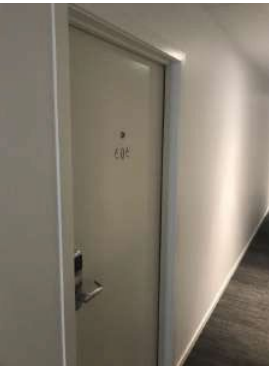
| Location | Building Element | Condition | Comments | Unit | Quantity | Unit Cost | Current cost | Future Cost | Photographs |
|---|---|---|---|---|---|---|---|---|---|
| Block 4<br>Internal<br>Level 2 | <b>Decoration</b><br><br>Internal<br>Paint to door and frame<br><br>Repaint Door And Frame<br>(One Side Only) | Very Good - As<br>New | Internal decoration presents in very good<br>condition | m | 9 | \$105 | \$945 | \$1,123 | |

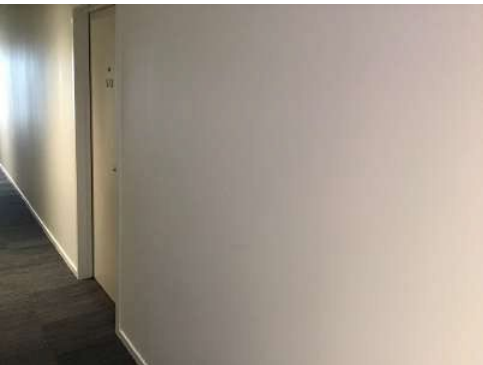
| Location | Building Element | Condition | Comments | Unit | Quantity | Unit Cost | Current cost | Future Cost | Photographs |
|---|---|---|---|---|---|---|---|---|---|
| Block 5<br>Internal<br>Level 2 | <b>Decoration</b><br><br>Internal<br>Paint - Enamel,<br>plasterboard walls and<br>ceilings<br><br>Prepare And Repaint | Very Good - As<br>New | Internal decoration presents in very good<br>condition | m2 | 111 | \$24 | \$2,644 | \$3,143 | |

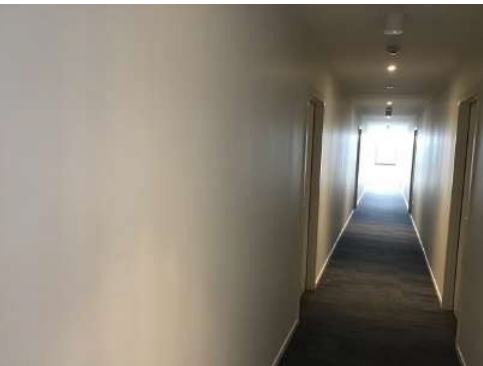
| Location | Building Element | Condition | Comments | Unit | Quantity | Unit Cost | Current cost | Future Cost | Photographs |
|---|---|---|---|---|---|---|---|---|---|
| Block 5<br>Internal<br>Level 1 | <b>Decoration</b><br><br>Internal<br>Paint - Enamel,<br>plasterboard walls and<br>ceilings<br><br>Prepare And Repaint | Very Good - As<br>New | Internal decoration presents in very good<br>condition | m2 | 111 | \$24 | \$2,644 | \$3,143 | |

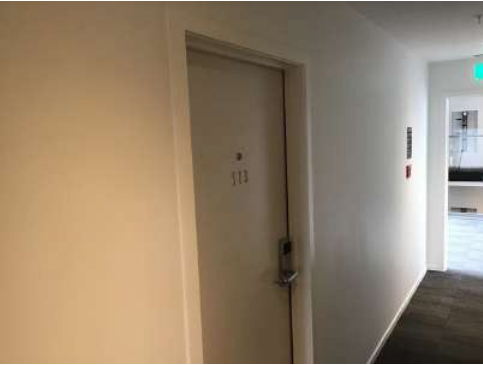
| Location | Building Element | Condition | Comments | Unit | Quantity | Unit Cost | Current cost | Future Cost | Photographs |
|---|---|---|---|---|---|---|---|---|---|
| Block 5<br>Internal<br>Level 2 | <b>Decoration</b><br><br>Internal<br>Paint to door and frame<br><br>Repaint Door And Frame<br>(One Side Only) | Very Good - As New | Internal decoration presents in very good condition | m | 6 | \$105 | \$630 | \$749 | |

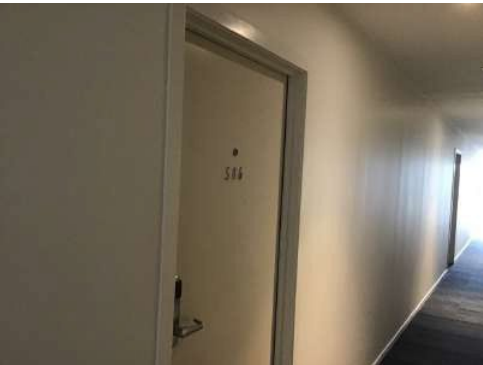
| Location | Building Element | Condition | Comments | Unit | Quantity | Unit Cost | Current cost | Future Cost | Photographs |
|---|---|---|---|---|---|---|---|---|---|
| Block 5<br>Internal<br>Level 1 | <b>Decoration</b><br><br>Internal<br>Paint to door and frame<br><br>Repaint Door And Frame<br>(One Side Only) | Very Good - As New | Internal decoration presents in very good condition | m | 6 | \$105 | \$630 | \$749 | |

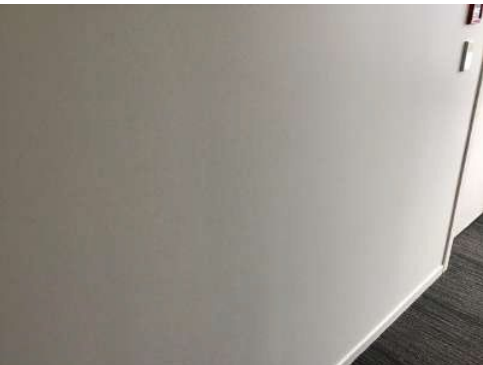
| Location | Building Element | Condition | Comments | Unit | Quantity | Unit Cost | Current cost | Future Cost | Photographs |
|---|---|---|---|---|---|---|---|---|---|
| Block 6<br>Internal<br>Ground floor | <b>Decoration</b><br><br>Internal<br>Paint - Enamel,<br>plasterboard walls and<br>ceilings<br><br>Prepare And Repaint | Very Good - As New | Internal decoration presents in very good condition | m2 | 150 | \$24 | \$3,573 | \$4,247 | |

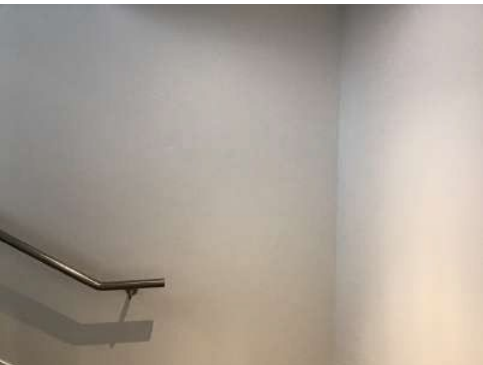
| Location | Building Element | Condition | Comments | Unit | Quantity | Unit Cost | Current cost | Future Cost | Photographs |
|---|---|---|---|---|---|---|---|---|---|
| Block 6<br>Internal<br>Stairway and<br>Landings | <b>Decoration</b><br><br>Internal<br>Paint - Enamel,<br>plasterboard walls and<br>ceilings<br><br>Prepare And Repaint | Very Good - As New | Internal decoration presents in very good condition | m2 | 260 | \$24 | \$6,193 | \$7,362 | |

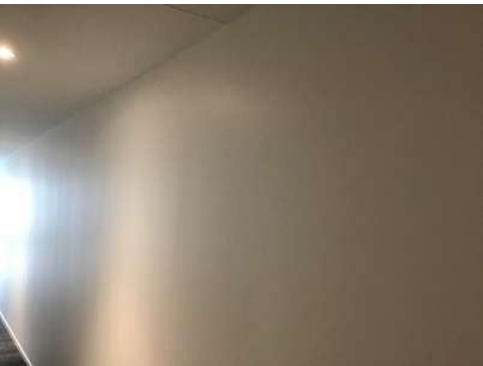
| Location | Building Element | Condition | Comments | Unit | Quantity | Unit Cost | Current cost | Future Cost | Photographs |
|---|---|---|---|---|---|---|---|---|---|
| Block 6<br>Internal<br>Level 1 | <b>Decoration</b><br><br>Internal<br>Paint - Enamel,<br>plasterboard walls and<br>ceilings<br><br>Prepare And Repaint | Very Good - As New | Internal decoration presents in very good condition | m2 | 150 | \$24 | \$3,573 | \$4,247 | |

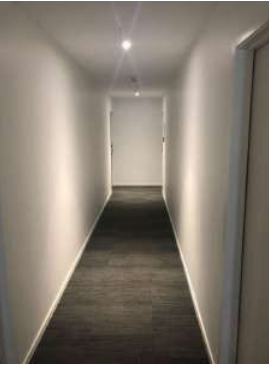
| Location | Building Element | Condition | Comments | Unit | Quantity | Unit Cost | Current cost | Future Cost | Photographs |
|---|---|---|---|---|---|---|---|---|---|
| Block 6<br>Internal<br>Level 2 | <b>Decoration</b><br><br>Internal<br>Paint - Enamel,<br>plasterboard walls and<br>ceilings<br><br>Prepare And Repaint | Very Good - As<br>New | Internal decoration presents in very good<br>condition | m2 | 150 | \$24 | \$3,573 | \$4,247 | |

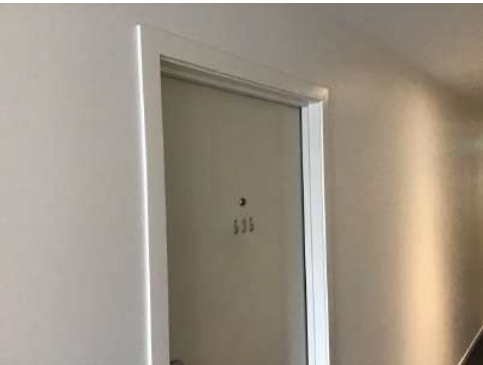
| Location | Building Element | Condition | Comments | Unit | Quantity | Unit Cost | Current cost | Future Cost | Photographs |
|---|---|---|---|---|---|---|---|---|---|
| Block 6<br>Internal<br>Ground floor | <b>Decoration</b><br><br>Internal<br>Paint to door and frame<br><br>Repaint Door And Frame<br>(One Side Only) | Good - Minor<br>Defects | Internal decoration presents in very good<br>condition | m | 8 | \$105 | \$840 | \$998 | |

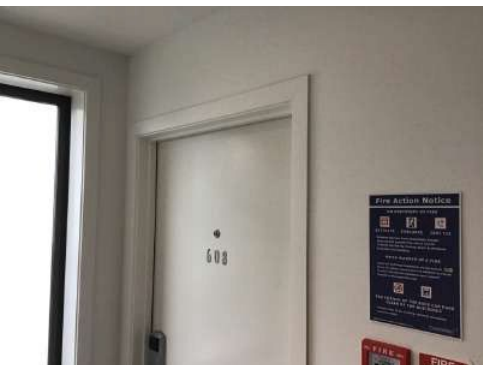
| Location | Building Element | Condition | Comments | Unit | Quantity | Unit Cost | Current cost | Future Cost | Photographs |
|---|---|---|---|---|---|---|---|---|---|
| Block 6<br>Internal<br>Level 1 | <b>Decoration</b><br><br>Internal<br>Paint to door and frame<br><br>Repaint Door And Frame<br>(One Side Only) | Very Good - As<br>New | Internal decoration presents in very good<br>condition | m | 8 | \$105 | \$840 | \$998 | |

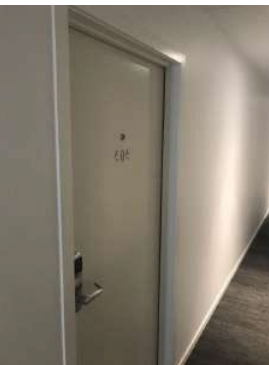
| Location | Building Element | Condition | Comments | Unit | Quantity | Unit Cost | Current cost | Future Cost | Photographs |
|---|---|---|---|---|---|---|---|---|---|
| Block 6<br>Internal<br>Level 2 | <b>Decoration</b><br><br>Internal<br>Paint to door and frame<br><br>Repaint Door And Frame<br>(One Side Only) | Very Good - As<br>New | Internal decoration presents in very good<br>condition | m | 8 | \$105 | \$840 | \$998 | |

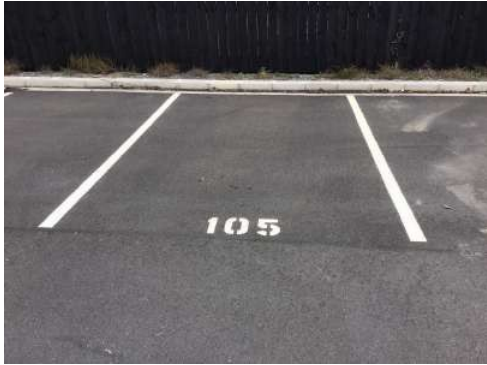
| Location | Building Element | Condition | Comments | Unit | Quantity | Unit Cost | Current cost | Future Cost | Photographs |
|---|---|---|---|---|---|---|---|---|---|
| External common areas<br>External | External Works | Very Good - As New | | m | 380 | \$14 | \$5,320 | \$6,324 | |

| Location | Building Element | Condition | Comments | Unit | Quantity | Unit Cost | Current cost | Future Cost | Photographs |
|---|---|---|---|---|---|---|---|---|---|
| | Repaint Car Park Markings | | | | | | | | |

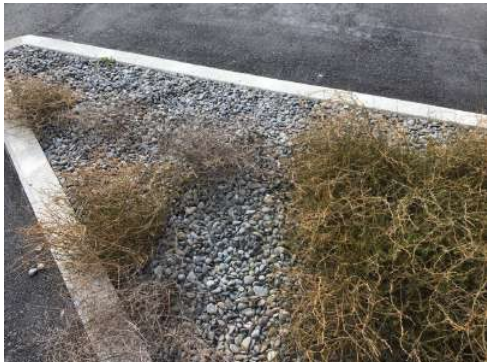
| Location | Building Element | Condition | Comments | Unit | Quantity | Unit Cost | Current cost | Future Cost | Photographs |
|---|---|---|---|---|---|---|---|---|---|
| External common areas<br>External | External Works | Very Good - As New | | No | 1 | \$2,500 | \$2,500 | \$2,972 | |

| Location | Building Element | Condition | Comments | Unit | Quantity | Unit Cost | Current cost | Future Cost | Photographs |
|---|---|---|---|---|---|---|---|---|---|
| | Soft Landscaping<br>Replace weed mat, bark or similar and planting<br><br>Replace Areas Of Weed mat and Stones | | | | | | | | |

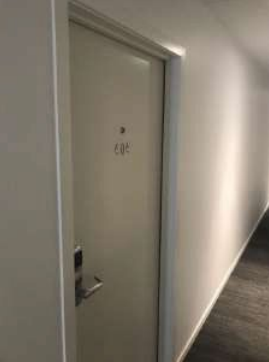
| Block 1<br>Internal/External | Doors<br><br>Personnel<br>Electronic Door Entry<br>System<br>General Repair Allowance<br>Door Entry Systems<br><br>General Repair Allowance<br>Door Entry Systems | Very Good - As<br>New | | No | 1 | \$1,500 | \$1,500 | \$1,828 | |

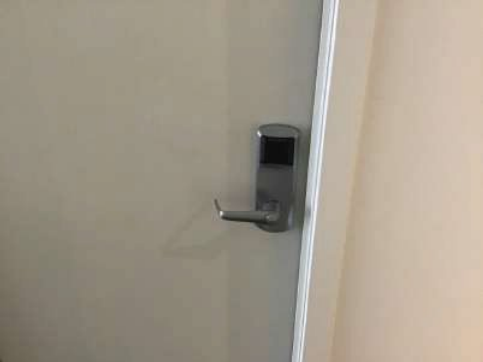
| Block 2<br>Internal<br>General Internal | Doors<br><br>Personnel<br>Electronic Door Entry<br>System<br>General Repair Allowance<br>Door Entry Systems<br><br>General Repair Allowance<br>Door Entry Systems | Very Good - As<br>New | | No | 1 | \$1,500 | \$1,500 | \$1,828 | |

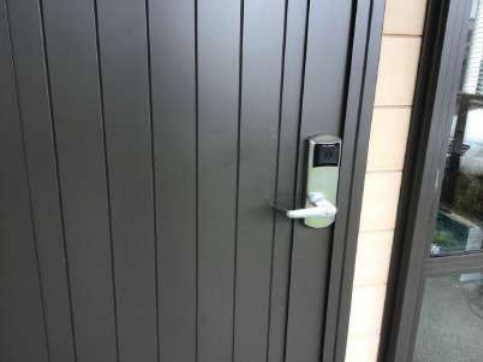
| Block 3<br>Internal/External | Doors<br><br>Personnel<br>Electronic Door Entry<br>System<br>General Repair Allowance<br>Door Entry Systems<br><br>General Repair Allowance<br>Door Entry Systems | Very Good - As<br>New | | No | 1 | \$1,500 | \$1,500 | \$1,828 | |

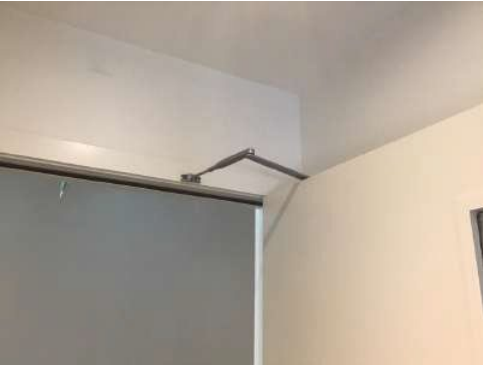
| Block 1<br>Internal<br>Level 2 | <div>Doors</div> <div>Personnel<br/>Door closer</div> <div>Replace Door Closer</div> | Very Good - As<br>New | | No. | 1 | \$370 | \$370 | \$462 | |

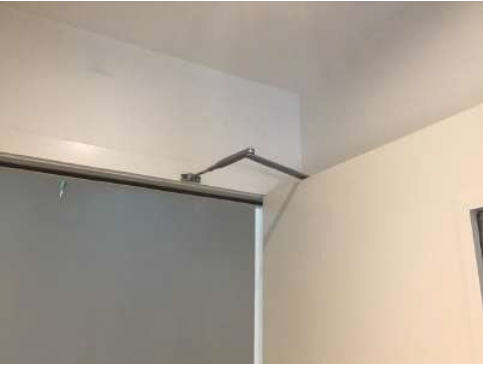
| Block 1<br>Internal<br>Level 1 | <div>Doors</div> <div>Personnel<br/>Door closer</div> <div>Replace Door Closer</div> | Very Good - As<br>New | | No. | 1 | \$370 | \$370 | \$462 | |

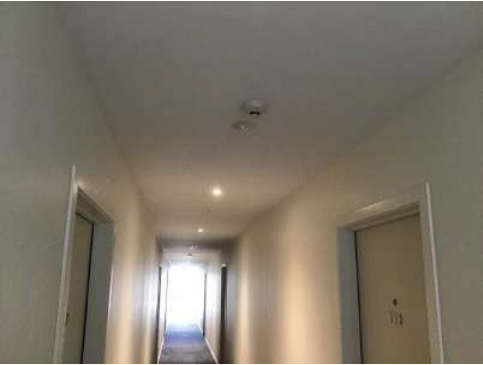
| Location | Building Element | Condition | Comments | Unit | Quantity | Unit Cost | Current cost | Future Cost | Photographs |
|---|---|---|---|---|---|---|---|---|---|
| Block 1<br>Internal<br>Level 2 | <b>Fire Safety</b><br><br>Active Fire Protection<br>Smoke Alarms, Wired<br><br>Replace Unit | Very Good - As<br>New | | No. | 3 | \$191 | \$573 | \$715 | |

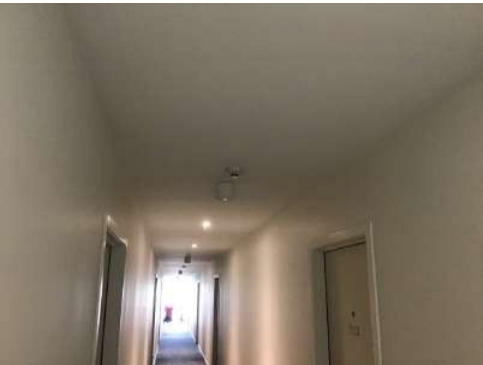
| Location | Building Element | Condition | Comments | Unit | Quantity | Unit Cost | Current cost | Future Cost | Photographs |
|---|---|---|---|---|---|---|---|---|---|
| Block 1<br>Internal<br>Level 1 | <b>Fire Safety</b><br><br>Active Fire Protection<br>Smoke Alarms, Wired<br><br>Replace Unit | Very Good - As<br>New | | No. | 3 | \$191 | \$573 | \$715 | |

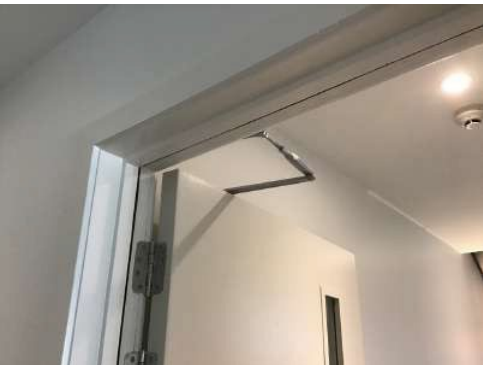
| Location | Building Element | Condition | Comments | Unit | Quantity | Unit Cost | Current cost | Future Cost | Photographs |
|---|---|---|---|---|---|---|---|---|---|
| Block 2<br>Internal<br>Level 2 | <b>Doors</b><br><br>Personnel<br>Door closer<br><br>Replace Door Closer | Very Good - As<br>New | | No. | 1 | \$370 | \$370 | \$462 | |
