## Visual Non-Invasive Property Inspection

21/05/2026

Phil Staunton

2 Chrystalwood Lane, Governors Bay

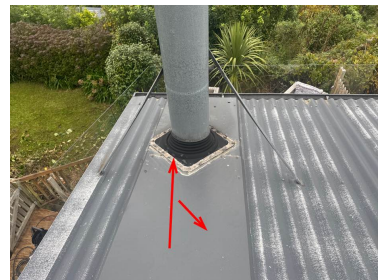
**Chimney penetration flashing**

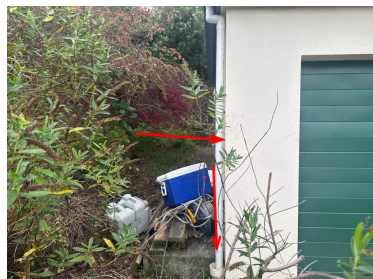
**All downpipes directed into stormwater as intended**

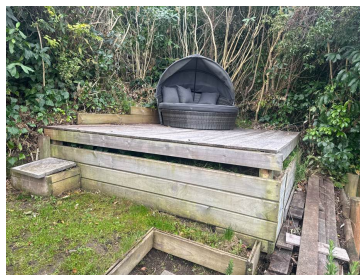
This platform needs a handrail, straightening underneath, steps
