**GEOTECHNICAL ASSESSMENT REPORT**  
**Proposed Subdivision**  
**LOT 36 DPS 328**  
**15 Glenfield Road, Owhata, Rotorua**

**Geotechnical Assessment for Proposed Subdivision**  
**15 Glenfield Road, Owkata, Rotorua**  
**February 2022**

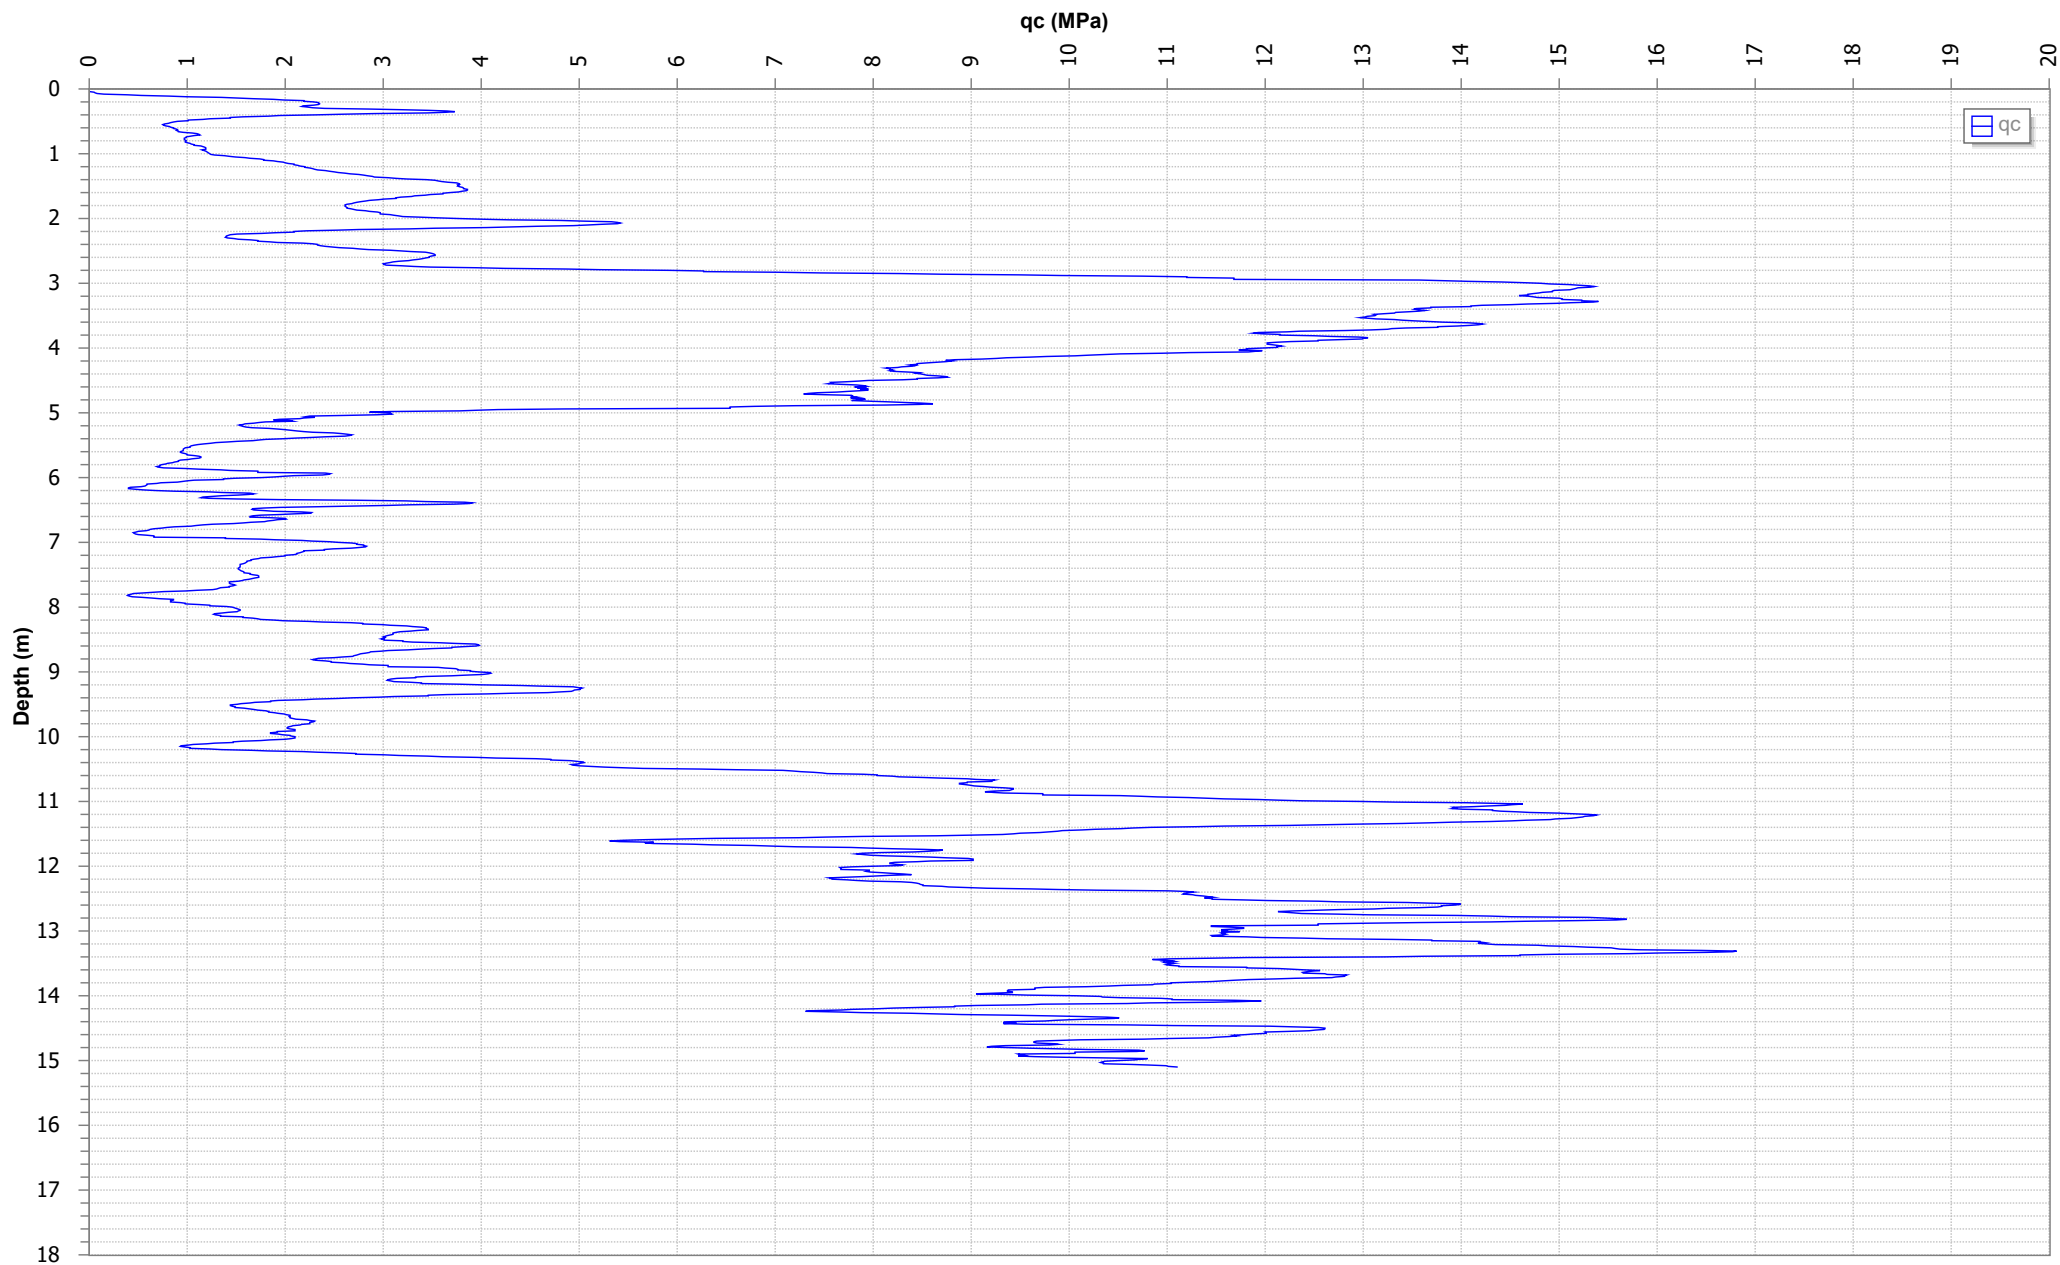
**APPENDIX H**  
**CPT Result (CPT01)**

# TIP RESISTANCE (q<sub>c</sub>)

Test No: **CPT01**

As the groundwater was detected at the depth of about 11.3m below ground level in the CPT hole only, we believe groundwater to be of the order of 11m or more below ground level, giving a significant depth of non-liquefiable 'crust' deposits. This crust will protect the site and structure from surface manifestations of liquefaction such as sand boils and fissures and should mitigate against differential settlement induced by liquefaction of deeper strata.
