# EARTHQUAKE RECOVERY (EQR) DOCUMENTATION

# EQR Property Overview Report

| EQC Property ID | Property Address | Vulnerable? | Property F Status | Property Finalisation Indicator | | |
|---|---|---|---|---|---|---|
| 2010131653 | 30 GLENROWAN AVENUE, AVONDALE | | F3 - Complete & Finalised | Some Finalisation has taken place | | |

## Increased Flooding Vulnerability (IFV) Engineering Assessment

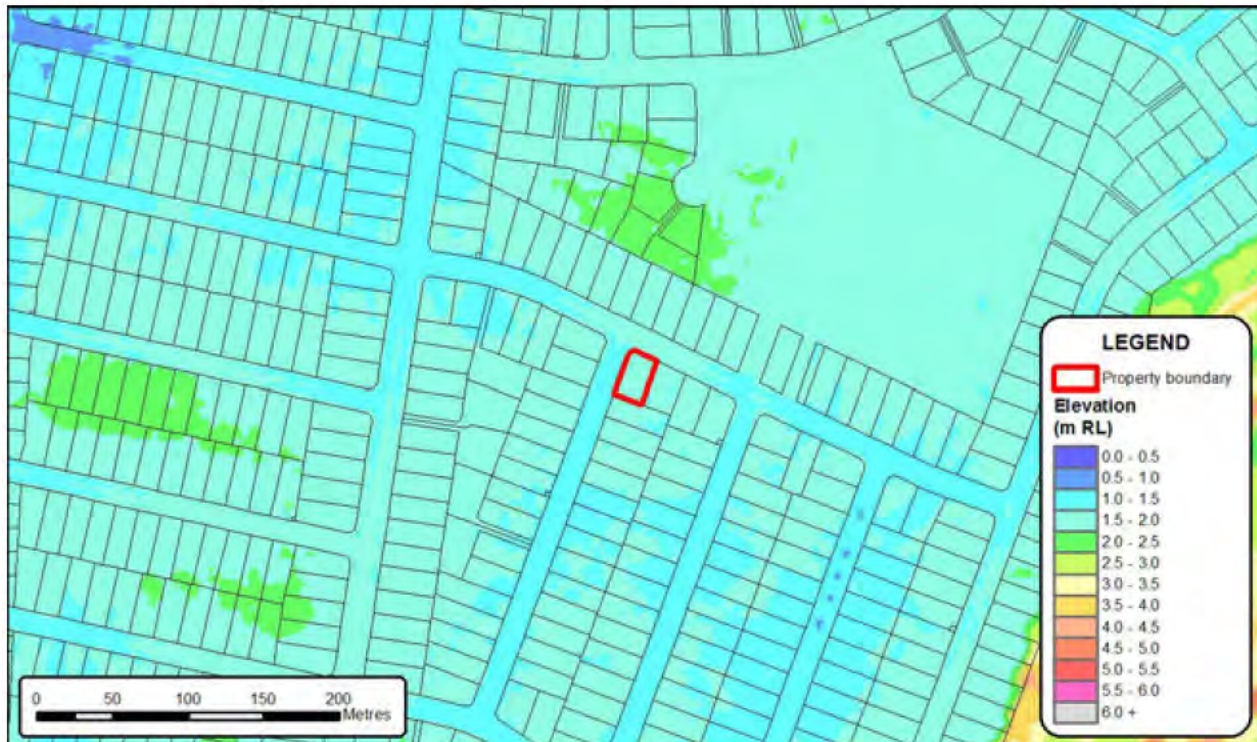
Map 4: Ground surface elevation post December 2011

Map 4 shows the ground elevation (i.e. the height of the land) following the Canterbury earthquake sequence. The ground surface elevation was measured using an aerial LiDAR survey (which involved scanning the ground surface

from an aircraft). This post-earthquake ground elevation survey is a key input into the modelling of the post-earthquake flood depth. Similar surveys were used as an input into the modelling of pre-earthquake flood depths.
