Geotechnical Assessment Report

**New 3 Lot Subdivision
27 Cureton Street, Morrinsville**

**Resource Consent - REV 2
31 January 2025**

25-0008 New 3 Lot Subdivision at 27 Cureton Street, Morrinsville

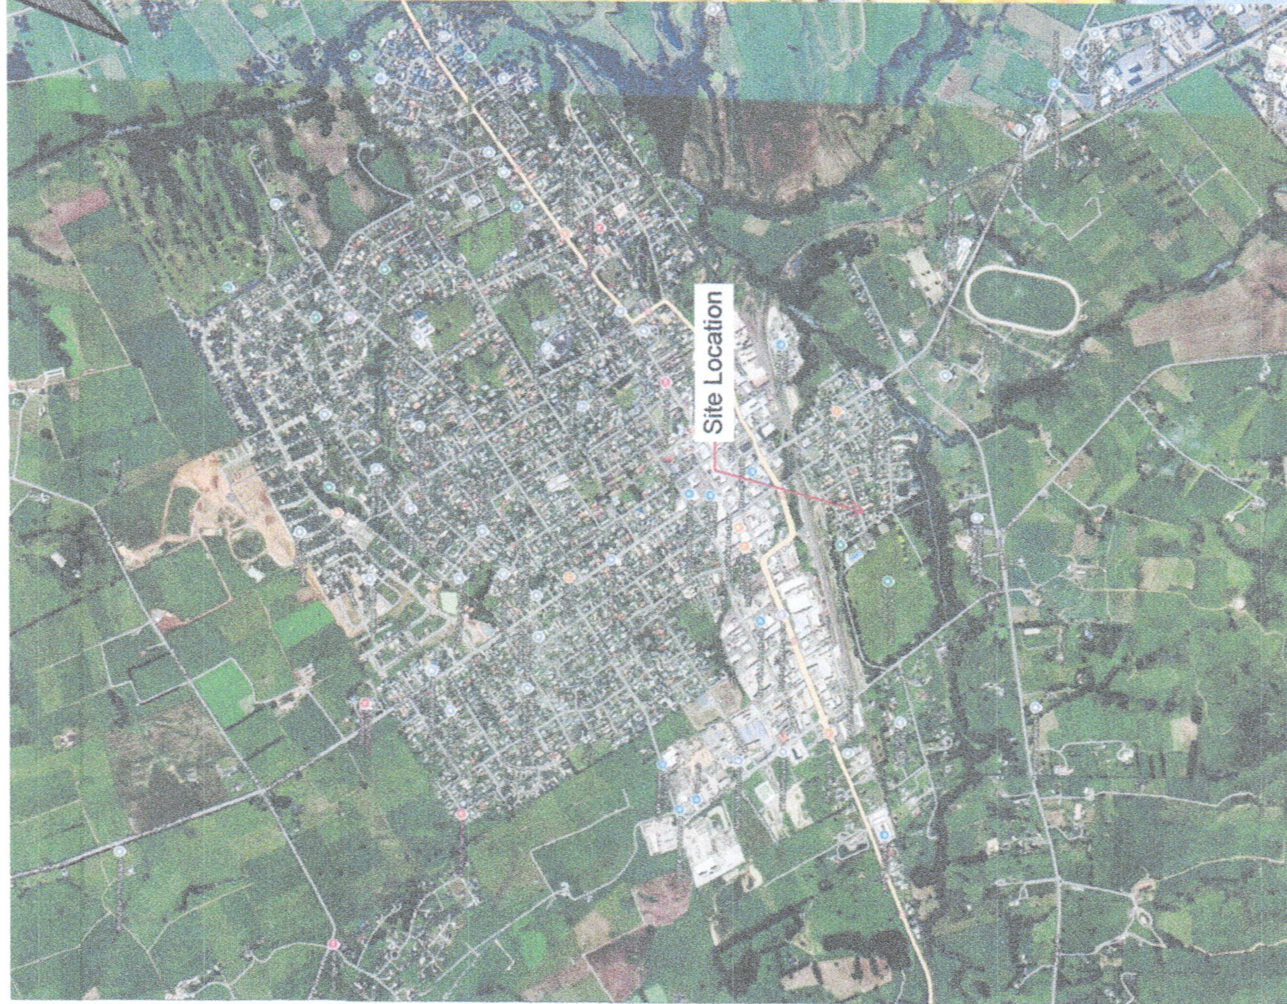
BIBLIOGRAPHIC REFERENCE

Leonard, G.S., Begg, J.G., Wilson, C.J.N. (compilers) 2010. Geology of the Rotorua area. Institute of Geological & Nuclear Sciences 1:250 000 geological map 5. 1 sheet + 102 p. Lower Hutt, New Zealand. GNS Science.

The 1:250,000 scale geological map (Leonard, G. S., Begg, J. G., Wilson, C.J.N, 2010) indicates that the site is underlain by Hinuera Formation, which is described as volcanogenic alluvium, comprised of cross-bedded sand, silt and gravel with interbedded peat. The Hinuera Formation is found throughout the Waikato alluvial plain and is typically deposited in a series of levees and swales of differing material composition representing the various depositional environments of the ancient, braided Waikato River system. (Lowe, 2010).
