## MARTIN McCAULAY MORTON LTD

re: RUTHERFORD - WESTBROOK PLACE - YOUR  
REF: 6596021

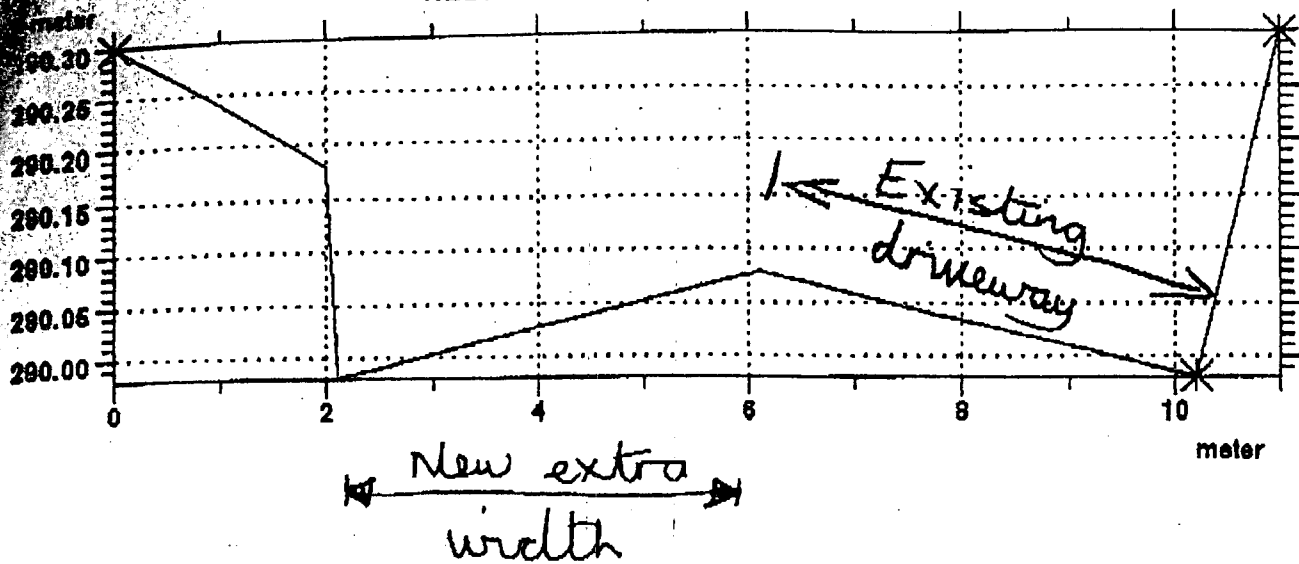
WESTBROOK 10.144 km TOPO ID : PETRIE

Typical x-s for  
new secondary flowpath  
at Westbrook Place

It was found that ~~even~~ with energy losses in the new manhole, the water level at 22 Petrie St was not affected. The water level was RL294.61m at 22 Petrie St for the 50 year return period storm used previously.
