Consent No: **24009002**  
Applicant: **Shannon Marie Burgess**  
Site Address: **7 Whitehaven Street, Weston**  
Work Type: **Construction of a 4 bedroom, 2 bathroom dwelling with media room and attached garage.**

Inspection Type: **Pre-Cladding - Wrap**  
Inspection Status: **Pass**  
Inspected By: **Gordon Innes**  
Inspection Date: **30 September 2024 11:54 AM**  
Duration: **45 minutes**

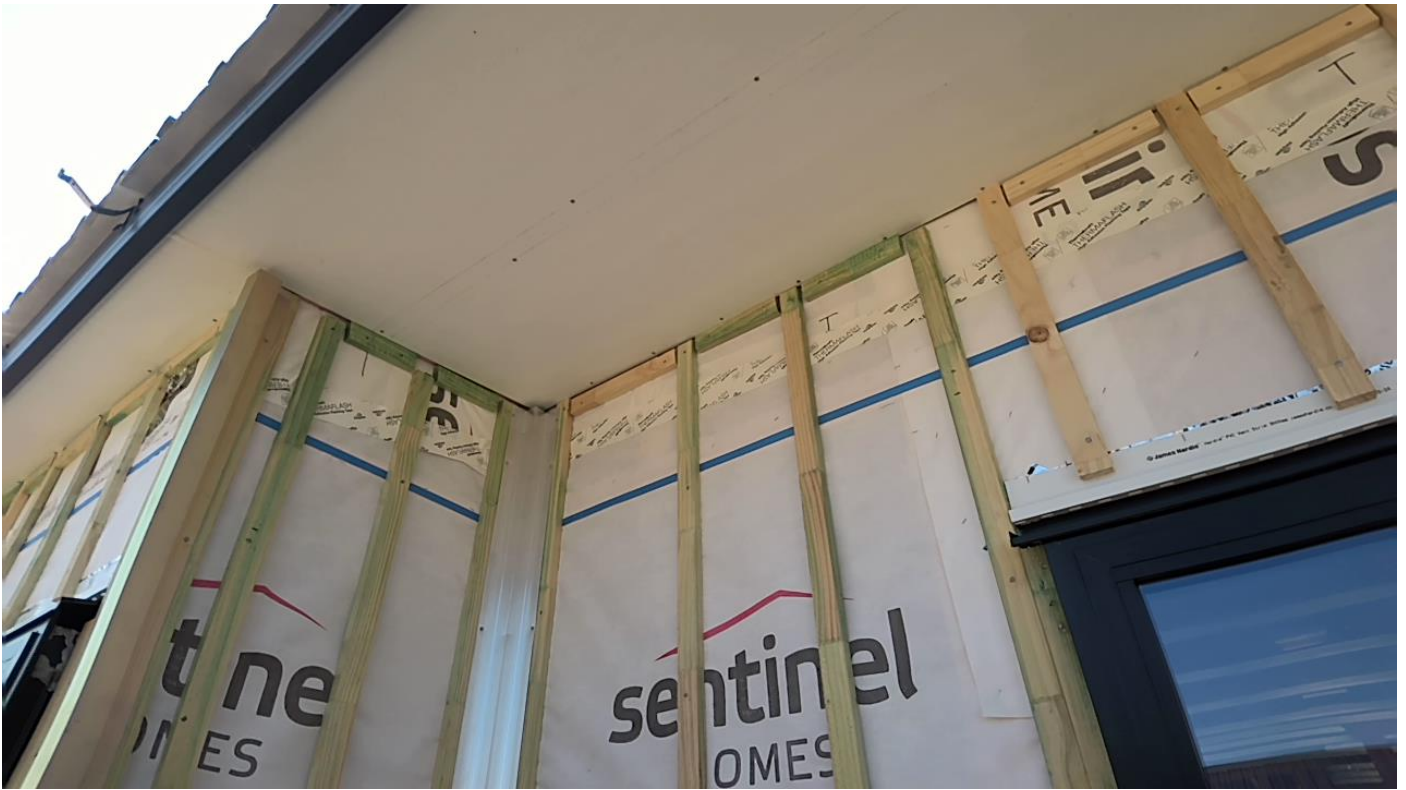
**Internal corner flashing**  
Taken at 11:59 AM on Monday 30/09/2024

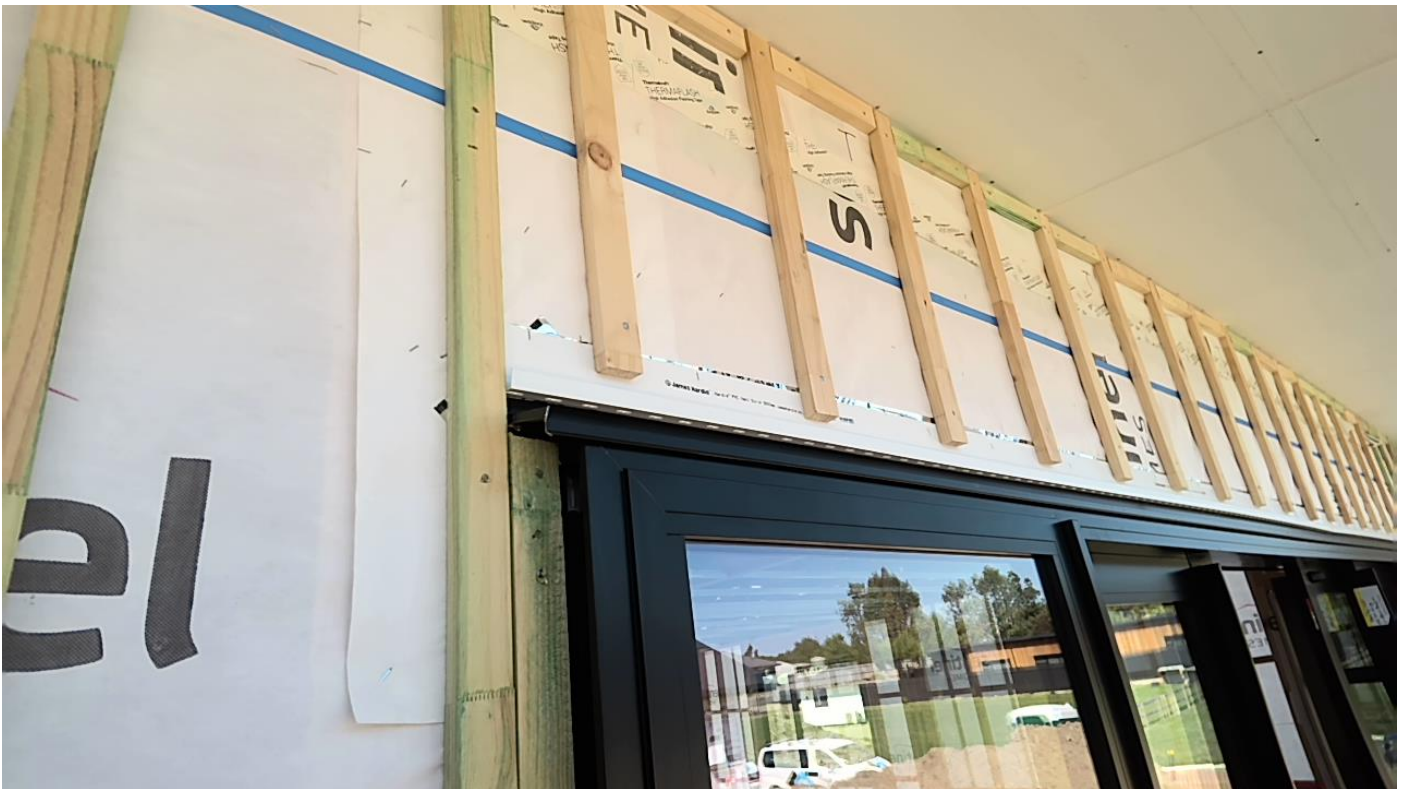
| <b>Stop ends in place at head flashing's as detailed.</b> | |
| <b>Head flashing's in place, correct dimensions and taped to wrap as detailed on the consent documents.</b> | |

**Head flashing with stop end**  
Taken at 11:59 AM on Monday 30/09/2024

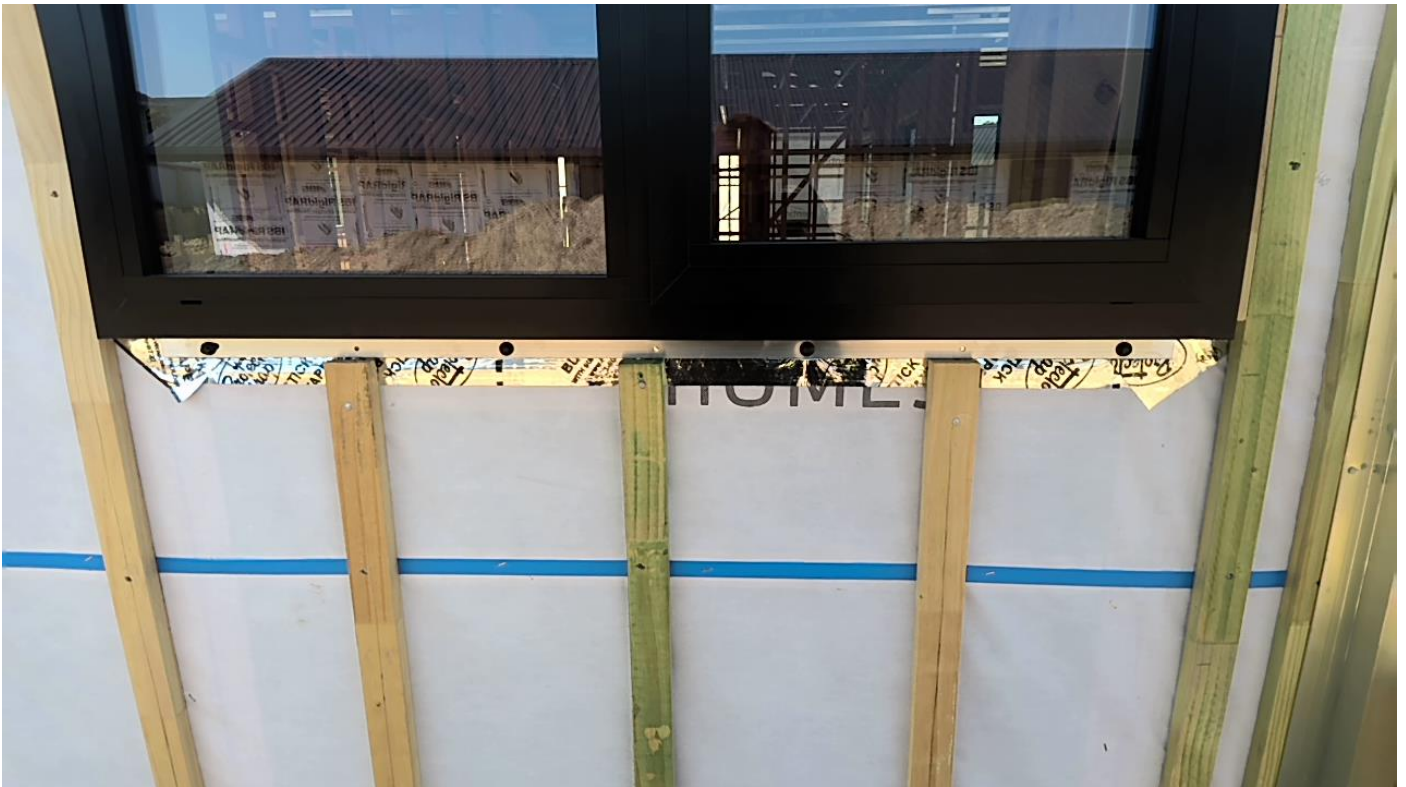
| <b>Support bars are in place, full length and fixed correctly to the framing.</b> | |

**Supportr bar in place**  
Taken at 11:59 AM on Monday 30/09/2024

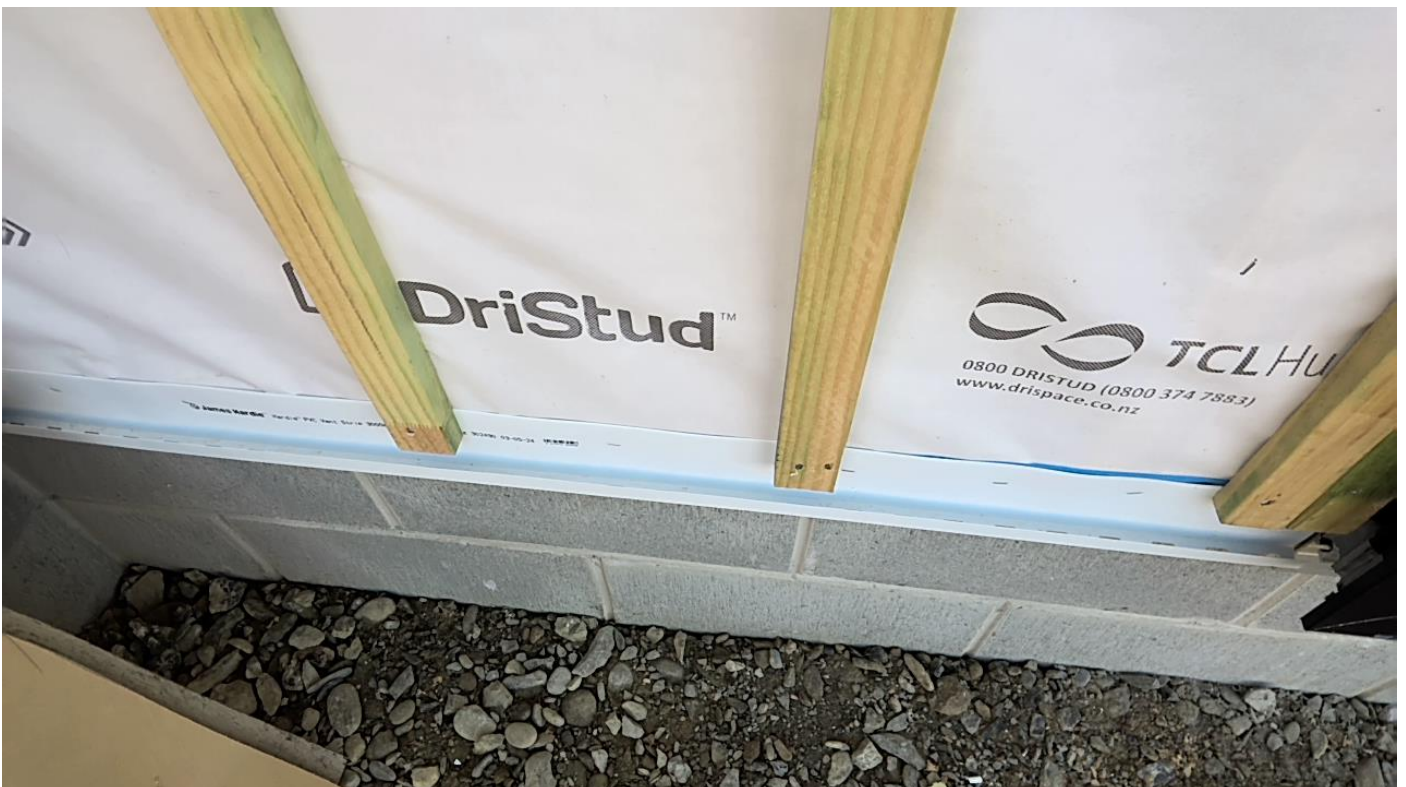
| <b>No gaps greater than 13mm noted during inspection, sufficient vermin proofing has been achieved.</b> | |

**Vermin control in place**  
Taken at 12:00 PM on Monday 30/09/2024

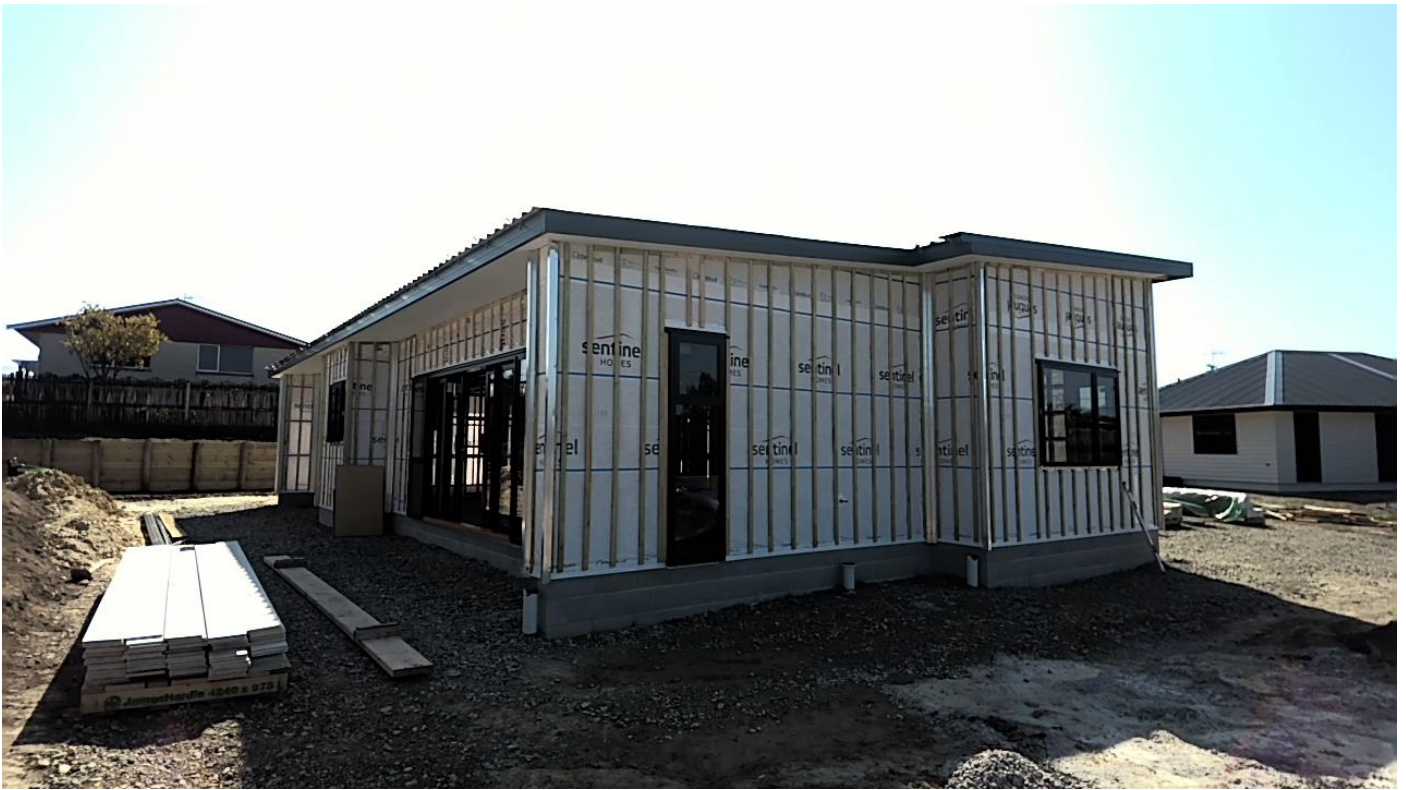
**Overview at pre clad wrap**  
Taken at 12:00 PM on Monday 30/09/2024

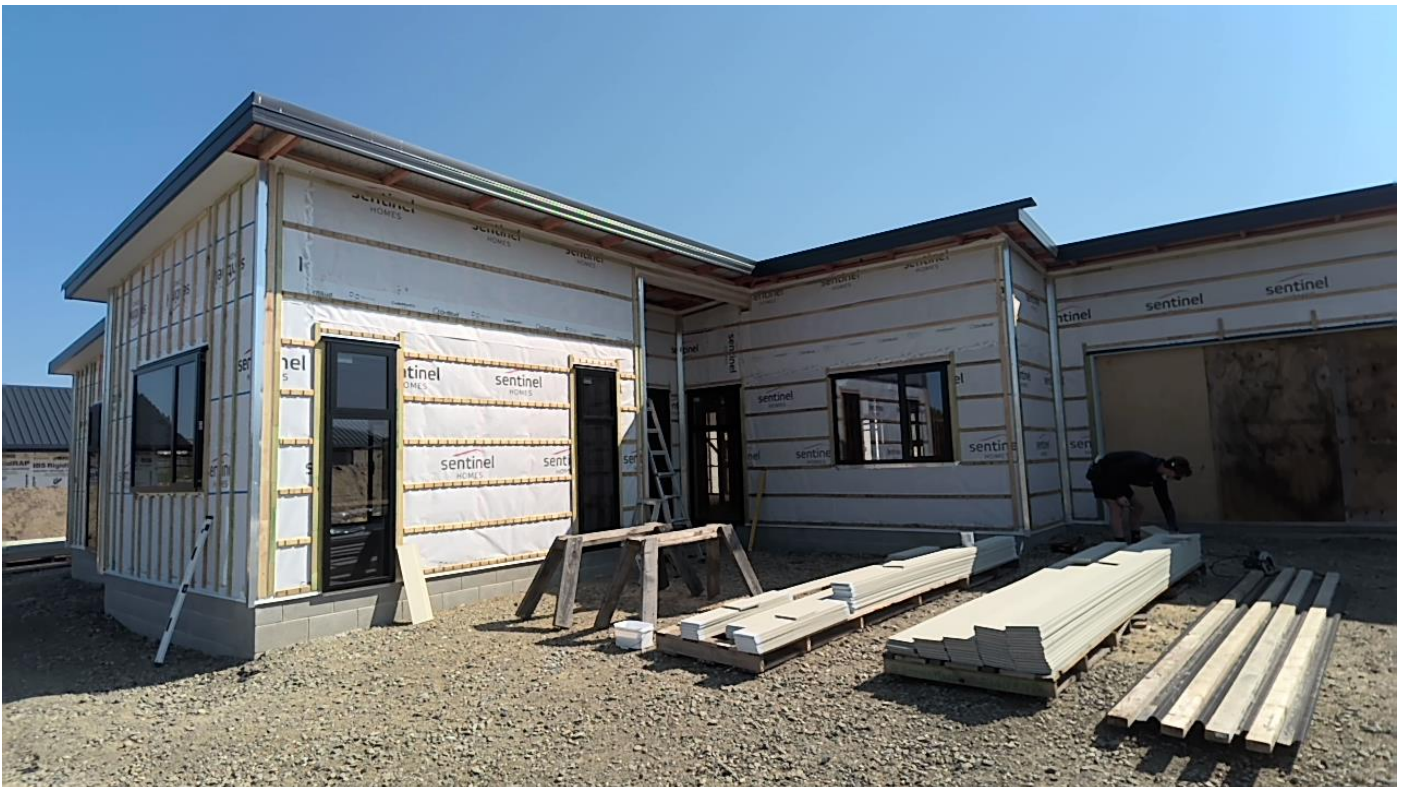
| Inspection Element | Status |
|---|---|
| <b>Battens are Max 300mm CRS for lineal, 400mm nogs for oblique so restraint for insulation is in place.</b> | |

**Overview of oblique area**  
Taken at 12:01 PM on Monday 30/09/2024

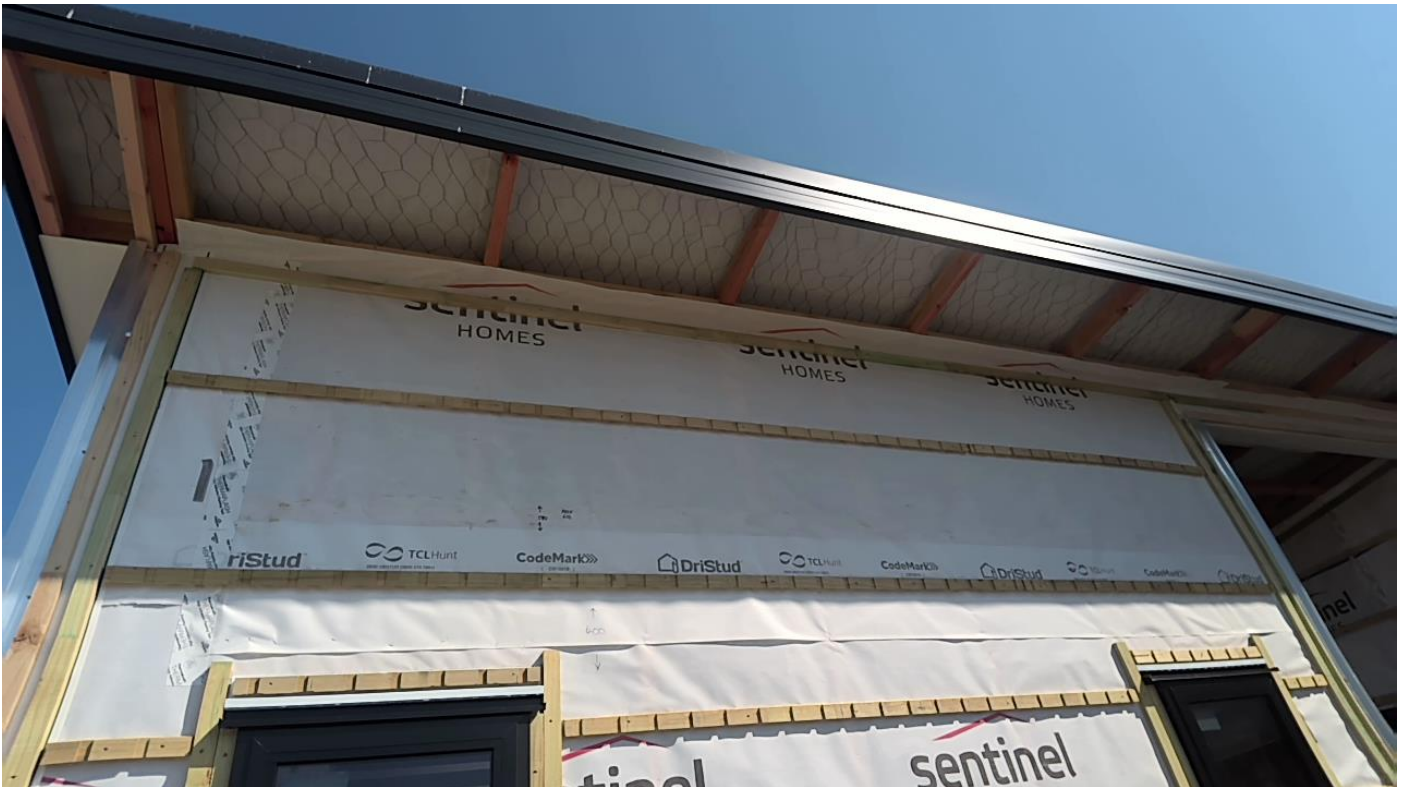
**Eave flashing to be added after cladding installed**  
Taken at 12:01 PM on Monday 30/09/2024

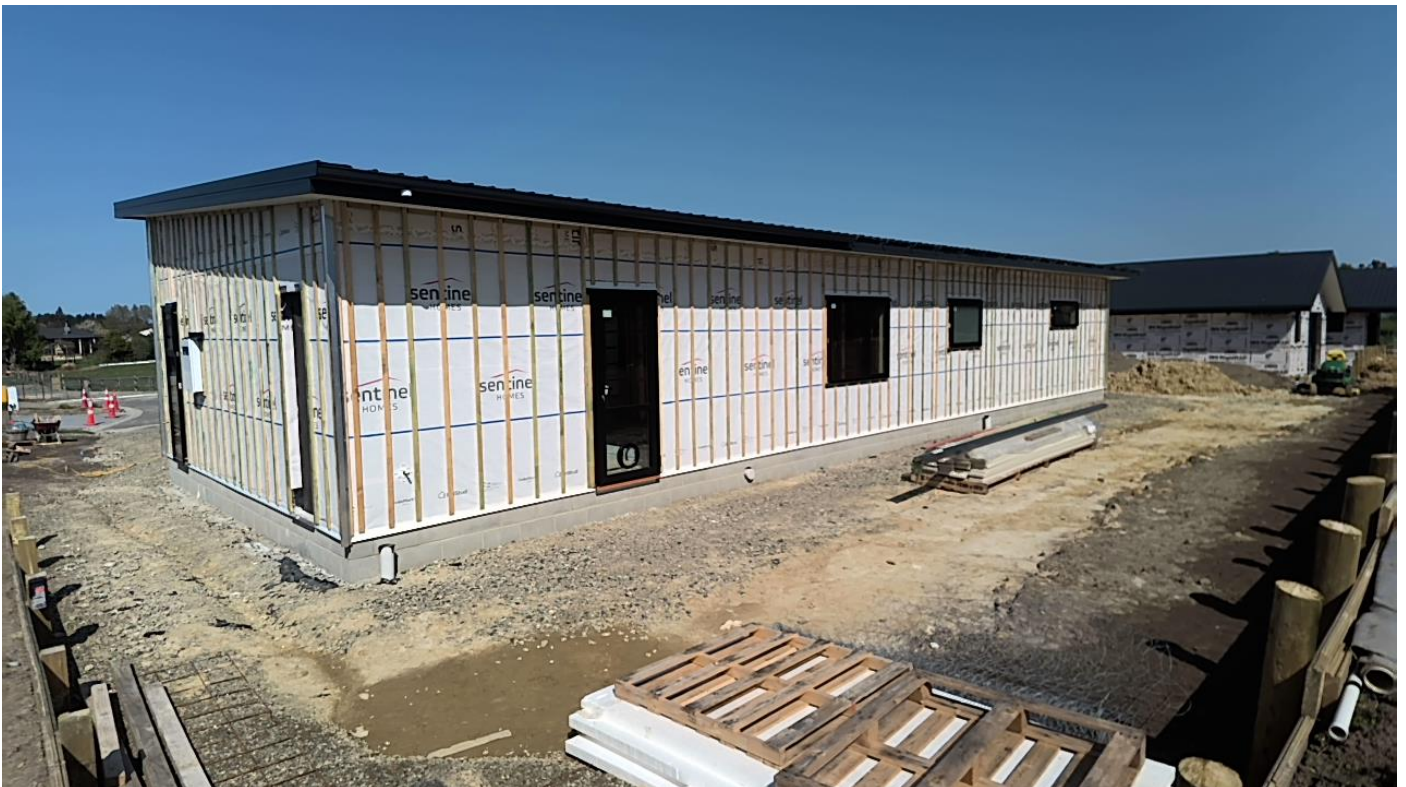
**Overview at pre clad wrap north elevation**  
Taken at 12:03 PM on Monday 30/09/2024
