# Air Monitoring Report : Work in Progress

30 Garden Heights Avenue, Glenview,  
Hamilton 3206

5 May 2026

Job ID 167 - WIP Air Monitoring

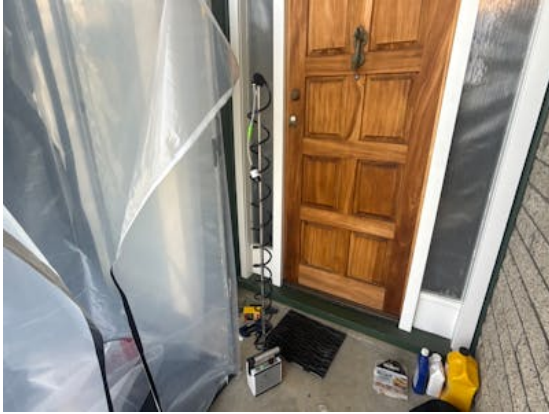
**Decontamination Unit**

Cowl Number: 348

Location: Front porch

Flow Rate (l/m): 2

Comments: Results: &lt;0.01 F/mL

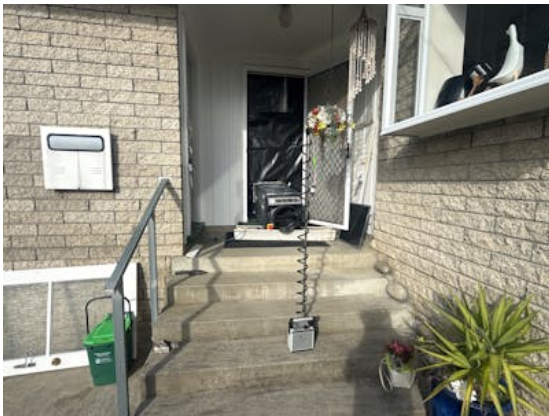
**Negative Pressure Unit**

Cowl Number: 438

Location: Rear porch

Flow Rate (l/m): 2

Comments: Results: &lt;0.01 F/mL
